HAMBLETON DISTRICT COUNCIL

Report To: Planning Committee
1 March 2012

Subject: TREE PRESERVATION ORDER NO 2011/4 – KNAYTON

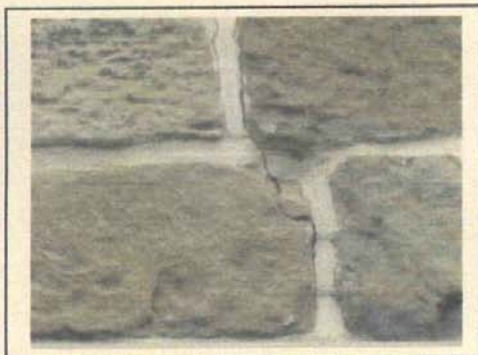
Vertical and radial cracks up to about 3mm wide exist in some of the external stonework towards the LH side of the main house. The cracks generally taper in width along their length and extend for over 2 metres in length to the underside of the roof eaves.. The cracks have appeared within the last 3 months and appear to be increasing in magnitude and extent.

Photo 3 – Typical Damage to External Stonework

Once the appropriate management has been undertaken the cracks should not be repaired for at least 2 years to allow the ground to recover and the cracks to close. The cracks can then be suitably repaired.

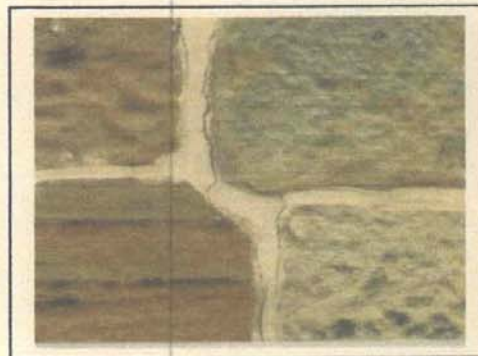
Photo 4 – Typical Damage to External Stonework

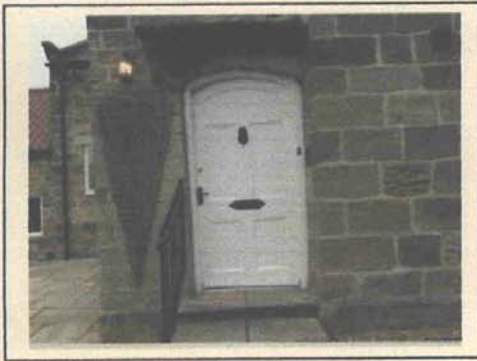
The front door frame and head have become distorted since the August inspection and the door now binds within the frame. Some of the stonework above the frame has become displaced.

Photo 5 – Distortion to Entrance Door

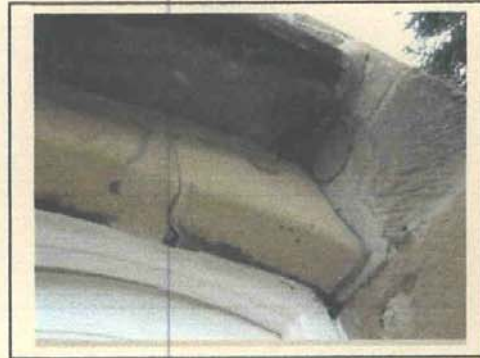
Photo 6 – Displaced Stonework above Door Head

The property is an older style residential house. The recent damage to the external stonework is minor although the displacement of the stonework above the front entrance door frame could cause some of the stones to fall away. The nature and disposition of the movement suggests it is most likely due to continuing root activity from the nearby tree although no major structural repairs are required at this time.

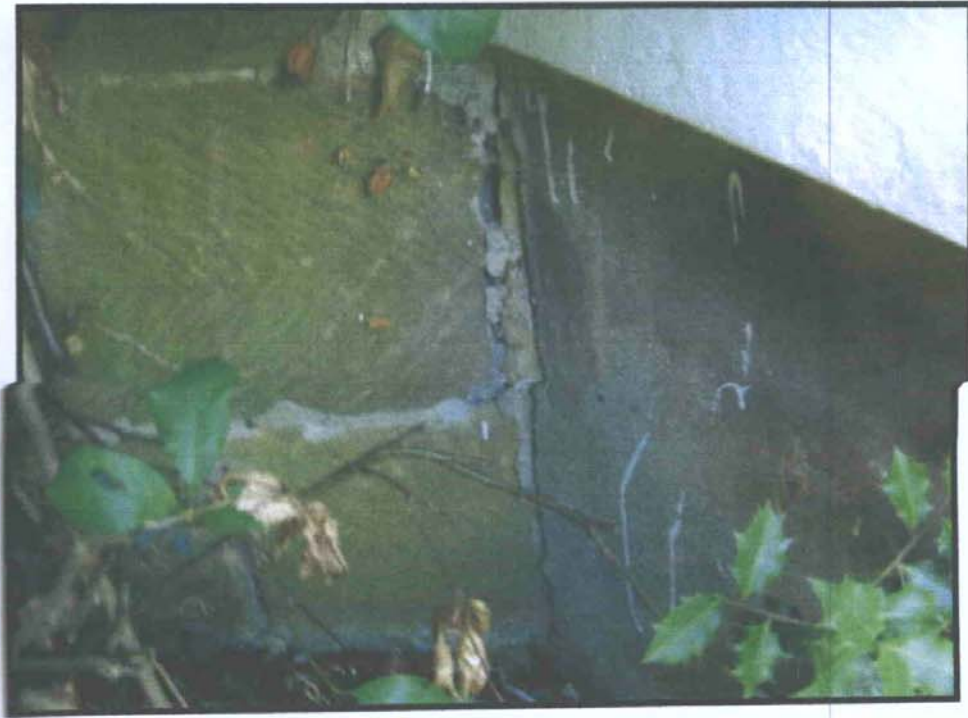
Cracked render to bay window lower wall

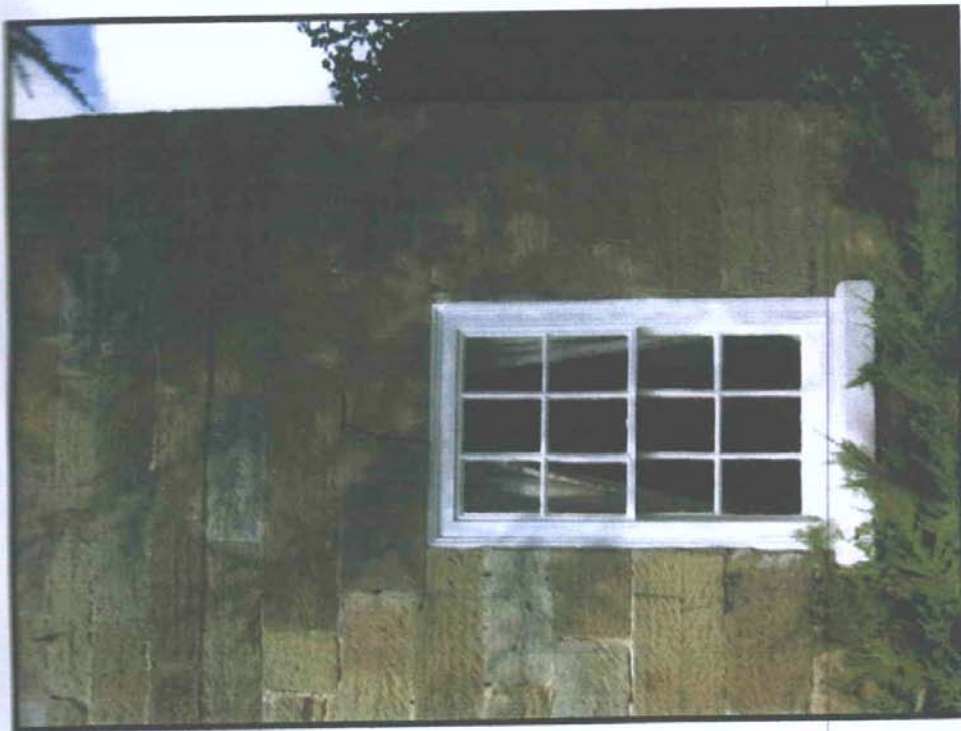
Left hand side gable with cracked lintel and cracking to wall

- 3.1 The vertical crack on the left hand gable wall is consistent with slight differential settlement between the front and side elevations of the property.

Crack stitching using
3 No. 1m long 6mm
stainless steel
Helical Bars.

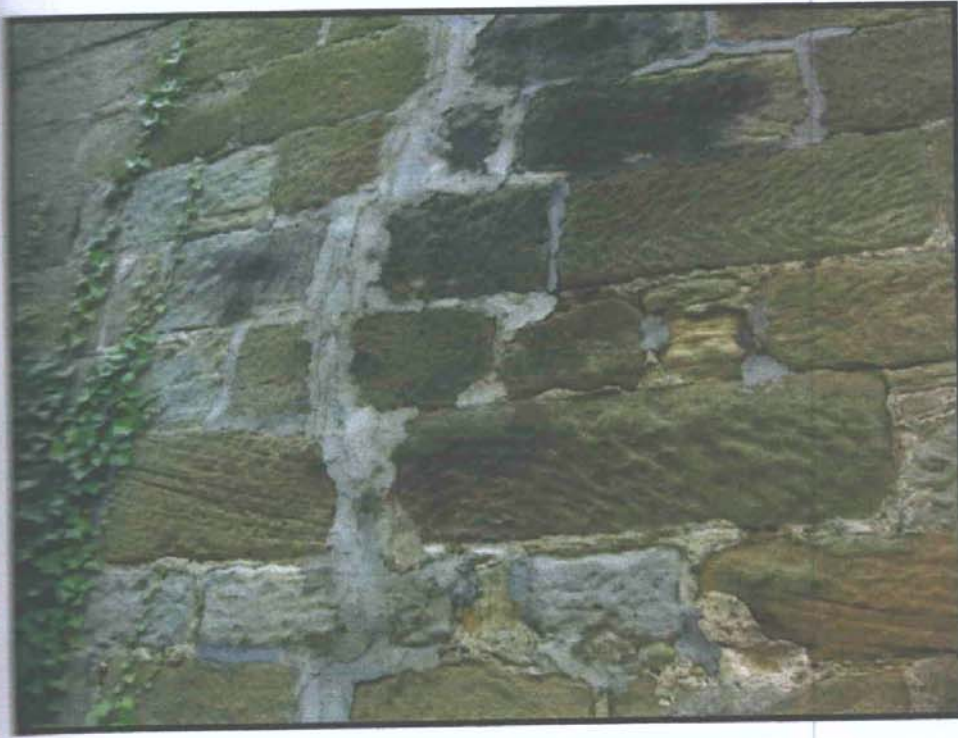
settlement between the front and side elevations of the property. In addition, the crack to the right-hand side Gable wall was considered to be exacerbated by the lack of tying between the masonry of the chimney and the Gable wall. Further cracking noted to the front elevation, notably the middle bedroom front wall was considered to be consistent with slight movement following the addition of the new Bay window.

Detailed view of right hand gable crack

Crack stitching using
6 No. 1m long 6mm
stainless steel
Helical Bars

Remove existing
cement mortar
along crack
and repoint
with lime
mortar after
stitch repairs.

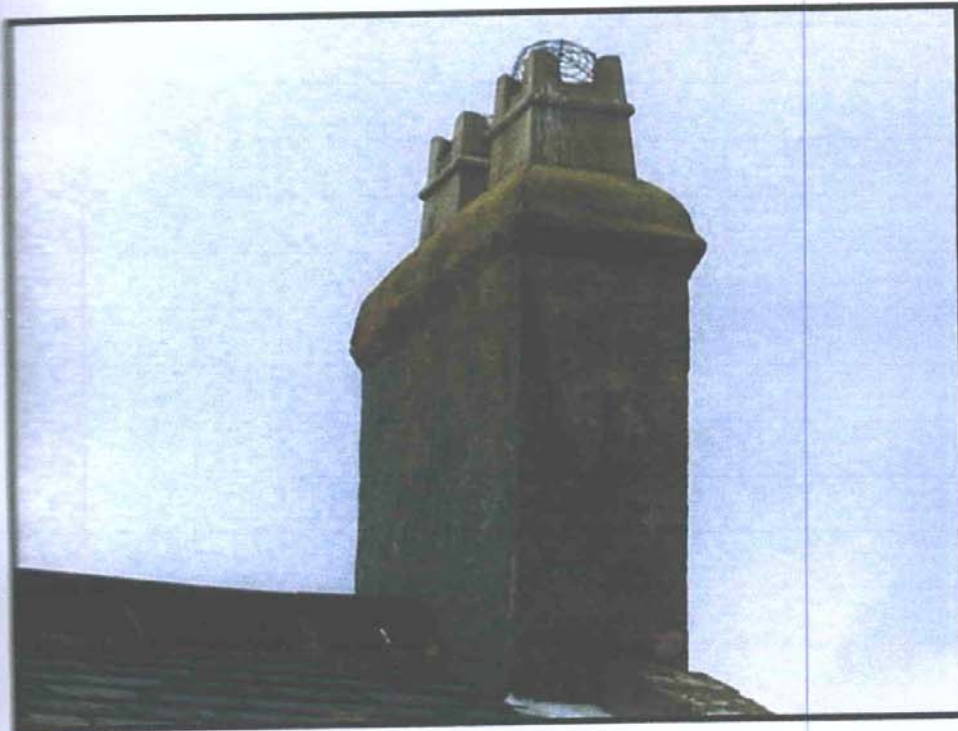
Right hand side chimney-stack leaning, and cracked and poor render
