Welburn Hall School

Appendix 2 – Heating and Drainage – Technical Assessment
29 September 2022

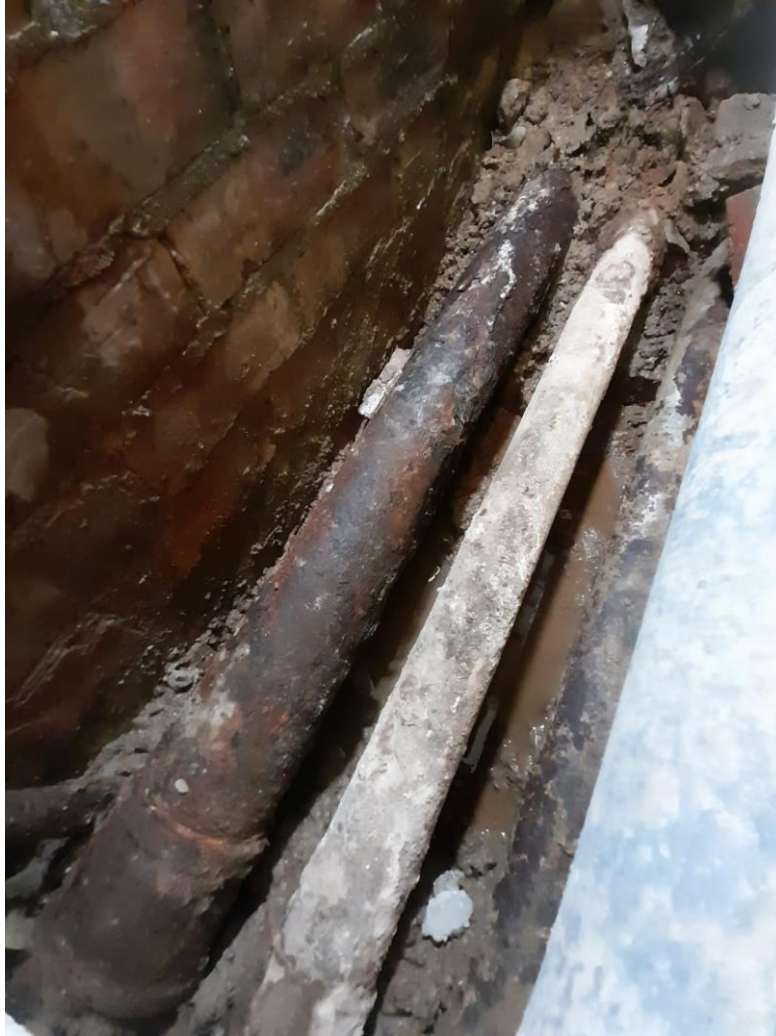
Fig2. Asbestos insulation and buried pipes in duct

Both the pipework and the ducts are insulated with ACM's (Asbestos Containing Materials) and, therefore, in accordance with the Control of Asbestos Regulations, can only be accessed under controlled conditions.

From the investigation and the repair of the heating pipework carried out in the winter of 21/22, it has been established that the pipework is in very poor condition and at risk of catastrophic failure. Such a failure would result in the affected area(s) not being heated and not usable by the School.

Note: There are 6No pipes in this duct – 5No are buried under silt/debris
