Whitby Cliff Lift – Lift Shaft and Tunnel Structures Options Report

North Yorkshire Council

31st January 2025

NY2455-APS-XX-XX-RP-S-000001

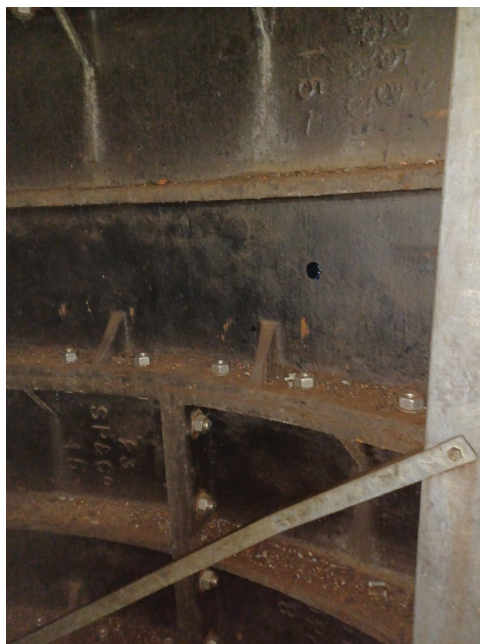
Ten thickness readings were taken in the shaft, ranging from 25.0mm to 26.1mm; at the landings on the staircase, with an average thickness of 25.6mm recorded. This is similar to the original shaft liner thickness of 25mm which indicates minimal section loss.

Plate 2: General view of test locations within shaft

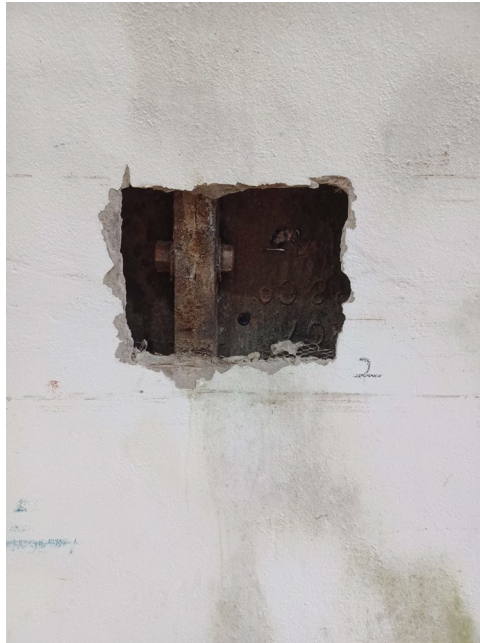
Similarly, eight readings were taken in the tunnel, ranging from 29.1mm to 32.5mm, with an average thickness of 30.1mm recorded. Referring to page 874 of the historical report (Appendix B) where the text implies that the tunnel lining thickness was different “*The tunnel was designed to be the same size as the shaft – namely, 15 ft. diameter outside and 14 ft. diameter inside, but the lining was 1 in. thick.*” This looks to be an error in the report as the thickness measured by IFA would suggest that 1 1/4in.(31.75mm) is more likely to be the original tunnel lining thickness. Based on this assumption, this indicates a 5.2% average section loss and an 8.4% max. section loss. However, this is an unknown and the initial thickness noted in the historical report at 1 inch (25.4mm) could be correct and the panels have been cast significantly thicker than this.

Plate 5: General view of exposed tunnel lining. Test Location 2

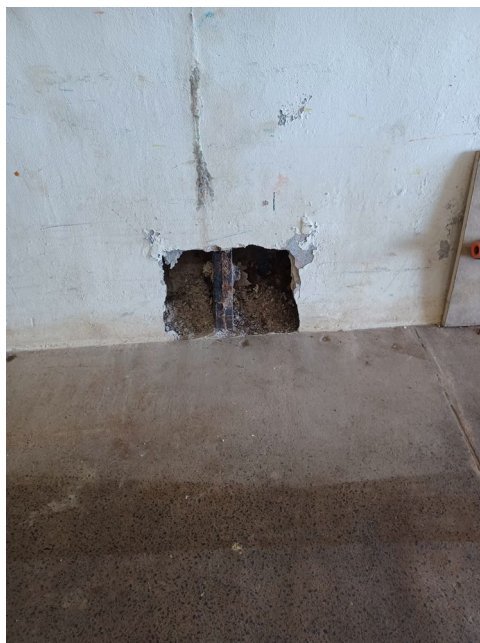
Plate 6: General view of exposed tunnel lining. Test Location 1
