5 Year Planned Preventative Maintenance Condition Survey

Property Name	Whitby West Cliff Lift
Address	West Cliff, Whitby, North Yorkshire, YO21 3JX
Property Reference Number	
Description of Building/Structure	brick gabled timber and tiled roof supported by concrete beams and brick piers covers a 50m deep pit shaft that offers access via an electrically operated unmaned lift to a 6.7 m pedestrian concrete tunnel leading to the beach below. Lifting gear, motor and electrical control unit is located in the roofspace. Originally there were two lift cars running in parallel, but since 2003 only one of the cars has been in use and an evacuation staircase has been installed. The lift is unmanned and open to the general public when in operation.
Age of Building/Structure	Circa 1931
Maintenance Responsibility	Full
Footprint Area (m2)	50m2
Name of Surveyor	Joe Poismans
Date of Survey	
Weather Conditions at Time of Survey	Overcast and rain
Exclusions	Lighting was limited in the shaft and there was none in the tunnel.

Additional Information	The building and shaft is in very poor condition and represents a high risk of fire and structural collapse in its current state of repair.

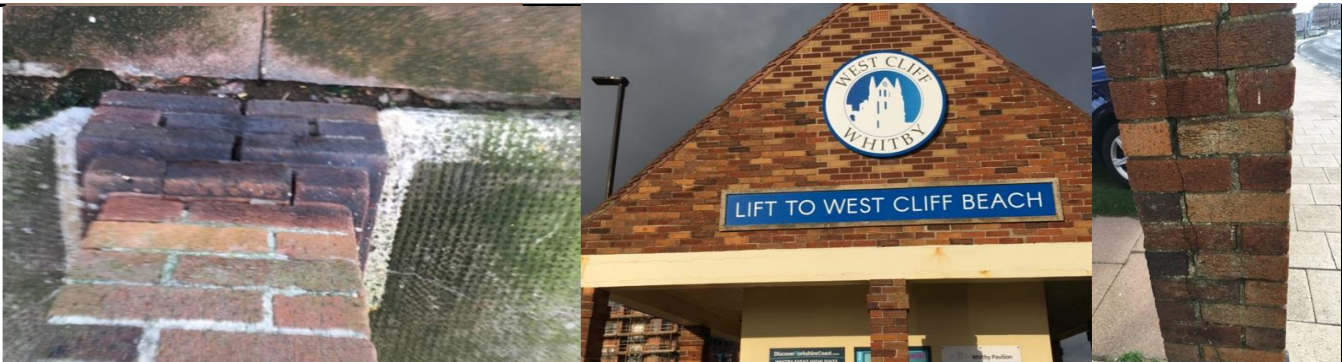
Walls External	There is structural cracking within the brick columns. The RWP'S are concealed within the brick columns at each corner and are probably leaking. Pointing is missing generally in isolated areas of the brick piers and the side gables have fractures within the brickwork	✓

Structure-tunnel	Carry out fire safety inspection to the building ,lift shaft and tunnel. Remove all flammable liquids and materials .Provisional sums have been allowed for the fire safety remedial works such as installation of emergency lighting, smoke alarms, sprinkler systems and signage	item	1	3,830.00	1	3,830.00
	Remove the door and door frame from the beach exit/entrance of the tunnel and make good as required	Nr	1	66.59	1	66.59
	Complete a specialist concrete survey of the tunnel to identify any immediate maintenance to the structure. Provisional sums have been allowed for the survey and minor repairs to surface spalling/ cracks only	item	1	1,780.00	1.00	1,780.00
Walls External	Temporary prop and take down defective brick columns & expose downpipes. Remove downpipes & rebuild the brick columns with brickwork to match existing	m2	1	197.08	15	2,956.20
	Grind out defective mortar and repoint the remaining brick columns	m2	1	33.33	6	199.98

Chop out defective and fractured brickwork and replace with brickwork to match existing to E/W side gables in isolated areas	m2	1	53.22	8	425.76
Walls Internal	Chop out defective and fractured brickwork and replace with brickwork to match existing	m2	1	53.22	8	425.76
	Slate wedge and point stepped fractures in mortar of internal walls	lm	1	38.33	4	153.32
Rain Screen and Cladding						
Internal Linings, Ceilings and Partitions						
Vertical and Horizontal Circulation						
Internal Joinery						
Windows

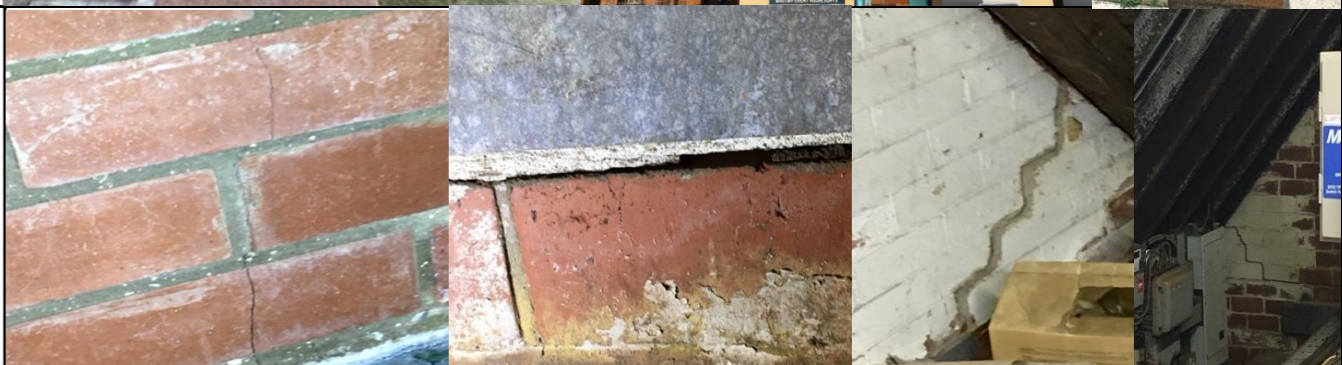
Walls Internal	There are structural cracks and stepped fractures evident on the internal brickwork. Loading is transmitted to the structure from the lifting beam and a structural engineer will need to determine the safety of these additional loadings on the structure	✓

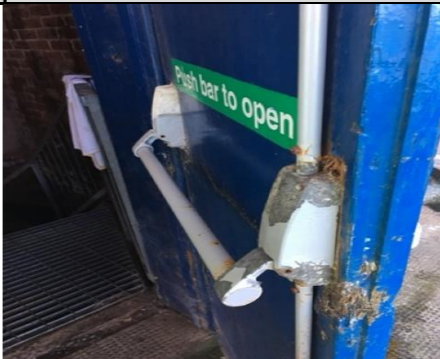
Rain Screen and Cladding					
Internal Linings, Ceilings and Partitions.					
Internal Joinery					
Windows					
Doors, Shutters and Gates	The fire exit door to the rear entrance is in poor condition.	✓

Doors, Shutters and Gates	Replace the rear fire door and frame with a new fire door set	Nr	1	1,236.36	1	1,236.36
	Provide LED illuminated fire door exit signage	Nr	1	85.45	1	85.45
Lintels	Carry out specialist concrete repairs to the external RC and steel beams around the whole perimeter. Provide support to the roof structure and remove the damaged concrete from the RC beams and until the corroded steel i beams are visible. Make repairs as per the agreed specification	Item	1	6,500.00	1	6,500.00
	Load test the lifting beam and provide certification The lifting equipment, including accessories, must be clearly marked to indicate their 'safe working loads' (SWL) - the maximum load the equipment can safely lift. Provisional sums have been allowed but a quotation will be required by a specialist	Nr	1	1,950.00	1	1,950.00
	Remove corrosion and paint the steel beams supporting the lift gear directly below lift house floor and the lifting beam within the roof space to the agreed specification	Item	1	250.00	1	250.00

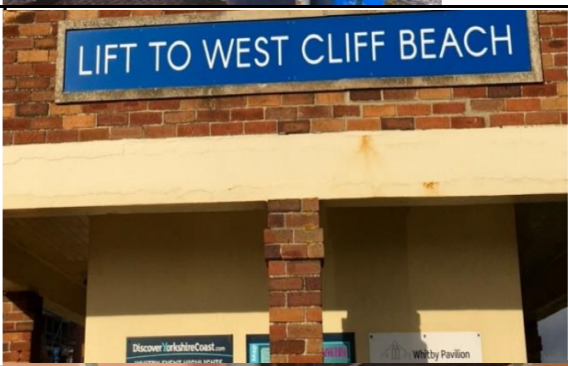
Lintels/Beams	The RC beams supporting the roof and gable externally are showing signs of rust through the concrete beams and will require specialist repair to the concrete and I beams	✓

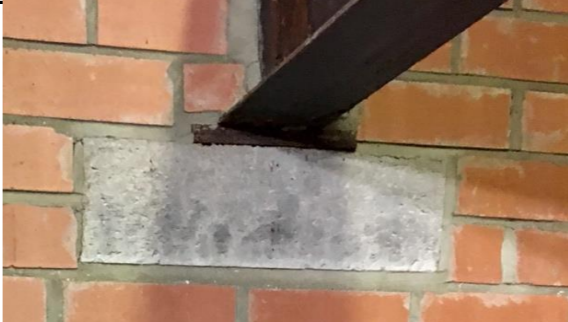
The main lifting beam within the control room has not been adequately load tested. Load testing will ensure that the lifting equipment has been installed correctly and is adequately supported and strong enough to resist the bending and shear forces generated with lifting operations. Internal beams are showing signs of rust	✓

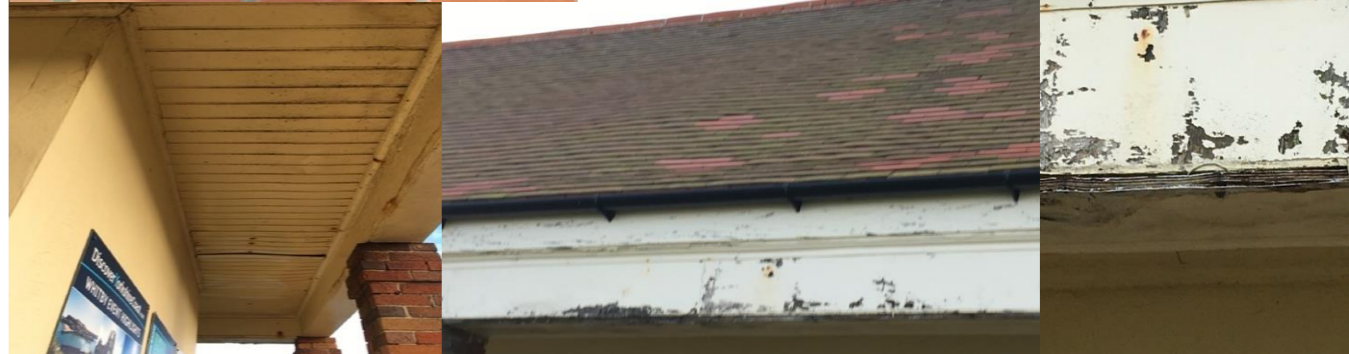
Soffits, Fascias and Undercloaks.	Fascia and under cloaking has decayed and in poor condition due to water ingress	✓

Soffits, Fascias, Undercloaks, Framework	Replace t&g under cloaking with low maintenance UPVc t&g boards	m2	1	54.45	25	1,361.25
Rainwater Goods	Re-route and replace external downpipes to surface mount on new brick columns discharging into surface gullies	Item	1	450.00	1	450.00
	Inset timber needles and props to provide temporary support to the roof and prevent structural collapse	Item	1	600.00	1	600.00
	Strip back and remove all existing roof tiles to the whole roof covering. Strip off the t&g under boarding to expose structural timbers. A timber specialist decay survey/ report will be commissioned to establish the condition of roof timbers .Provisional sums include tubes and fitting scaffolding	item	1	2,820.00	1	2,820.00

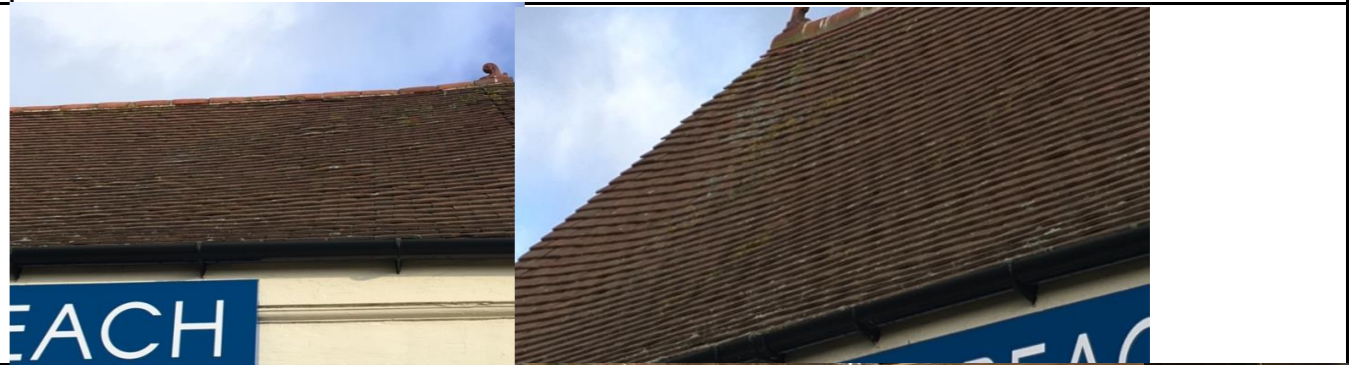
Rainwater Goods	Rainwater goods will need replacing and resiting in conjunction with the renewal of the roof and rebuild of the brick columns	✓				
Roof	There is evidence roof sagging on both sides of the roof. A structural engineers report will need to be commissioned but probable causation is by the existing poor condition of the, RC beams, timber rafters and or ridge beam (see below). Additional exhaust venting within the roof space and removing the tunnel door to improve air intake through the shaft will be required to prevent future issues of condensation poor air circulation and timber decay		✓

Roof	Replace the structural roof timbers including timber roof ridge board , defective common rafters and repair the wall plate in line with the specification of works and detailed drawings showing timber dimensions and spacings. Quotation required but provisional sums have been included for estimating purposes.	item	1	4,800.00	1	4,800.00
	Remove and replace all existing ridge tiles to the whole roof covering ;Install a dry ridge system to the roof to improve exhaust ventilation of the roof space. Replace tiles in a similar ridge tile to match existing finish, colour and size. Replace the two swan neck ridge tiles either end of the ridge to match existing. Quotation required but provisional sums have been included for estimating	lm	1	185.00	8	1,480.00
	Install new breathable underlay and battens .Replace the roof covering with new roof tiles to match the finish, colour and size of the existing. Install x8 Ubbink modern tile vents or similar to match the finish, colour and size of new roof tiles. Remove and replace all bedded cloak verge details to the gable-ends with new cloak verge to match existing. Quotation required but provisional sums have been included for estimating purposes	item	1	4,390.00	1	4,390.00

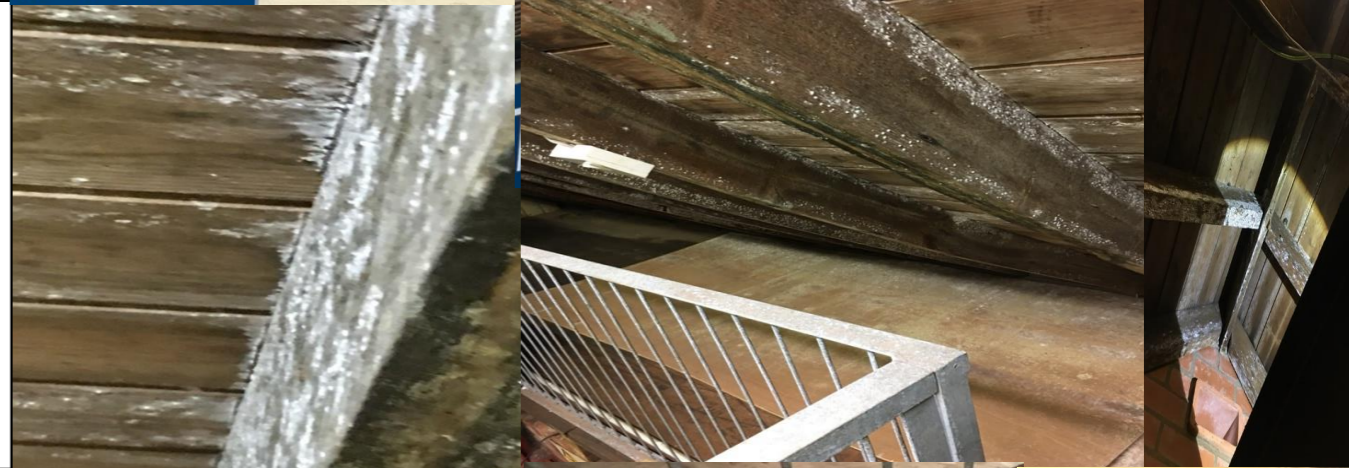
The roof timbers are wet and in poor condition. The roof is gabled with a ridge board and common rafters with a covering of t&g boards that collectively are showing significant signs of deflection, mould and decay caused by the high moisture content in the air and lack of ventilation within the structure. Left in this condition; the timbers will inevitably further deteriorate leading to dry rot and the potential structural collapse of the roof.		✓

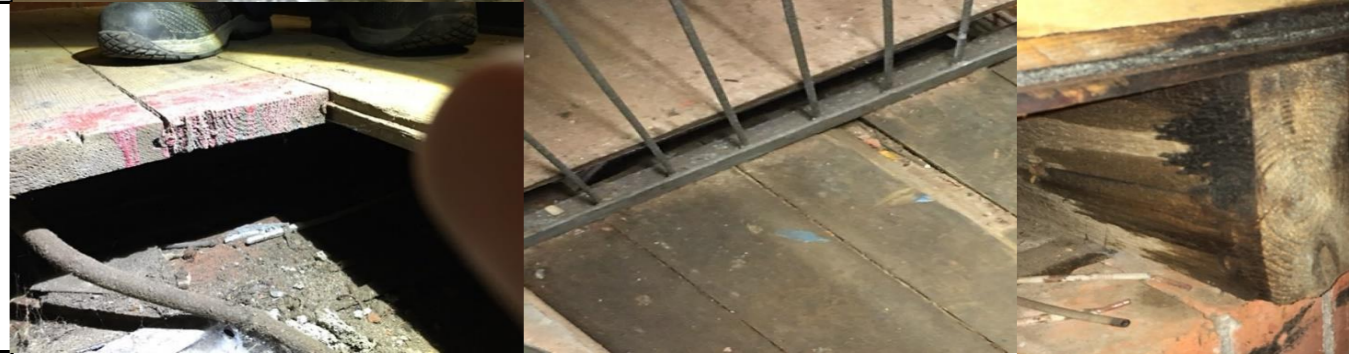
Floors, Steps inc Floorfinishes	The t&g floor in the control room is wet and in poor condition with missing/damaged floorboards. Joist ends are showing signs of water saturation and may fail under loading.		✓

Floors and Steps, inc Floorfinishes	In conjunction with the renewal of the roof timbers, take up the existing T&G floor to expose the wet floor joists. Replace defective joists.with new	m	1	18.47	40	738.80
	Replace all the T&G floorboards with new 25mm timber T&G boards include for new entrance hatch	Nr	1	113.78	25	2,844.50
Fixtures	Replace signage to gable following completion of brickwork repairs to match existing	item	1	90.00	1	90.00
Sanitary Equipment and Fittings						
Furniture inc Window Treatments

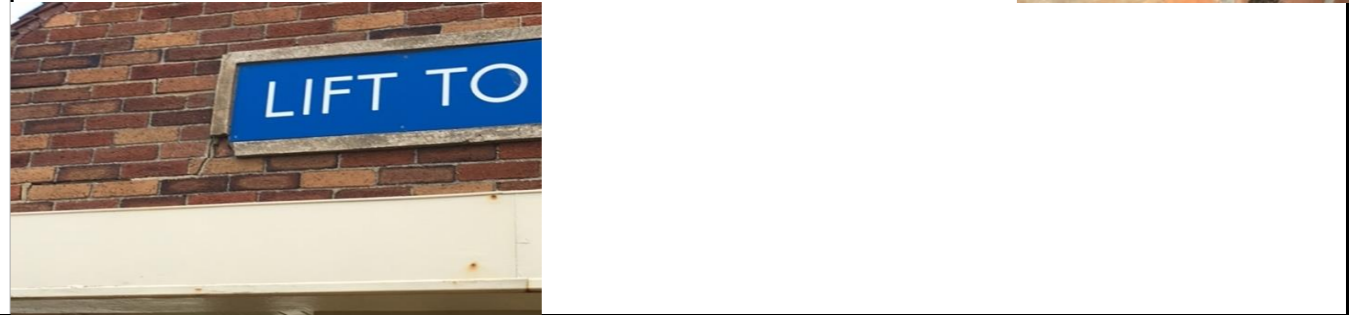
Fixtures	The signage is damaged and will need to be replaced in conjunction with repairs to the brickwork on the gables		✓

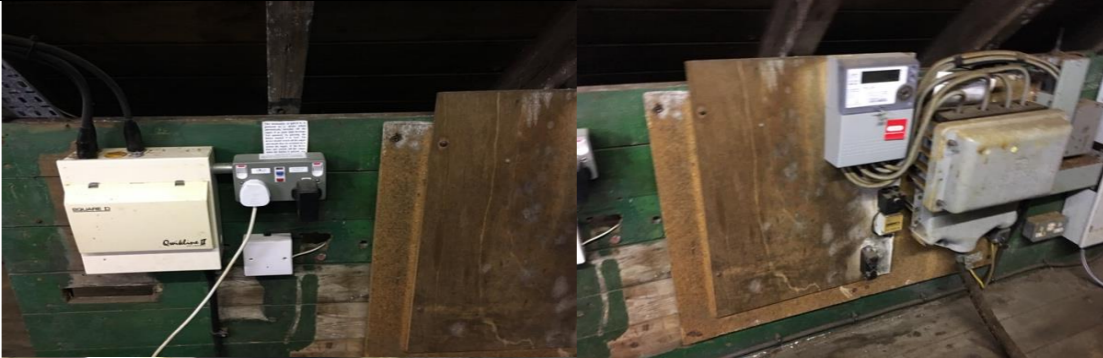
Water Services						
Heating						
Cooling, Extract and Air Handling						
Power	The installation, generally, is in poor condition due to the damp environment, water ingress and corrosion of metal parts the supply is 3 phase in the control room. There are unsheathed cables and a consumer unit in the tunnel in very poor condition. There is a power cable leading from the tunnel to the beach for public use which should be checked for safety. The water ingress and high moisture levels represent a high risk of electrocution and or fire to the public and workers. An electrical safety check to all installations of the motor room /lift shaft and tunnel has been undertaken and the whole installation is need of repair and complete upgrade. See electrical condition report (Appendix 4C)	✓

Decorative Finishes	Allowance made to repaint external exposed timber doors and frames and retendered walls in years 1,3,5. Quotation required but provisional sums have been included for estimating purposes	item	1,3,5	550.00	3	1,650.00
Water Services						
Heating						
Cooling, Extract and Air Handling						
Power/lighting	Rewire the motor room/lift shaft and tunnel as per EMCE quotation of works (See appendix 4 & 4a)	Quotation	1	8,904.02	1	8,904.02
Telecomms/ CCTV	Replace the intercom at the bottom of the lift shaft	item	1	1,580.00	1	1,580.00
	Install hard wired CCTV camera and system to the pedestrian tunnel. Quotation required but provisional sums included for estimating	item	1	3,300.00	1	3,300.00
Lightening Protection						
Works of Art, Sculptures, Plaques, Monuments, Memorials etc						
Landscaping and External Works	Hack up defective sections of the concrete perimeter path and relay 150mm of concrete to existing levels	m2	1	40.50	4	162.00

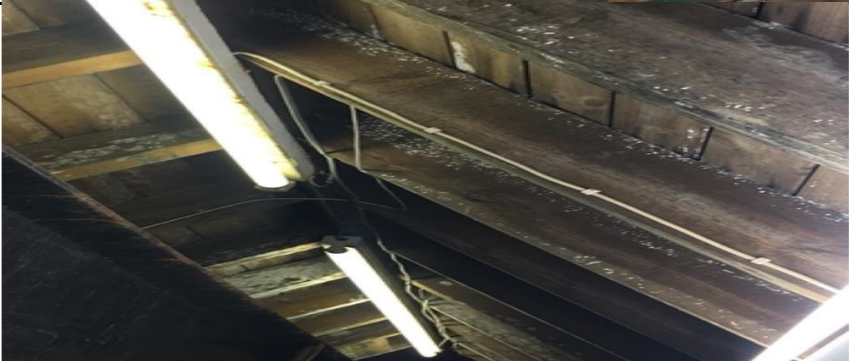
Lighting	Lighting is generally in very poor condition including that of the motor room lift shaft and pedestrian tunnel. Cables are face fixed with no conduit.	✓

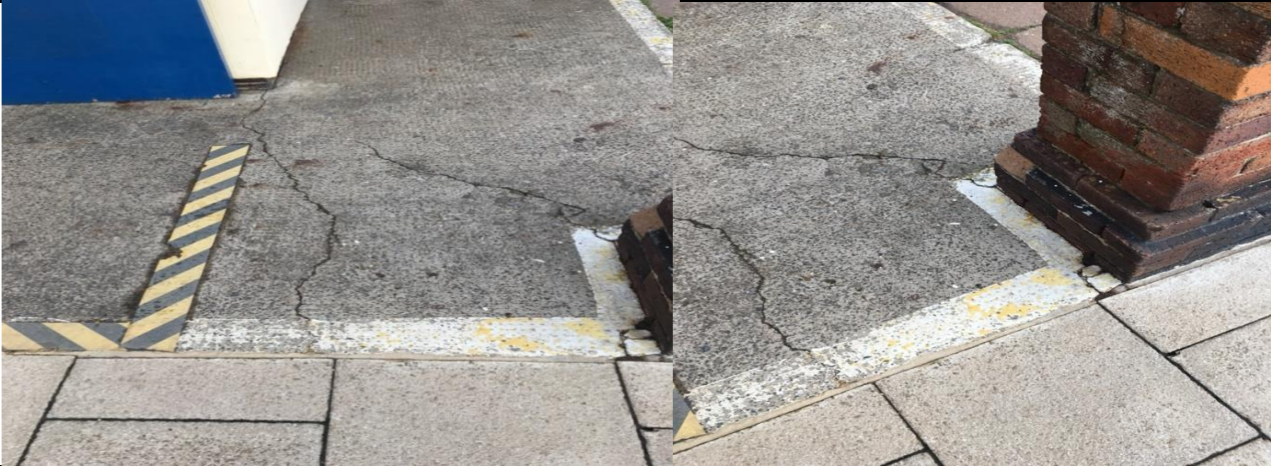
Telcomms	At the bottom of the lift shaft there is an intercom used by the engineers for communication. The intercom is broken, The CCTV camera and system at the end of the tunnel is not functioning compromising the security and safety of the users of the tunnel and lift	✓				
Alarms						
Lightening Protection						
Works of Art, Sculptures,						
Landscaping and External Works	The concrete perimeter path is cracking in isolated areas	✓
