Section 19 Report on the August 2017 Flooding in Scarborough

Flood Investigation Report

Scarborough August 2017

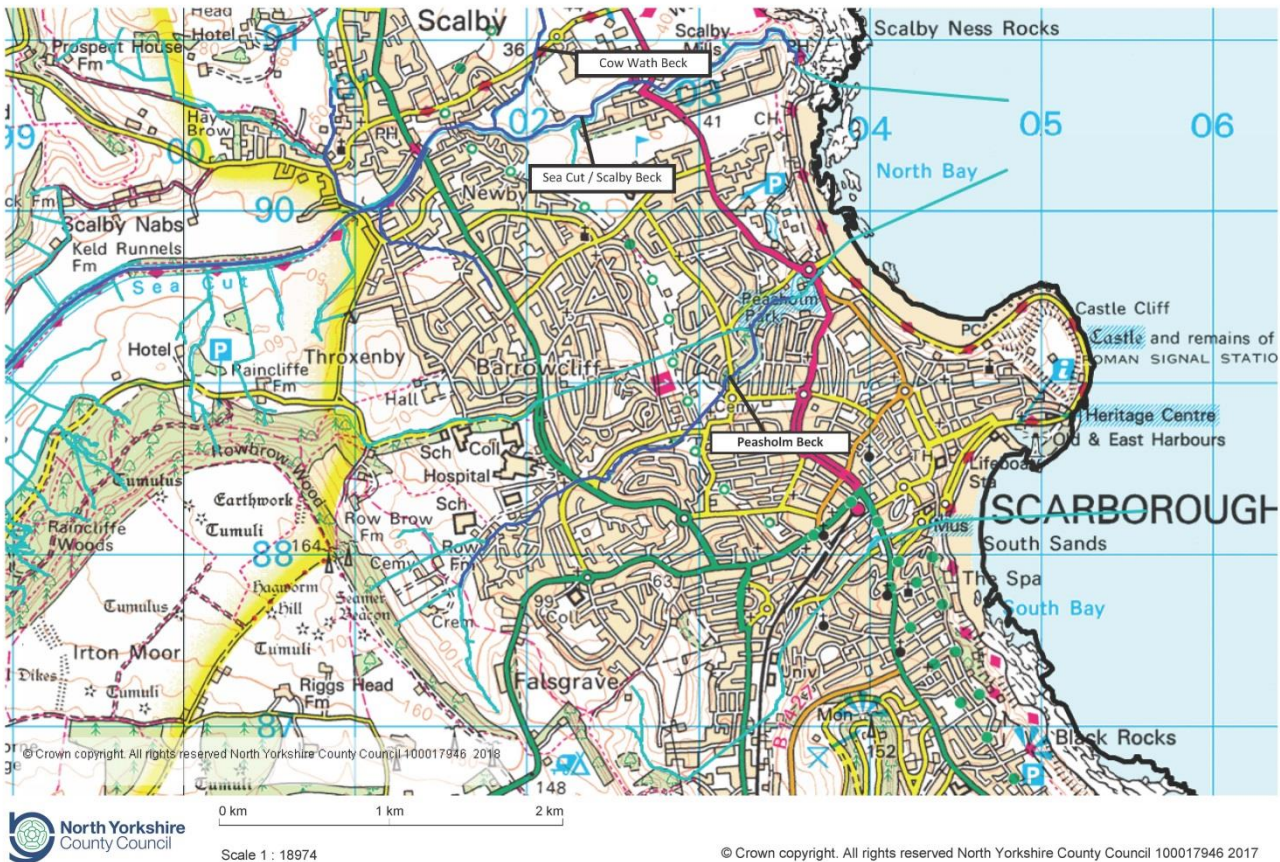
The town rises steeply away from the seafront, which is split into 2 bays by a rocky promontory. The hinterland which drains to the North Sea is a relatively narrow strip, extending approximately 3km inland from the coast. Within Scarborough town itself the catchment is heavily urbanised and highly impermeable, and is dependent on sewers and culverts for drainage. Scarborough receives 686mm of rain annually on average. There are a number of watercourses which run west – east across the town including Scalby Beck, also known as the Sea

Cut, and Peasholm Beck or Woodlands Vale Beck. These watercourses tend to be in steep and narrow cloughs or ravines, hence the area of flood risk associated with them is relatively constrained.

Figure 2 – Scarborough Town & Watercourses
