**Flood and Water Management Act 2010 Section 19 Investigation and Report
on the 30 July 2019 Flooding Events in Richmondshire**

Flood Investigation Report

Richmondshire July 2019

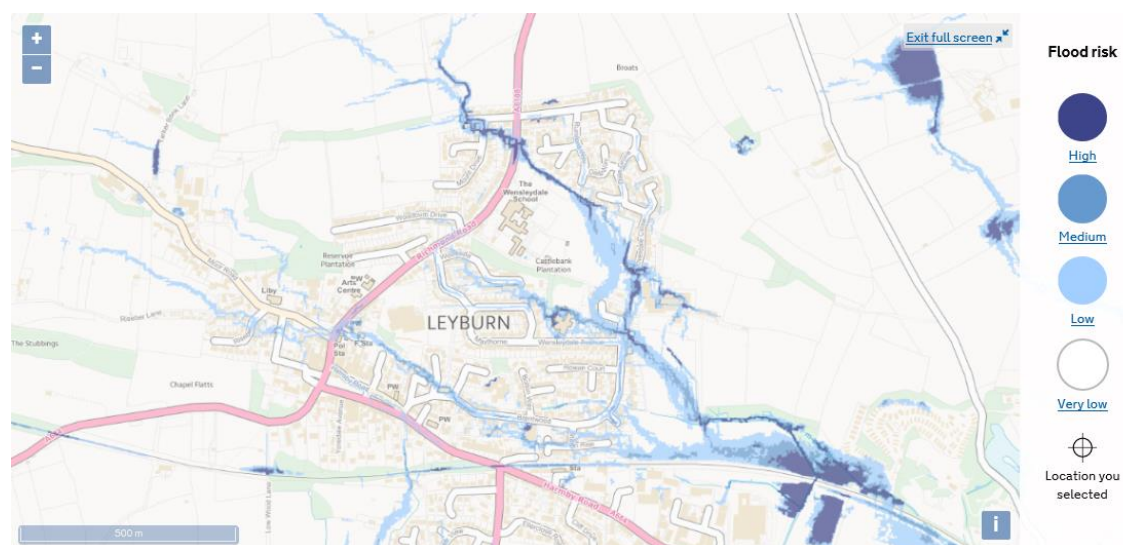
The pluvial flood risk in Leyburn follows the natural topography of the town with the three distinct flood pathways that strongly correlate with the three watercourses identified in Section 2.1.1. The highest area of risk is shown to be in the vicinity of the watercourse around part of Mount Drive, Bellerby Road, Coverdale Close and Bishopdale Close, where the flood risk is shown to be high (events that occur more frequently than 1 in 30-years). Other notable areas at high risk include Wensleydale Primary School and the Medical Centre off Brentwood.

The flood risk relating to the watercourse originating in Risber Lane is predominantly shown to be low risk (events that occur less frequently than 1 in 100-years), with increased areas of risk (medium – events that are expected to occur with a frequency between 1 in 30 and 1 in 100-years) in the vicinity of the fire station, rear or properties off the nurseries and Brentwood.

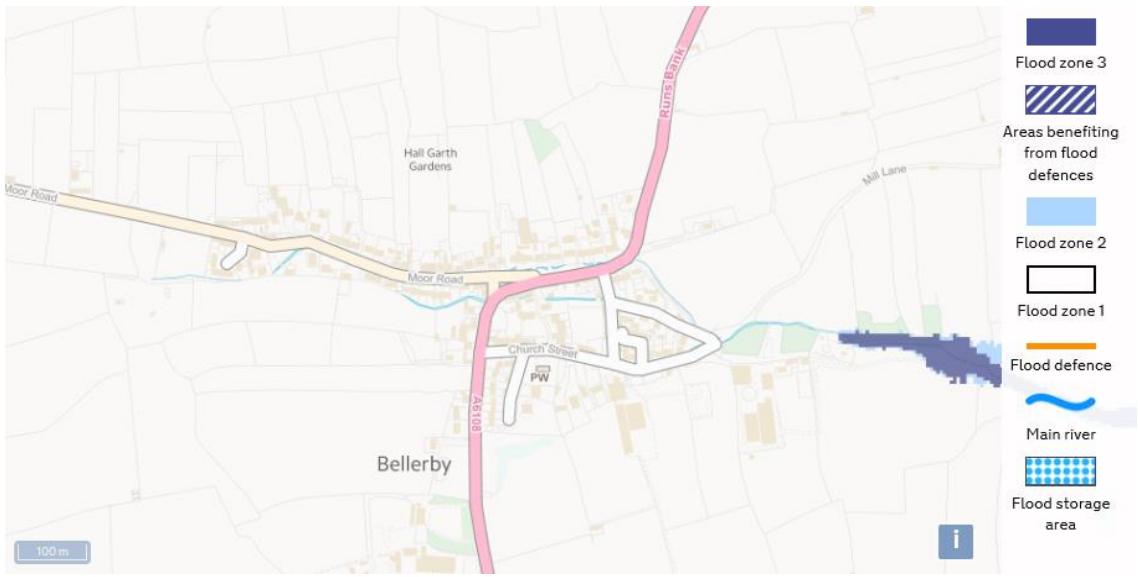
<p>The flood map for planning indicates that all of Bellerby is located entirely within Flood Zone 1. It is noted that none of the watercourses identified in Section 2.1.2 of this report have been captured within the national generalised model. The abrupt start of flood zone 3 extent shown to the east of the village suggest that the catchment for the watercourse upstream of this point is less than 2km² and has therefore not been assigned a flood zone designation.</p>
Pluvial Flood Risk (Surface Water)

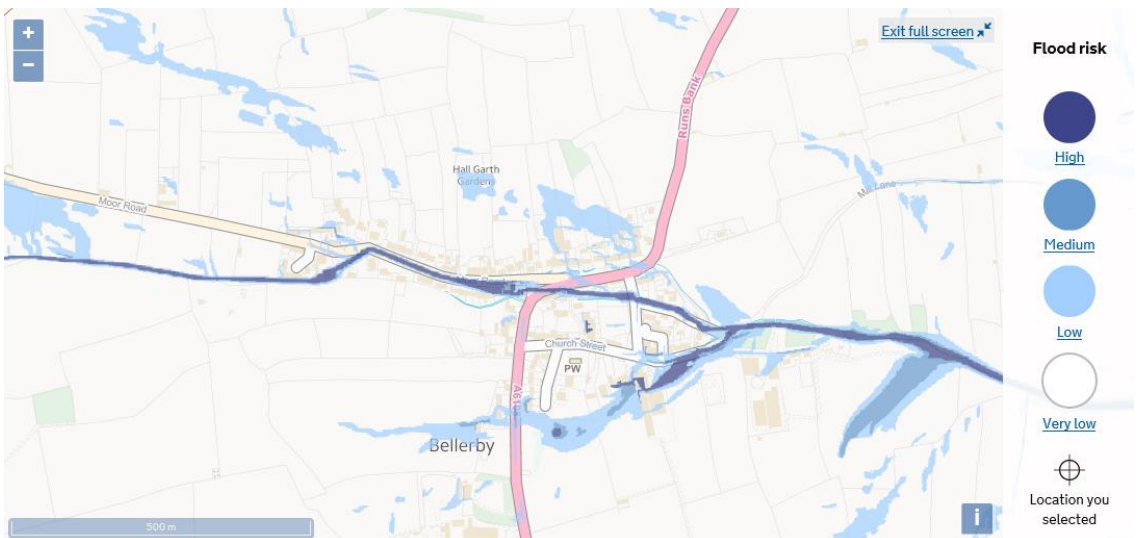
<p>The Risk from Surface Water Flood Map shows the entire length of Moor Road, across the A6108 and to the rear of the Cross Keys to be to be at high risk (occur more frequently than 1 in 30-years) of surface water flood events. This high risk flow pathway continues along the course of the beck through the village.</p> <p>It is noted that properties on the southern side of Moor Road are not shown to be at risk. This could be for a number of reasons, for example, highway kerbs may give an inaccurate representation of the drop of the road surface level when in reality, Moor Road is in some instances higher than the property thresholds. Furthermore, the surface water flood maps do not account for the presence of any culverts and the dimensions of any channels which may impact upon surface water risk.</p>
<p>Reservoir Flooding</p>	<p>Bellerby is not shown to be at risk of flooding from any reservoirs.</p>

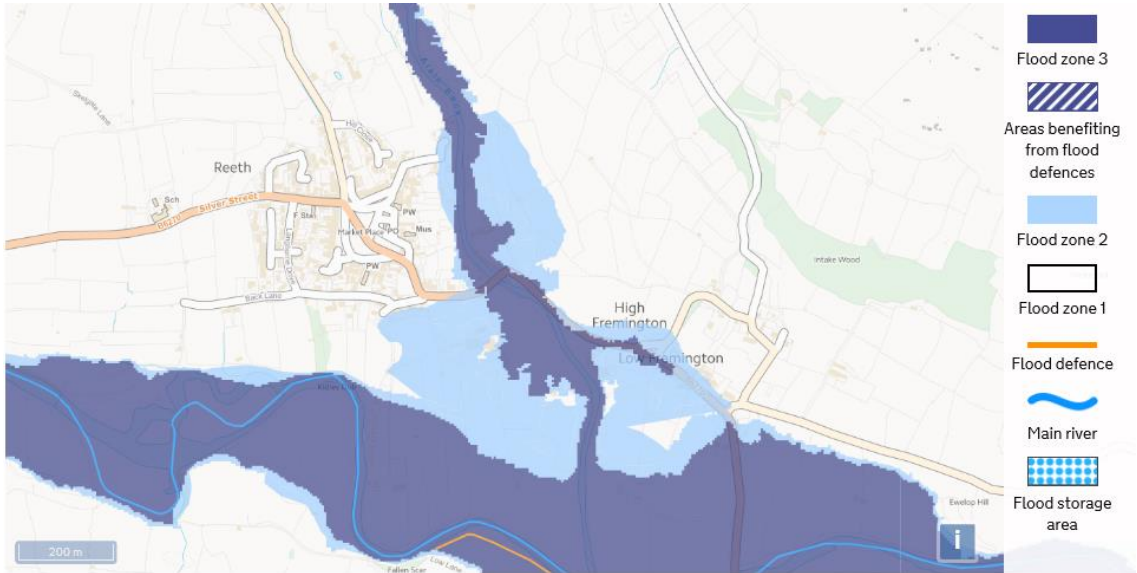
<p>Reeth is shown to be predominantly in Flood Zone 1, with some properties in the vicinity of Arkle Beck being in Flood Zone 2 and 3. Low Fremington is predominantly located in Flood Zone 2 with an area along the B6270 in Flood Zone 3.</p>

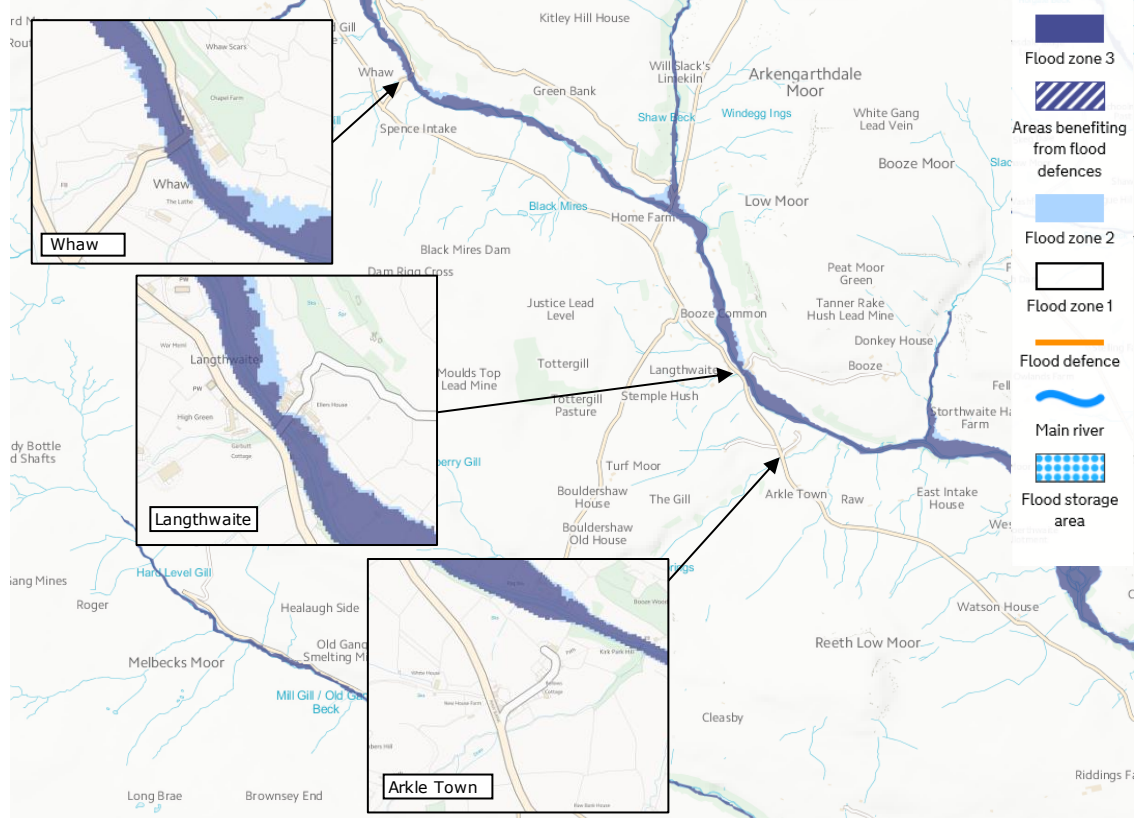
<p>The flood extents for Arkengarthdale reflect the narrow and steep nature of the valley. The minor watercourses are not represented on the mapping. It is noted that there is little difference between the Flood Zone 3 (1 in 100 year frequency event) and Flood Zone 2 (1 in 1,000 frequency event). This is predominately due to the steep sided nature of the valley. Rather than spread out laterally, flood depths are likely to increase significantly during a 1 in 1,000 year event.</p> <p>Whaw Properties on the right bank of Whaw are shown to be predominantly be in Flood Zone 1 with a low risk of Fluvial flooding, however the flood zone 2 and 3 extent is very close to some of the properties. As explained earlier in the report, the map cannot be used to give a measure of risk at individual property level.</p> <p>Langthwaite A number of properties adjoining the river are shown to be located in Flood Zone 2 and 3. The extent narrows through the centre of the settlement as the ground rises quickly up the hill and out of the village.</p>

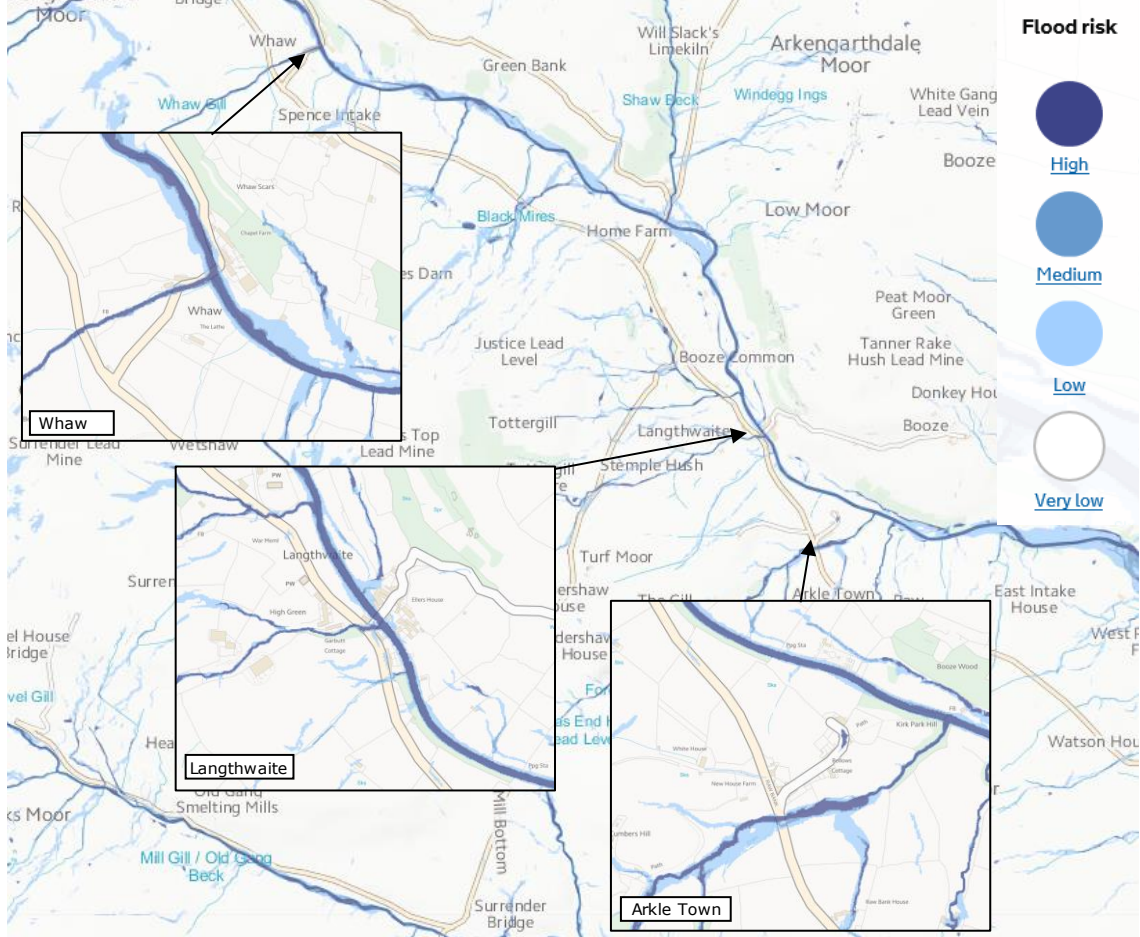
<p>Many of the smaller watercourses not highlighted at risk on the fluvial flood map are within the area indicated to be at high risk of surface water flooding (flooding frequency of greater than a 1 in 30 year event). The flood extents are narrow with little variance between the high and low likelihood events, due to the steep and narrow topography around the gills and becks.</p> <p>Whaw</p> <p>In addition to the risk identified from Arkle Beck, the risk of flooding from the minor watercourse that flows in an easterly direction towards the village and under the access road is shown to be high. Some disruption to the road could be expected from this source.</p> <p>An additional flow overland flow route which does not appear to follow a watercourse has been identified to the east of the village. The risk associated with the overland flow routes is predominately low with some areas of medium and high risk.</p> <p>Langthwaite</p> <p>There are two surface water flow paths identified flowing towards Langthwaite. The first is an area of low, medium and high risk flowing in a south easterly direction. This flow path does not appear to be directly linked to any watercourse. During the event</p>

<p>however, it would be hard to determine whether this flow route exacerbated the issue as it is also located within the Flood Zone 2 and 3 extent.</p> <p>The second flow path is linked to an un-named tributary of Arkle Beck. Areas of low, medium and high risk are also evident. Flooding from this source could have affected the properties on the west side of Raw Bank</p> <p>The mapping does not show surface water flood risk along the road unclassified road leaving the village up the hill to the east. During a site visit however, residents commented that some properties were affected by surface water coming down the hill.</p> <p>Arkle Town</p> <p>The risk associated with the unnamed watercourse to the west of Raw Bank is shown to be high, however the extents are not shown to affect Arkle Town. There however an area of high risk shown in the middle of the town. Rather than a flow path this suggests that this area is susceptible to accumulation of sheet flow.</p>

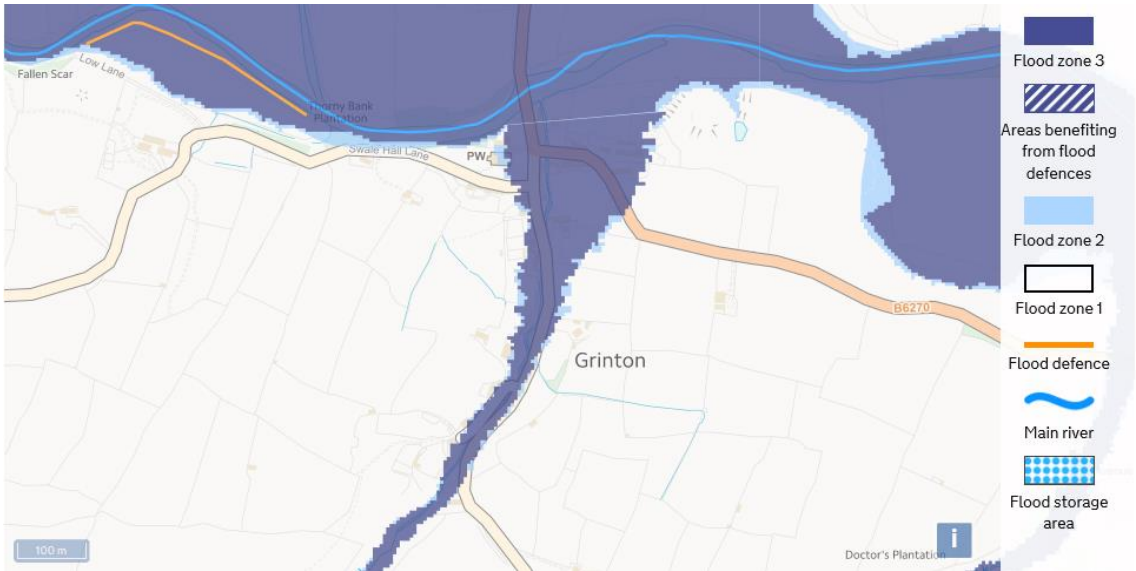
<p>All of Grinton is shown to be located in Flood Zone 2 and 3. There is little difference between the two flood extents for the village, which is reflective of the steep and narrow catchment. It is noted however, that the properties flooded in Grinton were limited to those that were below the level of the highway and were flooded from a flow path conveying down the highway. None of the properties adjacent to the Gill reported internal flooding from the back of the properties facing the Gill.</p>

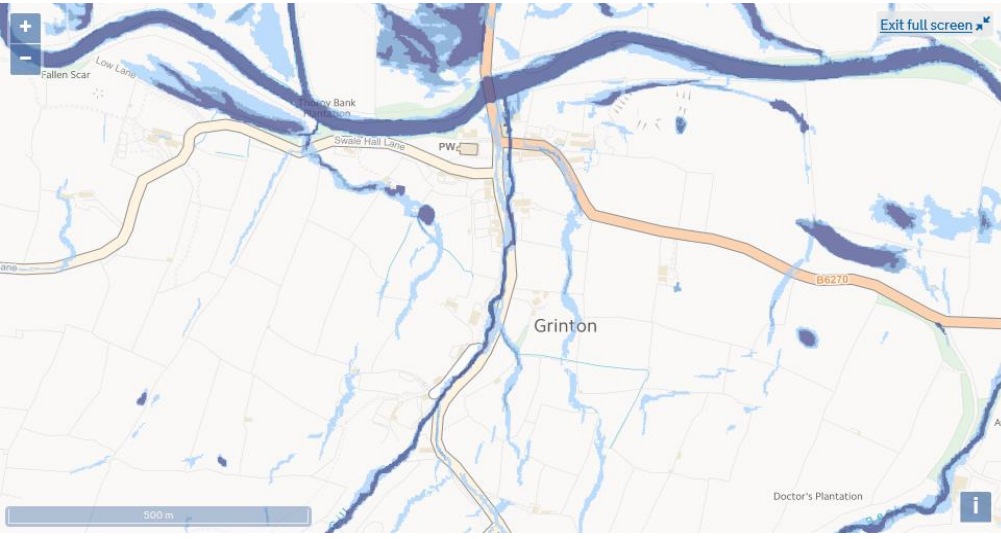
<p>The surface water flood map more closely demonstrates the flow paths and flooding that was reported during the event. The Gill flows in a deep ravine and is in a state of degradation with significant amount of continuous ongoing erosion.</p> <p>A low risk (between 1 in 100-year and 1 in 1,000-year event) flow path is shown to flow off the Moor and onto the road through Grinton. From the evidence presented, it would appear that the properties were flooded from a combination of this flow path and water from Grinton Gill.</p>
<p>Reservoir Flooding</p>	<p>Grinton is not shown to be at risk of flooding from any reservoirs.</p>
<p>Flood Alert and Warning Areas</p>	<p>Grinton is included within the Upper River Swale Flood Alert Area.</p>
<p>Current Flood Defences</p>	<p>There are no recorded flood defences within Grinton. Grinton is not shown to benefit from any defences.</p>

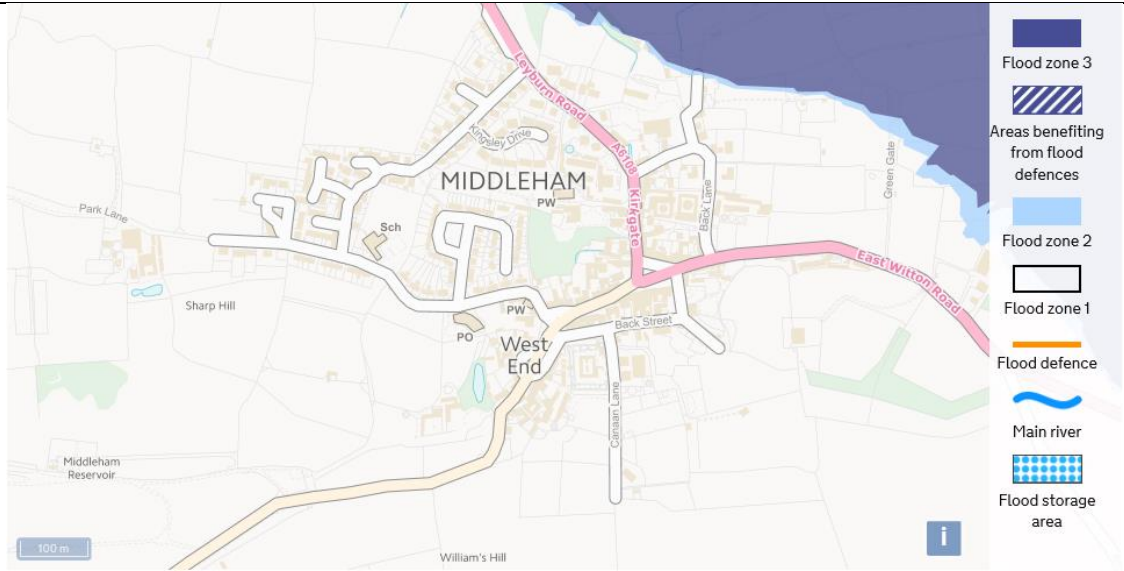
<p>Middleham is not shown to be at risk of Fluvial Flooding from the River Ure and is located within Flood Zone 1 (event with a frequency greater than 1 in 100 years).</p>
<p>Pluvial Flood Risk (Surface Water)</p>

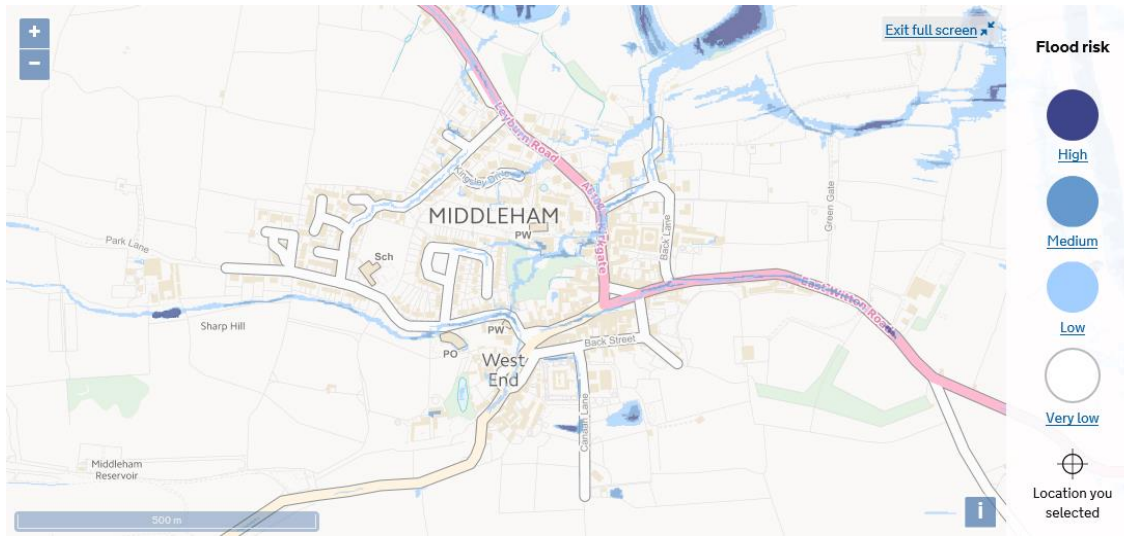
<p>The surface water flood risk in Middleham is predominately shown to be low. There are however areas of low and medium risk identified within two distinct flow paths. The most prominent of which flows in a west to east direction towards the Key Community Centre (see Figure 10). The flow path relates to the minor ordinary watercourse observed flowing at the community centre entrance at the time of the visit. The flow path continues past the centre, before flowing through the church yard. Flooding was reported in the churchyard, with water attenuating behind a dry stone wall. Seepage from the wall was reported to externally affect properties on Kingsley Drive. Surface water flows are also shown to be present on Kirkgate, where some properties were internally flooded.</p> <p>An area of low risk is also shown adjacent to the “Plantation”. It was confirmed that a property was affected in this area, primarily as a result of flow emanating from the Gallops and flowing down the highway and accumulating in a low spot off the highway.</p>

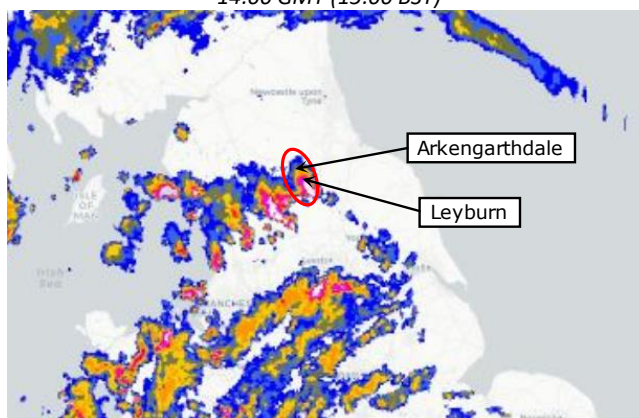
Figure 12 – Rainfall Radar 30th July 2019

The most significant rainfall on 30th July 2019 happened in the Richmondshire and the Yorkshire Dales area. At Arkle Town peak 1 minute rainfall rates in excess of 150mm/hr equivalent indicate the exceptional nature of a storm cell that persisted for several hours. At this intensity, the average July rainfall fell in two hours, with a return period in excess of 1000 years⁴, with rain continuing to fall beyond this period.

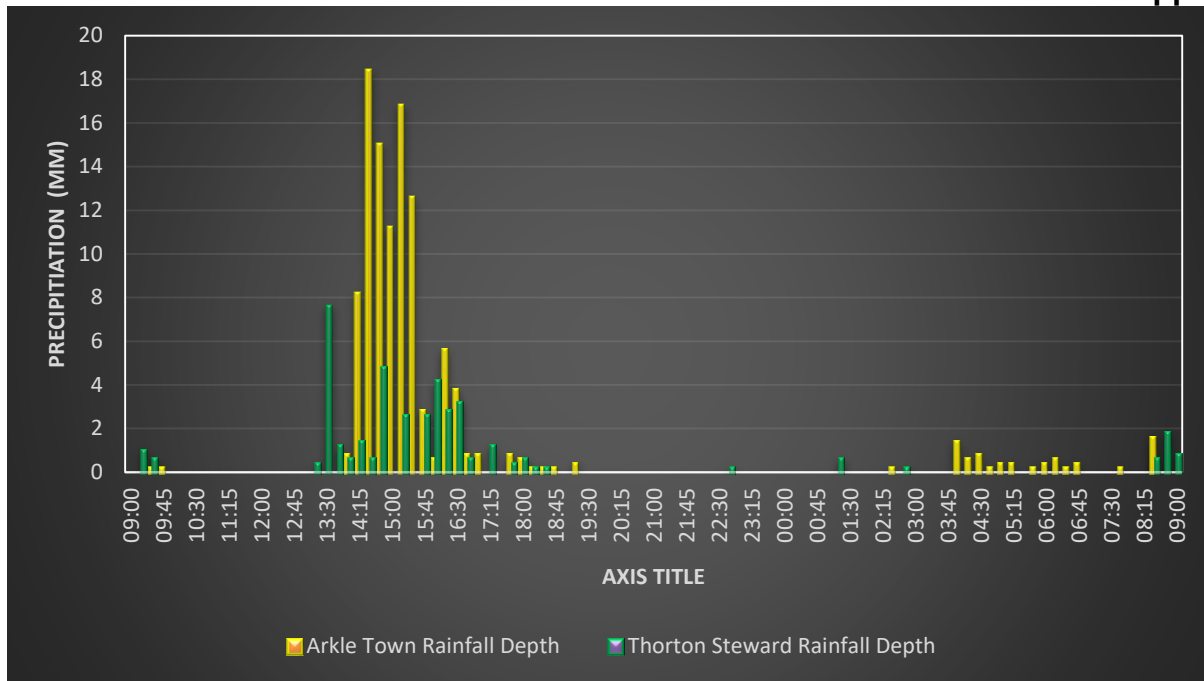
Figure 13 - Upper Dales Rain Gauge Data

The long-term average for this location is 70.7mm of rain for the month of July⁷. The rain gauge at Thornton Steward indicates that 82% of the monthly average fell in this area over a 4-hour period, and local rainfall at Bellerby and Leyburn where the storm centred may have been higher. At Arkle Town 140% of the monthly average rainfall fell over 5-hour period. The return period for both areas for the day exceeds the 1 in 1000-year storm event⁴.

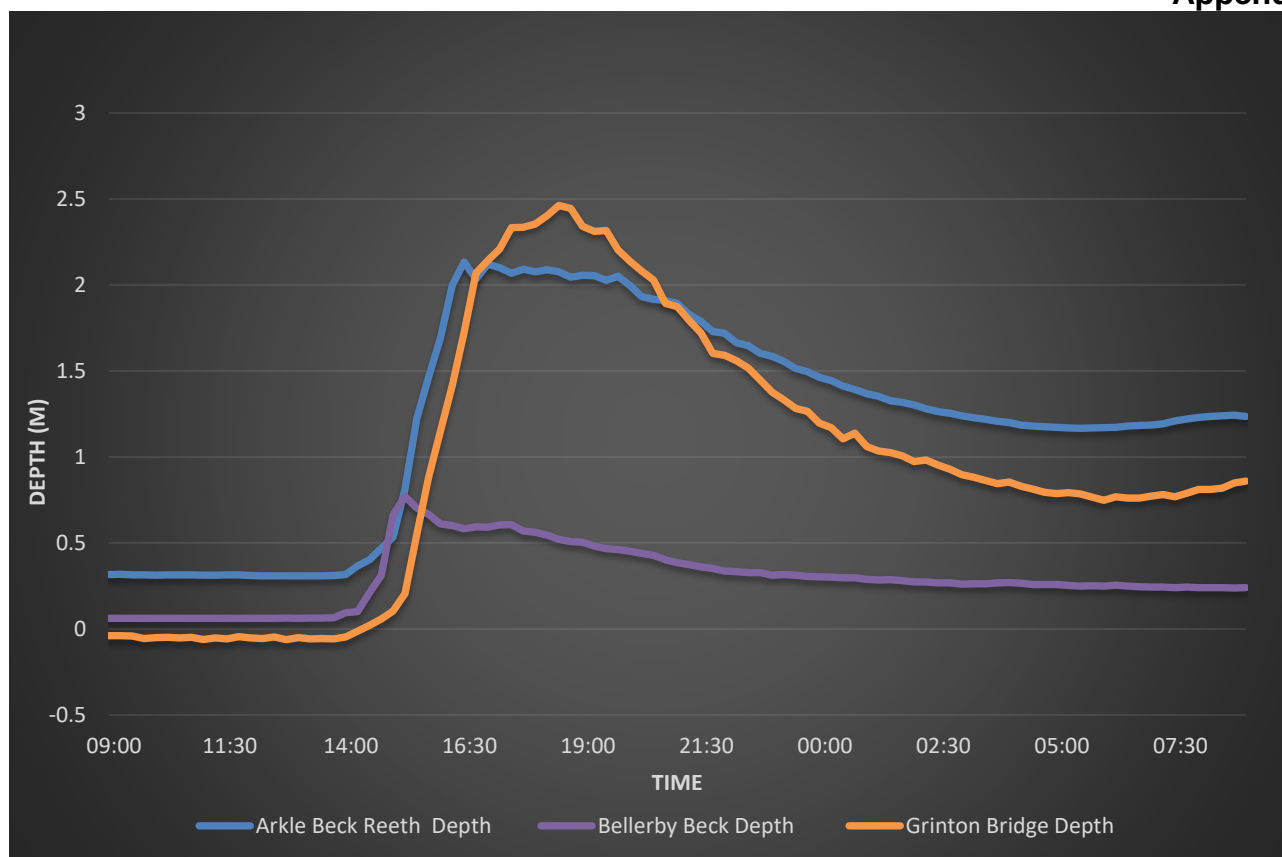
Figure 14 - River Level Gauge Data

The levels quoted in the following section are relative to the gauge datum. The Environment Agency operates river flow gauges on the River Swale and Arkle Beck. The gauge at Arkle Beck in Reeth is shown to have recorded a peak level of 2.134(m) at 16:30hrs on 30th July 2019, which correlates with the peak of the rainfall intensity having been reached before this time. It should be noted that the peak level at Arkle Beck was the highest the gauge could record, therefore the peak could have been (and is assumed to have been) much higher. Further to this, the gauges on River Swale at Grinton Bridge and Catterick Bridge recorded peak levels of 2.463(m) at 18:30hrs and 2.873(m) at 21:00hrs respectively⁷.

Only Arkle Beck at Reeth recorded the highest level on record during this event during this storm. This however was affected possibly by the water reaching the top of the bank and overflowing into the surrounding area. The impact of the localised rainfall drives the significant peak river levels down the length of the Swale as far as Catterick Bridge. The rate of rise at the sites mentioned was notable, at Catterick Bridge the water level rose by 1.8m in 30 minutes. At Grinton Bridge it was 2m in 2 hours, and Reeth by 1.6m in 1.5 hours. Peak flows were recorded at Catterick Bridge. The flows that were recorded correlate with the rainfall gauge at Arkle Town with the storm starting at approx. 14:00hrs.
