North Yorkshire Local Access Forum**11 October 2017****Deadman's Hill****Report of the Secretary****1.0 Purpose of the Report**

Dead Man's Hill

Assessment report on the use of recreational motor vehicles

September 2011

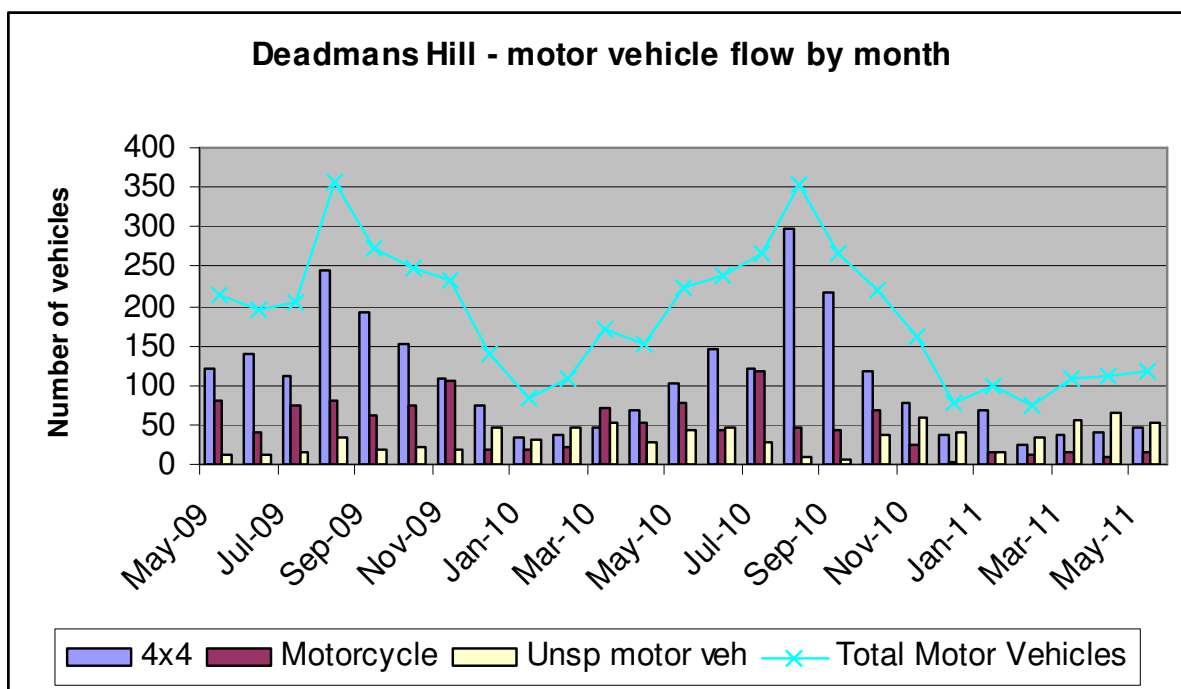
32. A vehicle logger has been in place on this route since March 2007 and a complete set of data is available. However, the graph below show levels of motor vehicle use recorded on Dead Man’s Hill for the past two years only to give greater clarity whilst still allowing trends to show. The logger is located on the Arkleside part of the route.

33. There is a striking seasonal pattern to the data with August and September being the busiest months for motor vehicle traffic, related to the grouse shooting season which takes place on the moor above Arkleside. It should be noted that the bulk of motor vehicles using the route for moorland access leave it at SE048 795 and use the southwards trending track. This data also shows that the usual increase in traffic following the winter low-point has not occurred in 2011 – presumably because of the affect of the temporary traffic regulation order in place on the route. Further evidence of this is apparent in the days of the week analysis below.

34. This route carries considerable motor vehicle traffic with 194 motor vehicle movements recorded on an average month at the vehicle logger location over the complete data available. This is split between different types of vehicle with 100 4x4 type vehicles on average, 54 motorcycles and 39 unspecified motor vehicles.

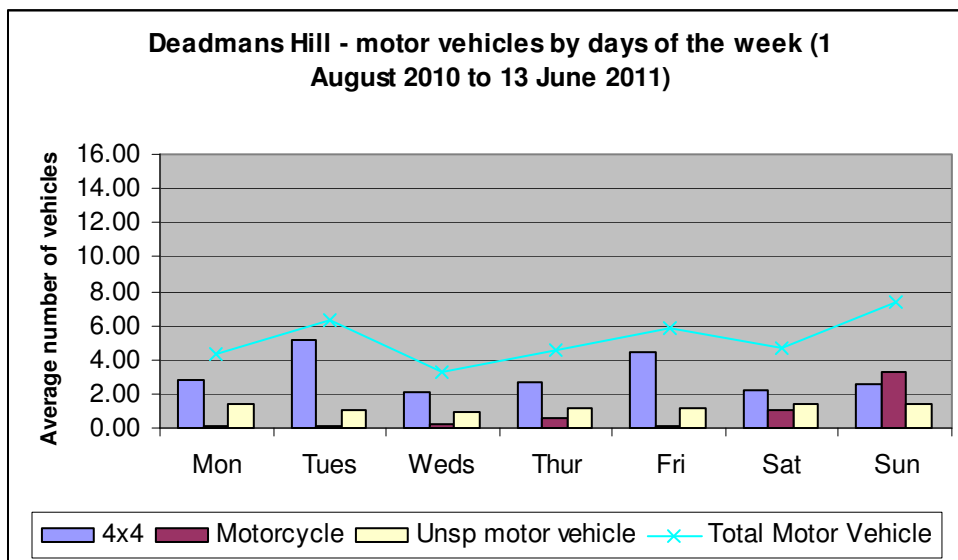
35. The days of the week analysis has been carried out over two recording periods. The first is 1 August 2009 to 31 July 2010 – which should reflect a ‘normal’ year’s usage. The

second period is from 1 August 2010 to 13 June 2011 during which period a temporary traffic regulation order restricting use by recreational motor vehicles has been in place.

36. For the first period, there is clearly a base of agricultural/land management use, including access to the grouse moor, with increased use at weekends showing the recreational use of the route. Dead Man’s Hill is clearly used both by recreational motorcyclists and 4x4 users. Overall agricultural use accounts for approximately 66% of motor vehicle use, with 34% being recreational.

37. In the second period the impact of the temporary TRO is apparent in the reduced weekend usage of the route. This analysis suggests that agricultural/land management use of the route is now approximately 80% of the total motor vehicle usage.

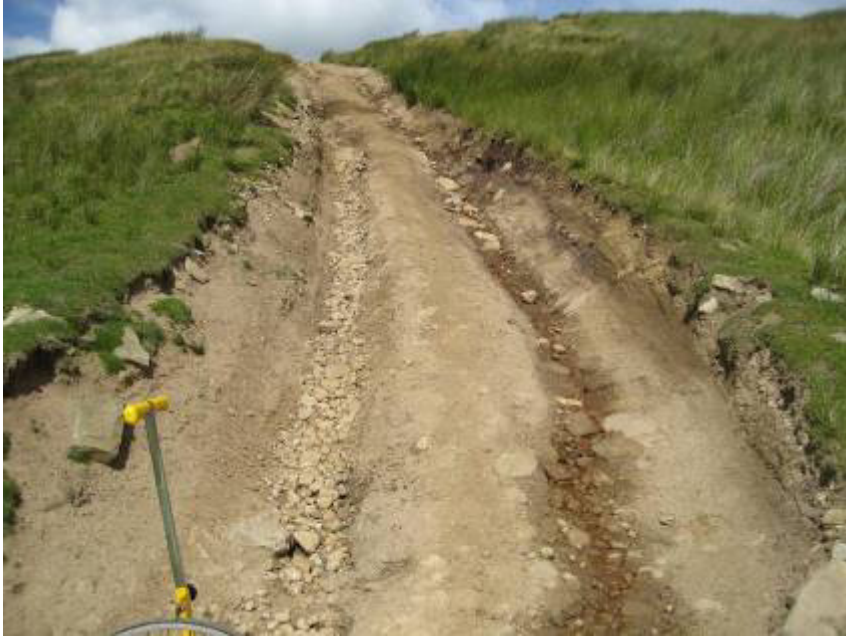
NYCC July 2007, eastern zig zag

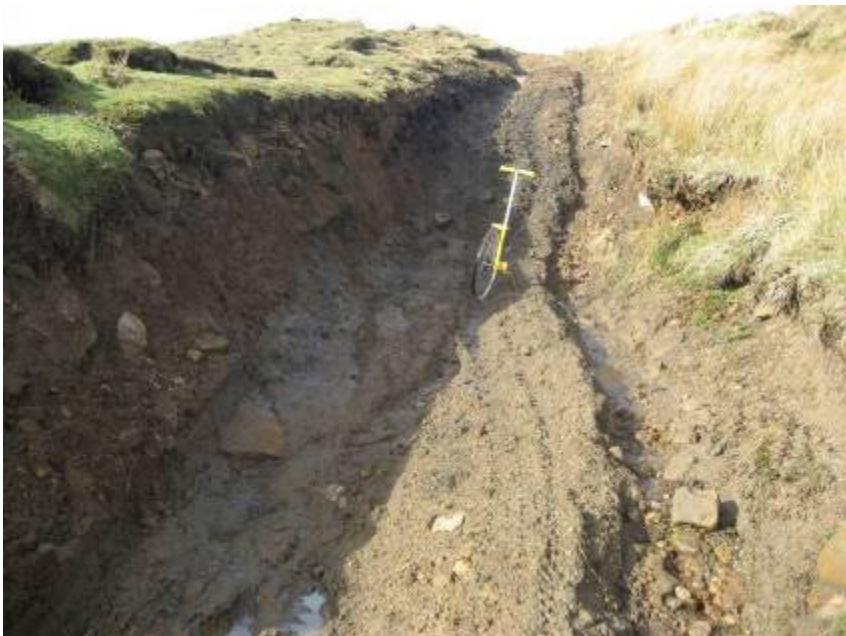
30. The zig zags themselves have also deteriorated markedly. There are three main tracks in this area, all with very deep ruts. In 2007 the deepest ruts were recorded at 400mm in this area – in 2011 the eastern track has an area with a maximum rut depth around 1500mm, and on the western track a maximum depth of around 1000mm. In this area the track erosion appears to be through a mixture of water and 4x4 use. Despite the significant depth of erosion, no bedrock is present and the situation is likely to continue to deteriorate.

NYCC Feb 2011, eastern zig zag

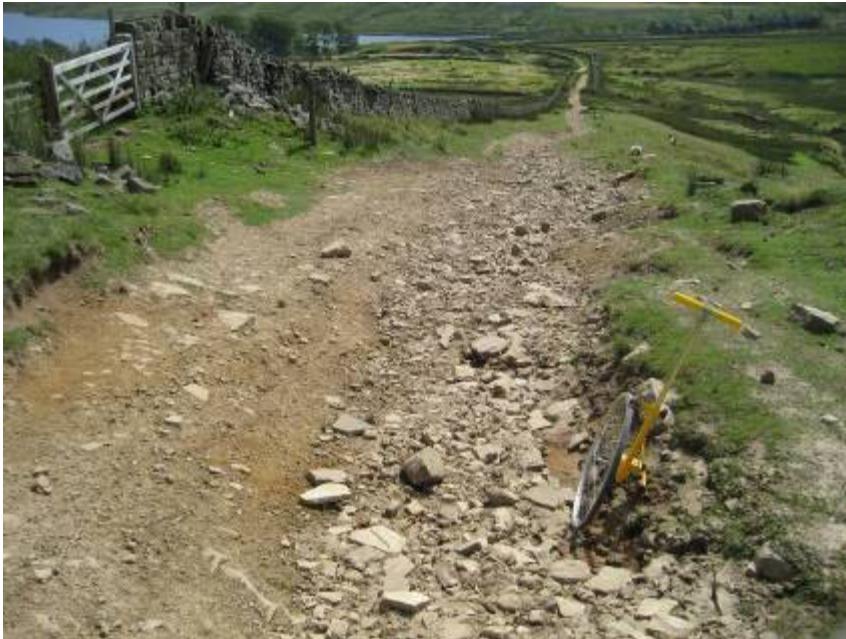
NYCC July 2007, section between zig zags and Lodge

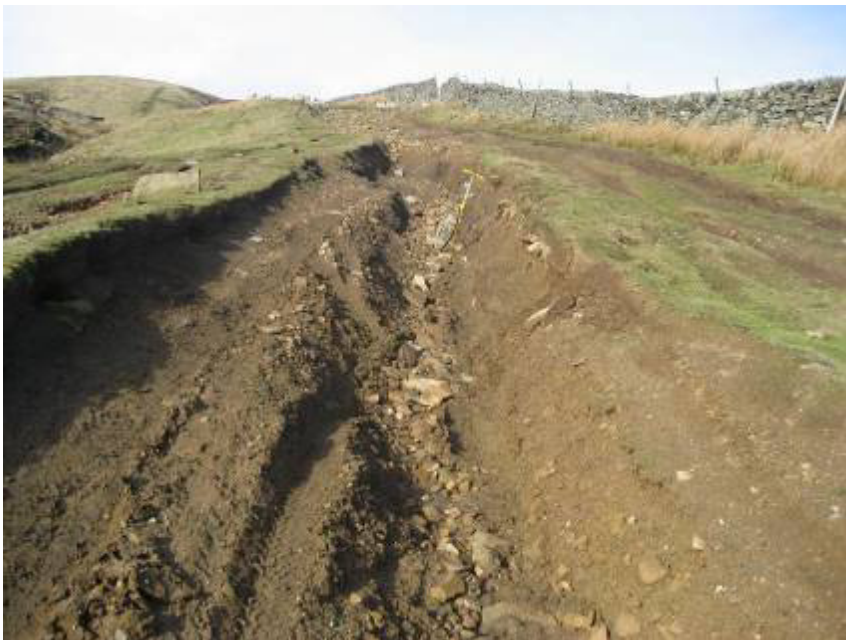
29. The area of minor damage below the zig zags has developed into an area of major rutting, with the old track having been washed out over a distance of approximately 100m, and side tracks developed to either side. This damage appears to be caused through water erosion, with the side tracks being formed by 4x4 use.

NYCC Feb 2011, same section looking uphill to the gate
