C2/10/02487/CCC

Extraction and processing of sand and gravel including the construction of a site access, conveyors, bridges, associated plant and machinery with restoration to agriculture, nature conservation and wetland at Killerby Sand and Gravel Quarry, Killerby, North Yorkshire, DL10 7PY

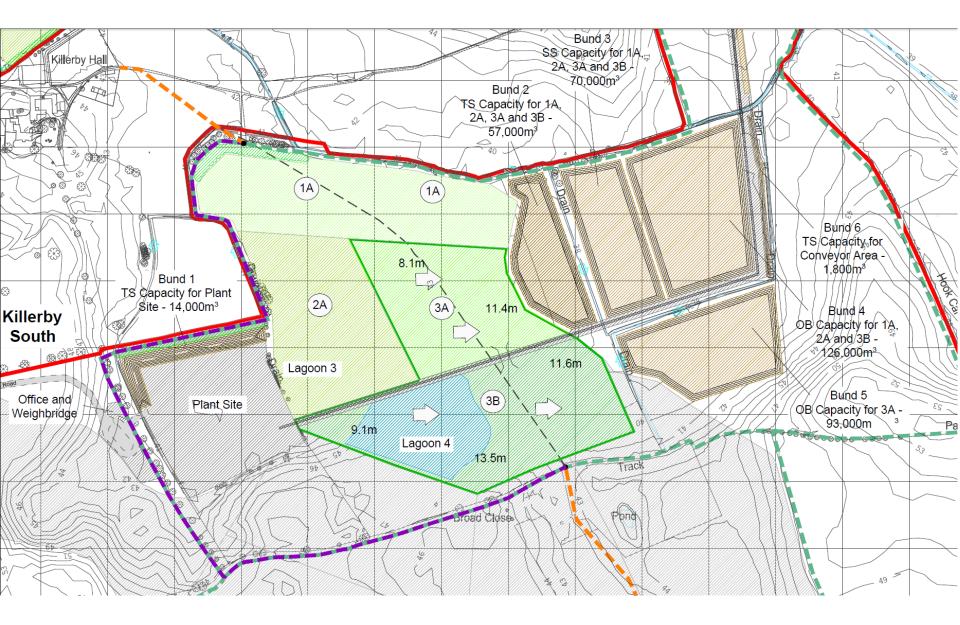
Phase 3 (extract from drwg no. NT10306/12/Figure 3.5 rev A, dated 4th March 2015)

Proposed sand & gravel quarry at Killerby 3.8m wale Plantation 4C 5.7m Shingle 3.9m 4D 4.8m 4B **Killerby** 5.0m **East** 4E 5.4m 7.6m Bund /17/ Bund 16 S\$ Capacity for 4B TS Capacity for 4B -48,000m 34,000m Bund 3 Bund 2 TS Capacity for 1A SS Capacity for 1A, 2A, 3A and 3B -2A, 3A and 3B 27,500m³ 70,000m³
