Summary of assessment

The route travels in a generally North Westerly direction from the property in Stainsacre village, and for the most part follows the Cinder Track to Whitby where the school is located.

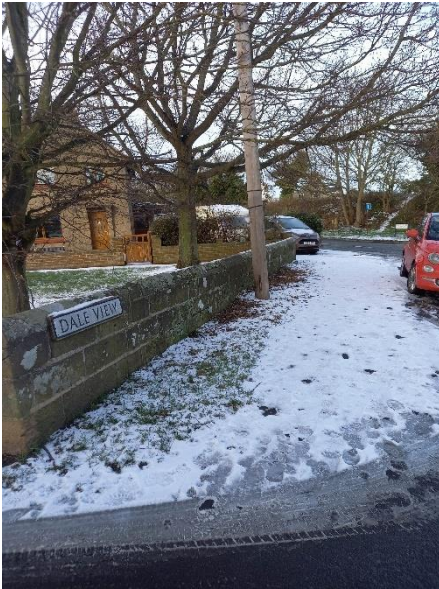
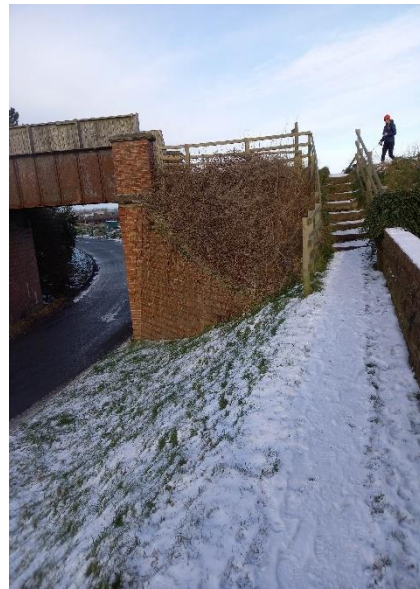
The Cinder Track can be accessed from points along Rigg View.(Photo 1 and 2)

Photos 1 and 2 showing access points to Cinder Track.

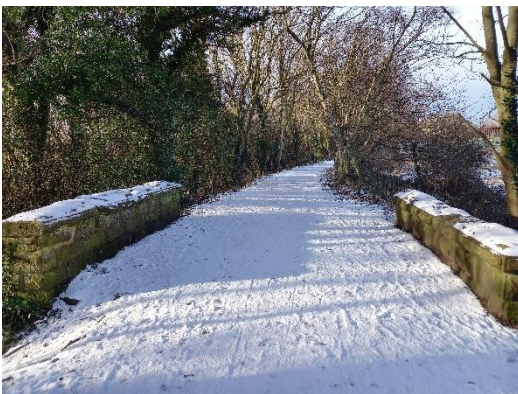
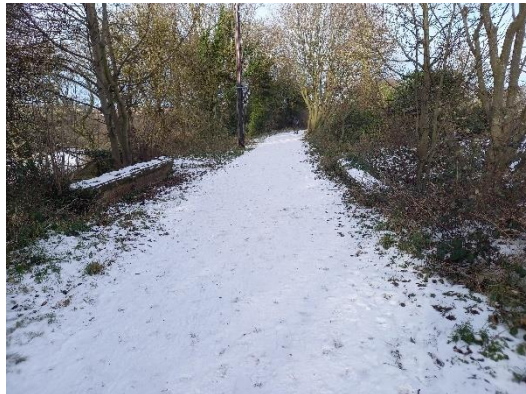
The level track can be followed easily for 2km, occasionally crossing small culverts with low walls. There does not seem to be any significant danger of falling over these or falling down the embankments as the track is wide and level. (Photo 3 and 4)

Photo 3 and 4 showing level track and short culvert crossings

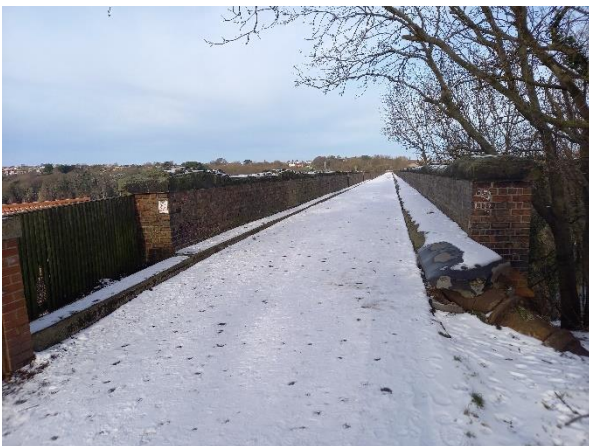
The track continues over a viaduct crossing the River Esk. The viaduct is 225 m long and is walled on both sides. The wall on the west side is approx. 1.5m high and does not present a significant danger for pedestrians. The east side of the viaduct has a similar height wall, although there is a platform of approx. 30cm running along the base of the wall. There is no significant risk of a pedestrian accidentally falling from the viaduct. (Photo 5)

Photo 5 track across viaduct

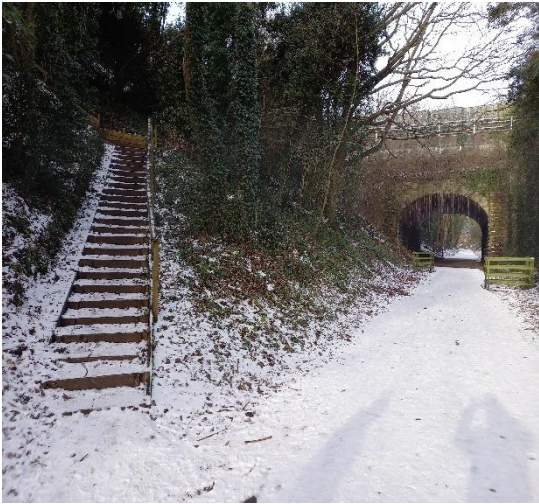
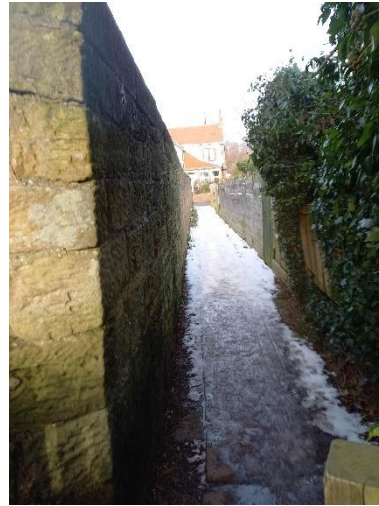
After a further 600m a set of steps on the West side of the track leads up towards the A171. A short ginnel is followed to reach the A171(Photo 6 and 7)

Photo 6 and 7 showing steps and ginnel leading to A171

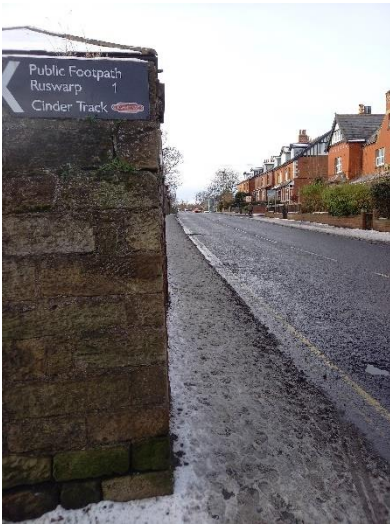
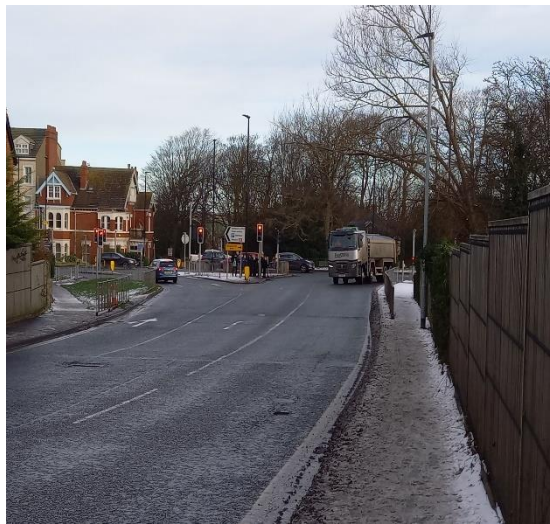
The A171 can be crossed safely at this point, alternatively by following the footway east along the A171 a pedestrian crossing point can be reached after 50m. (Photo 8 and 9)

Photo 8 and 9 showing crossing points of A171

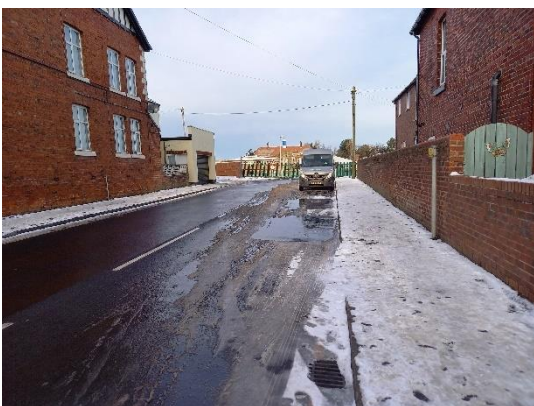
After crossing the A171 a footway can be followed along a short lane leading to the school gate. (Photo 10)

Photo 10 lane leading to school gate.
