Flood Investigation Report

Knarborough 06 May 2024

This document has been prepared specifically for the purpose of meeting the requirements of Section 19 of the Flood and Water Management Act 2010.

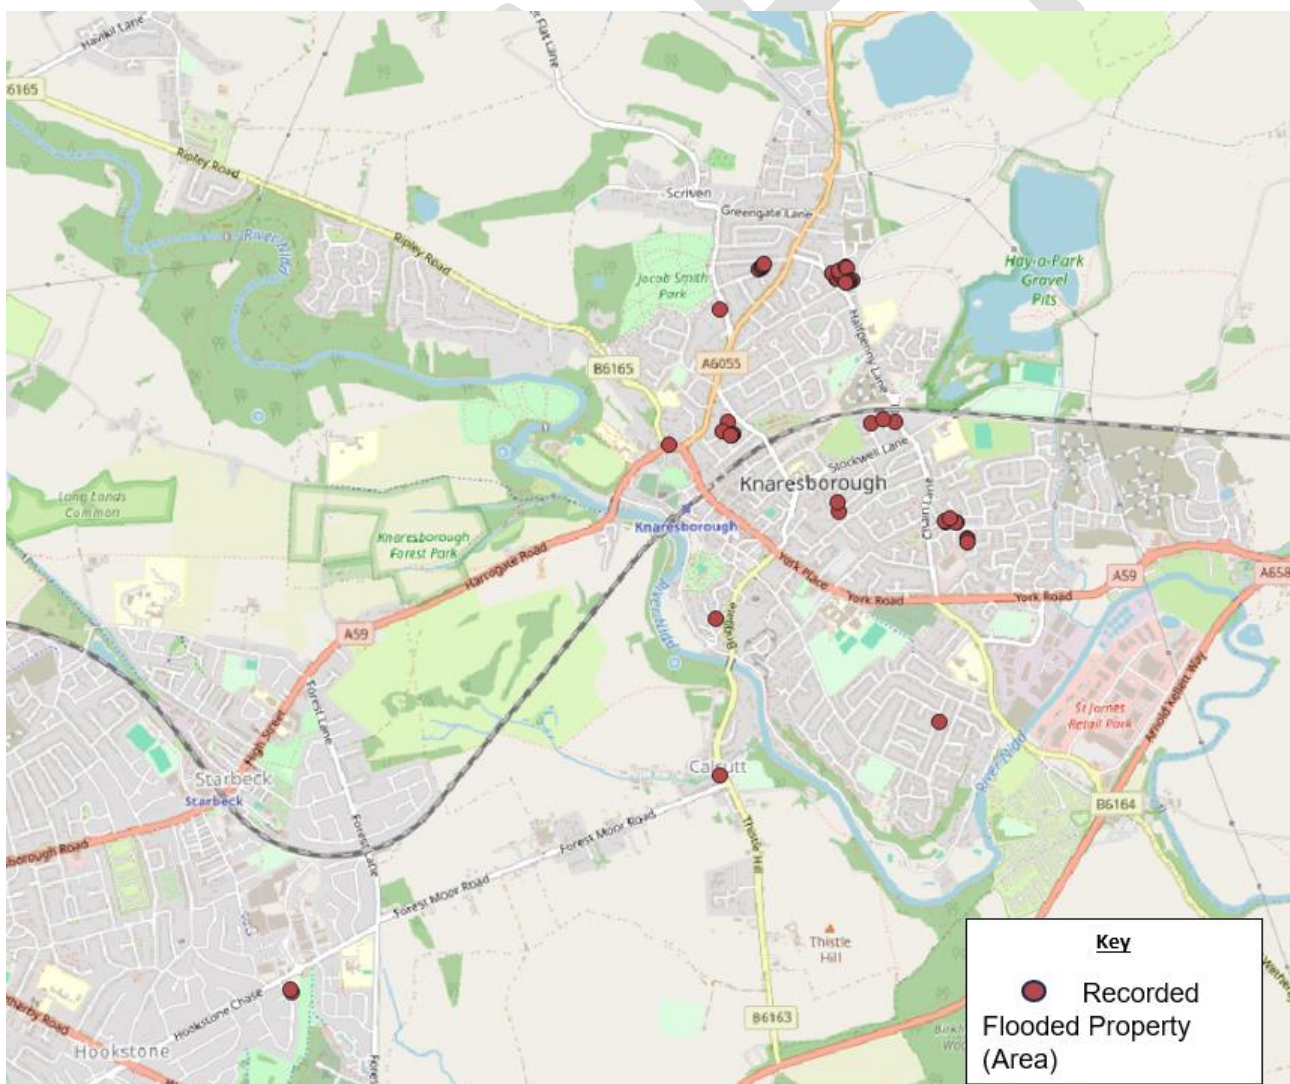
Figure 1: Recorded internal flooding locations

Flooding incidents were recorded at 51 private residences and 4 businesses during the event on the 6th May 2025. A map is shown below (Figure 1) that highlights the areas that were affected to show the clear scale and distribution of the incident within Knaresborough.

In general, the recorded incidents are distributed across Knaresborough, with clear areas of clustered properties and business affected. There are also several isolated incidents where a single property has reported flooding. To avoid going into granular detail that would identify and risk publishing details of individual properties, this report will focus on areas where individual properties will be more difficult to identify. This is consistent with our flood risk management strategy response to investigating flood incidents. We will address the issues affecting individual properties on a case by case basis with the property owners. Based on the clustering of properties in Figure 1 and shared concerns raised at each location, the report will cover in more specific detail the areas of Park Avenue, Orchard Close and Halfpenny Lane, St Margaret's Gardens, Queen's Road, Dentdale Drive, Lundale Avenue and Cotterdale Close.

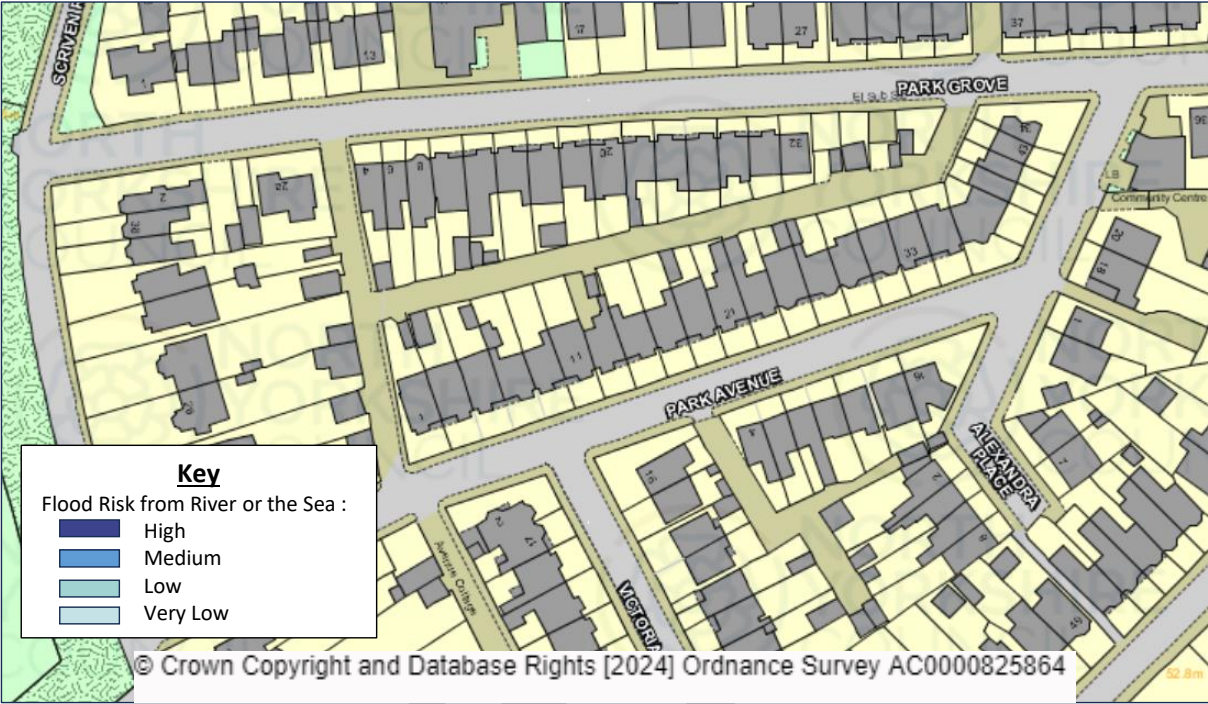
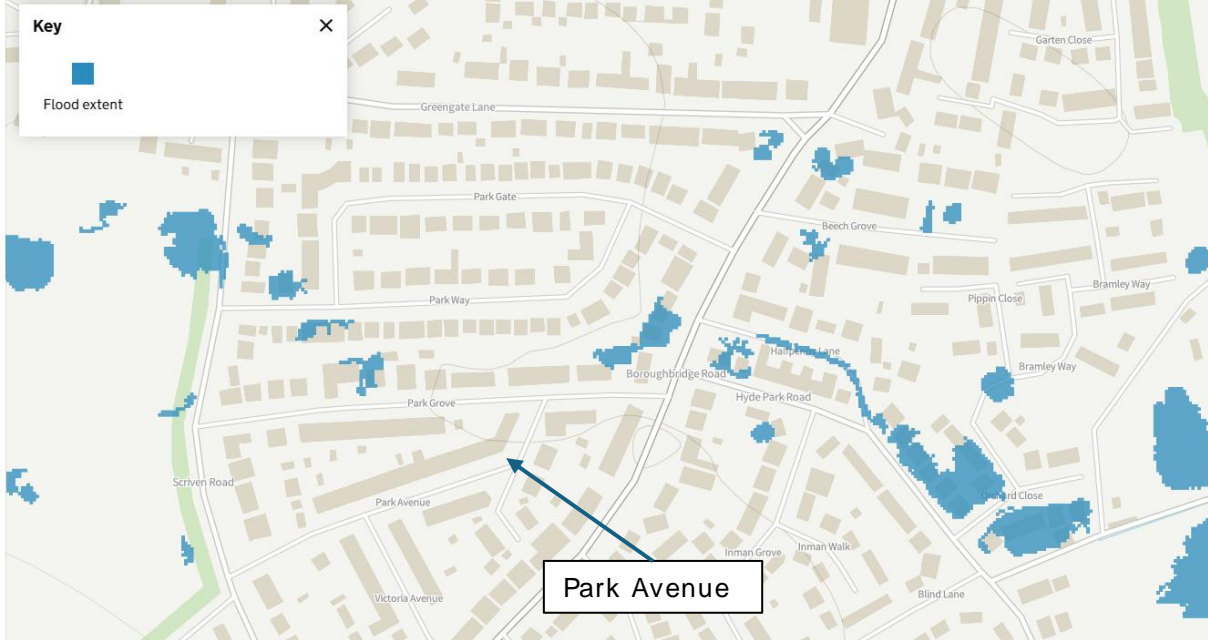
Table 1: Park Avenue Understanding of Flood Risk

The Risk of Flooding from Surface Water map indicates that there are some pockets of High risk of flooding (1 in 30 year event) associated with localised low spots along Park Grove but properties along Park Avenue are not show to be at risk. In the Medium and Lower likelihood scenarios, the flood extents expand, and flow paths emerge from Jacob Smith Park and flow along Park Grove, whilst some flood extent would be expected in the 1 in 1,000 year event on Park Avenue and significant flooding on Park Grove, the properties on Park Avenue that reported flooding continue to be indicted as being very Low risk.

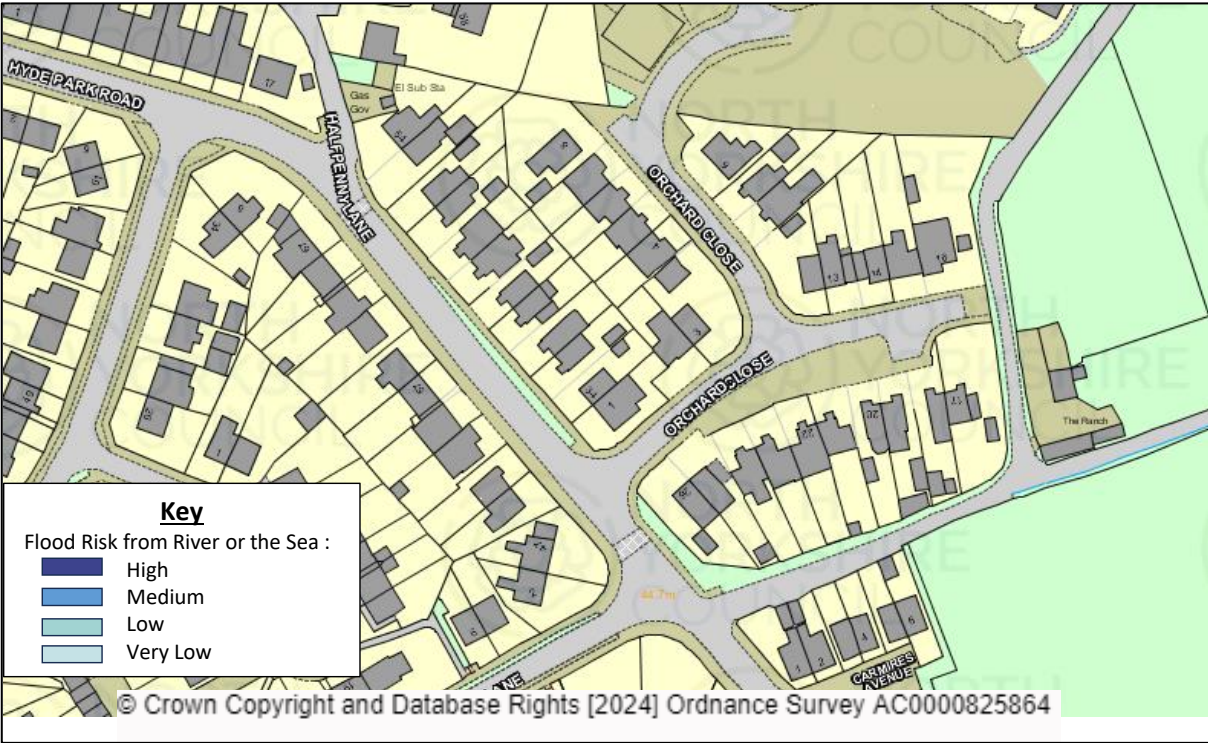
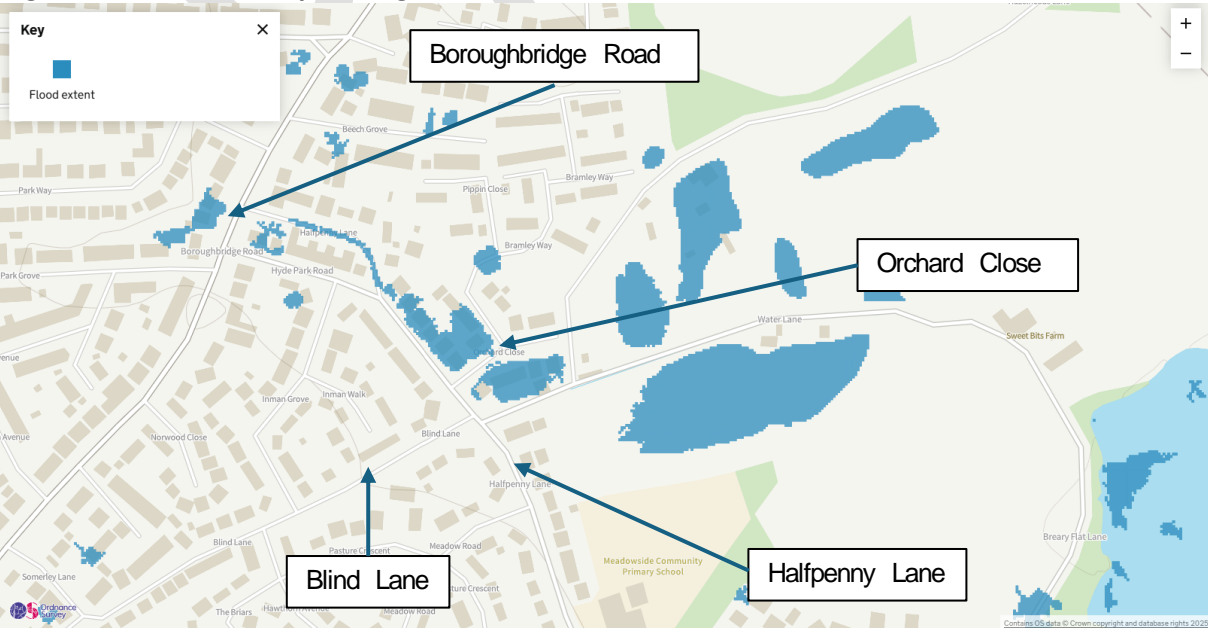
Table 2: Orchard Close and Halfpenny Lane Understanding of Flood Risk

The maps identify a large number of properties within the High and Medium risk area from surface water flooding. Initially in the High risk scenarios the flooding is isolated to ponding within low spots. As the intensity increases it appears that the highways become conduits for surface water. There is a strong correlation of runoff along Park Grove, Boroughbridge Road and Blind Lane converging on Halfpenny Lane and the Orchard.

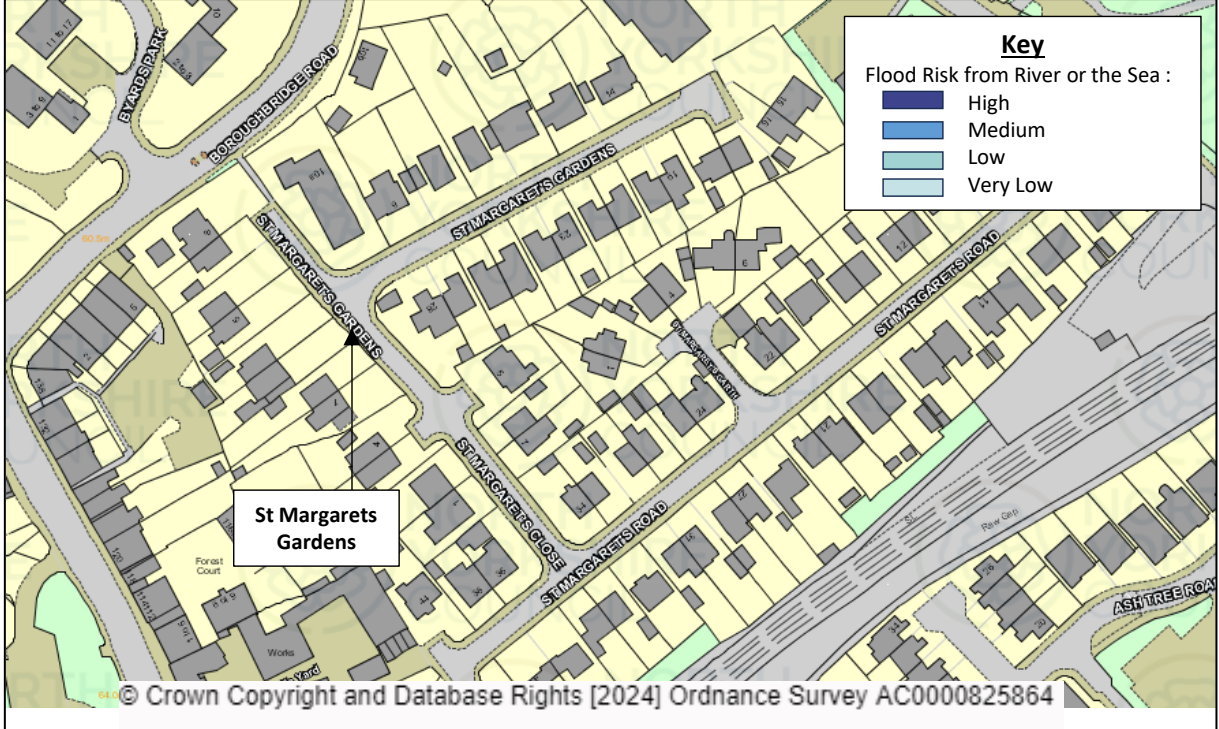
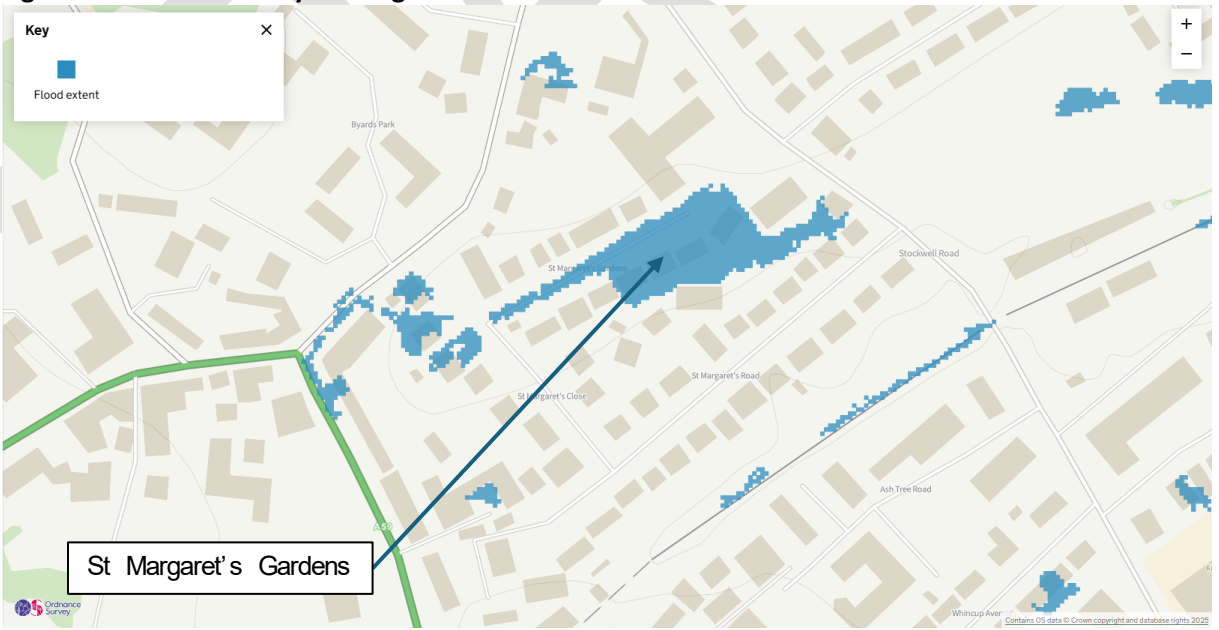
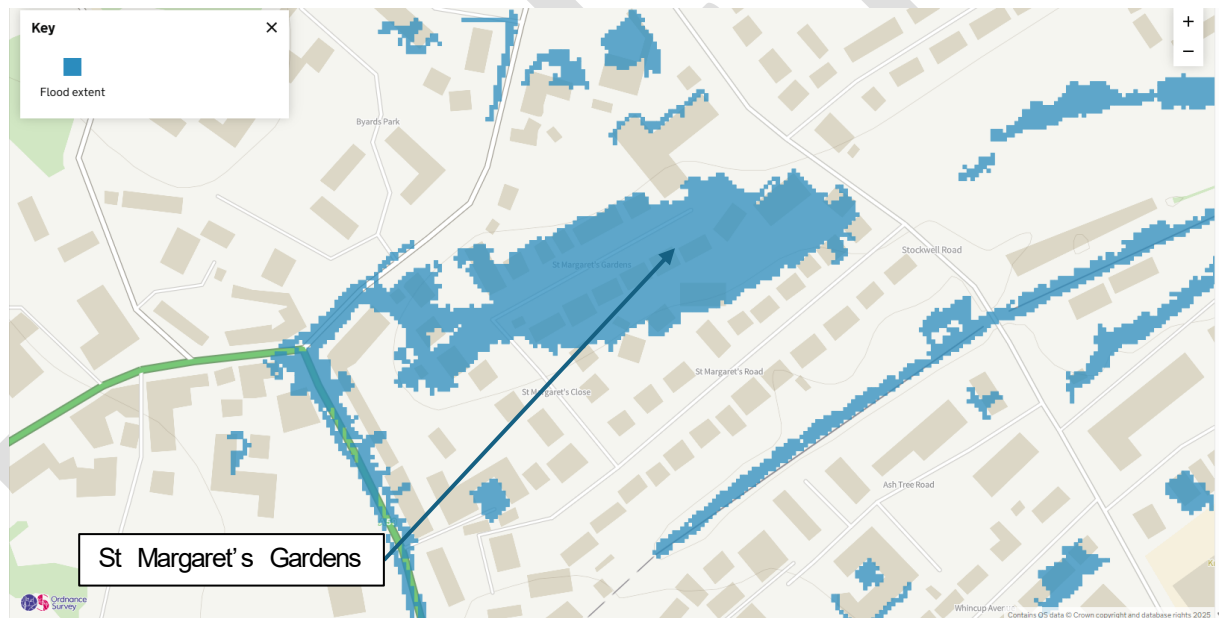
Table 3: St Margaret's Gardens: Understanding of Risk

It is noted the map above shows the surface water flood risk for St Margaret's Gardens. The data presents a large area of properties that are within the High and Medium risk area from surface water flooding. The mapping in this location shows a higher number of properties at risk of flooding than reported flooding during event. It could be considered that the above flood extent and risk is conservative.

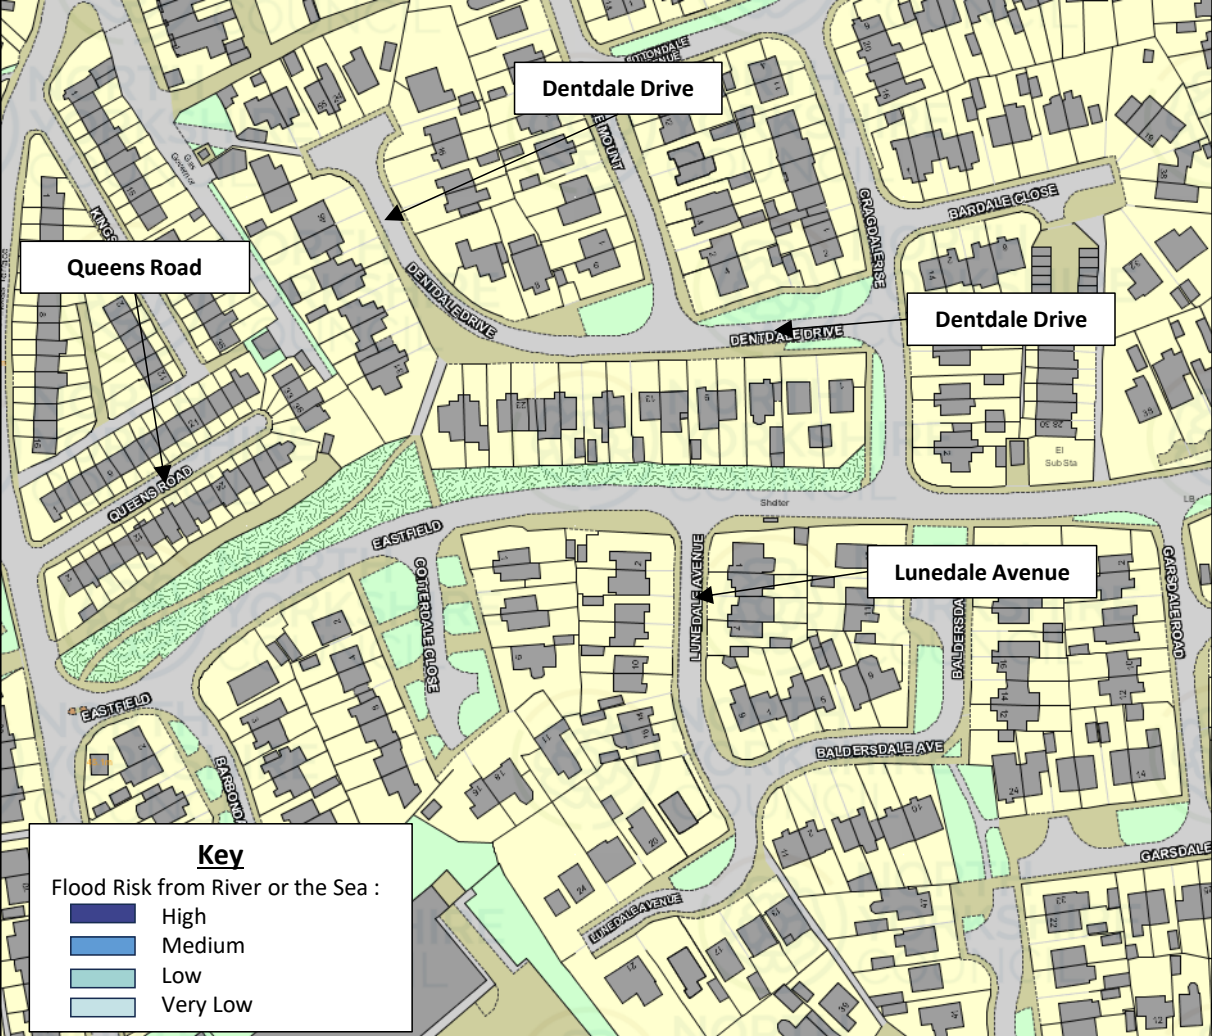
Table 4: Queen's Road, Dentdale Drive and Lunedale Avenue: Understanding of Risk

It is noted the map above shows the surface water flood risk for Queen's Road, Dentdale Drive, Lundale Avenue and Cotterdale Close. The data presents a large area of properties that are within the High and Medium risk area from surface water flooding. The Highway is primarily within a Medium/Low risk area with some areas of the Highway being partially within a High risk area.

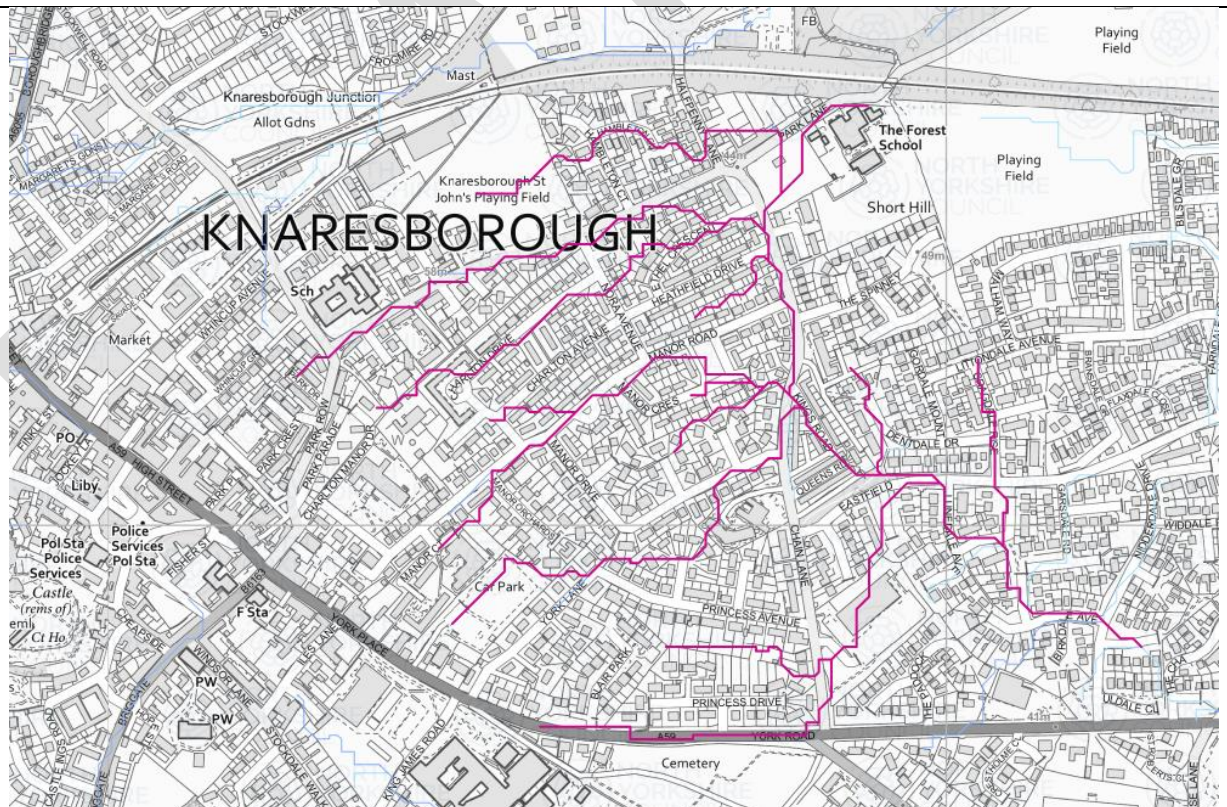
Overland Flow Maps

The overland flow maps demonstrate a significant catchment that contributes runoff towards the Eastfield, Cotterdale Close and Lundedale Avenue from York Road to the South to the railway line to the North. The catchment is also particularly steep generating high velocities of runoff.

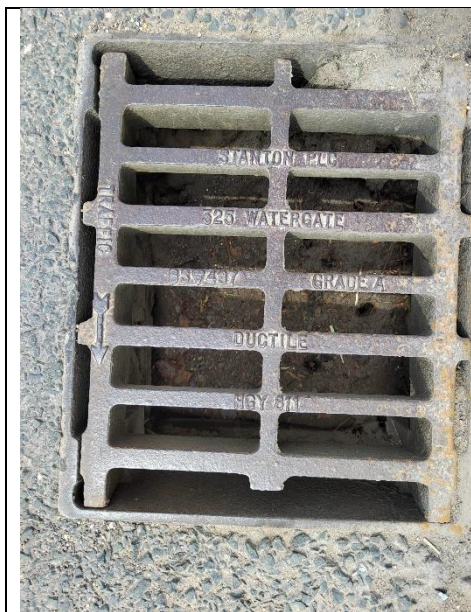
Figure 8: Gully Halfpenny Lane

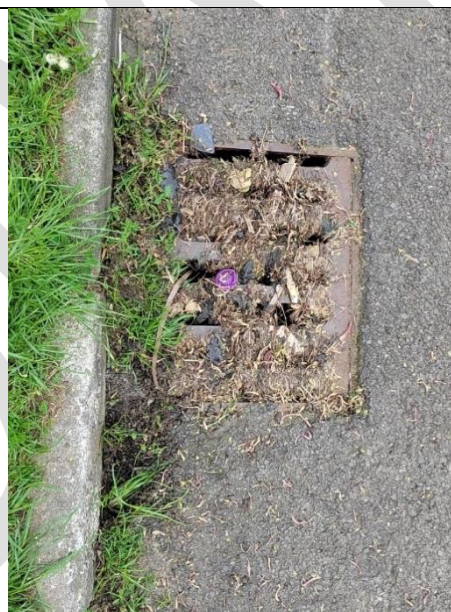
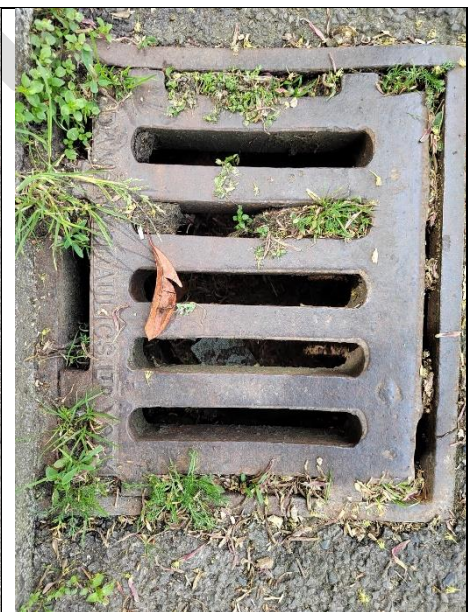
Further gullies on Blind Lane were also identified by residents as being ineffective during the event. Photographs of the two gullies are presented in Figure 9 and Figure 10 below. The gully in Figure 9 is blinded with debris. It cannot be proven when this occurred, but a significant amount of debris would have been washed onto the gully grate during the event. The gully chamber and outlet were not full and blocked. Likewise, the gully in Figure 10 does have vegetation growing out of the grate, but the gully chambers itself was clear with the outlet functional. This indicates that the two particular gullies whilst blinded are emptied at an appropriate frequency. It does highlight however a requirement for further sweeping and inspections.

Figure 9: "Blinded" Gully on Blind Lane

Figure 10: Gully on Blind Lane
