HAMBLETON DISTRICT COUNCIL

Report To: Planning Committee
1 March 2012

Subject: TREE PRESERVATION ORDER NO 2011/4 – KNAYTON

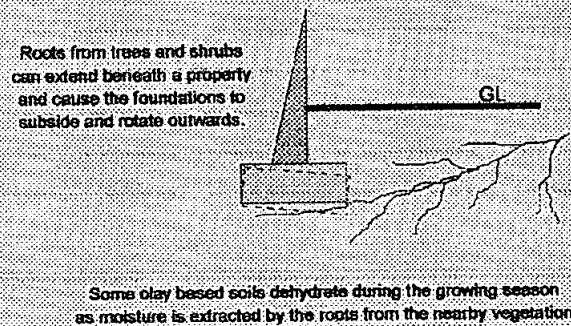
Figure 1

Roots can infiltrate into the clay soil beneath the foundations

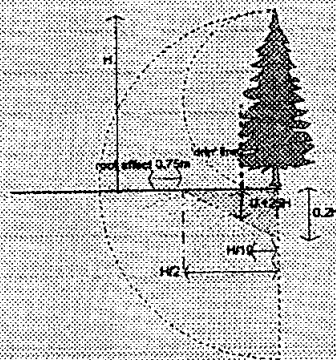
Figure 3

Typical proportions of a Cedar tree. However, the root zone will depend on the type of soil, the health of the tree and the climate.
