North Yorkshire County Council
Business and Environmental Services

Section 19 Report on the February Flooding Events in the Aire Catchment

Flood Investigation Report

February 2020

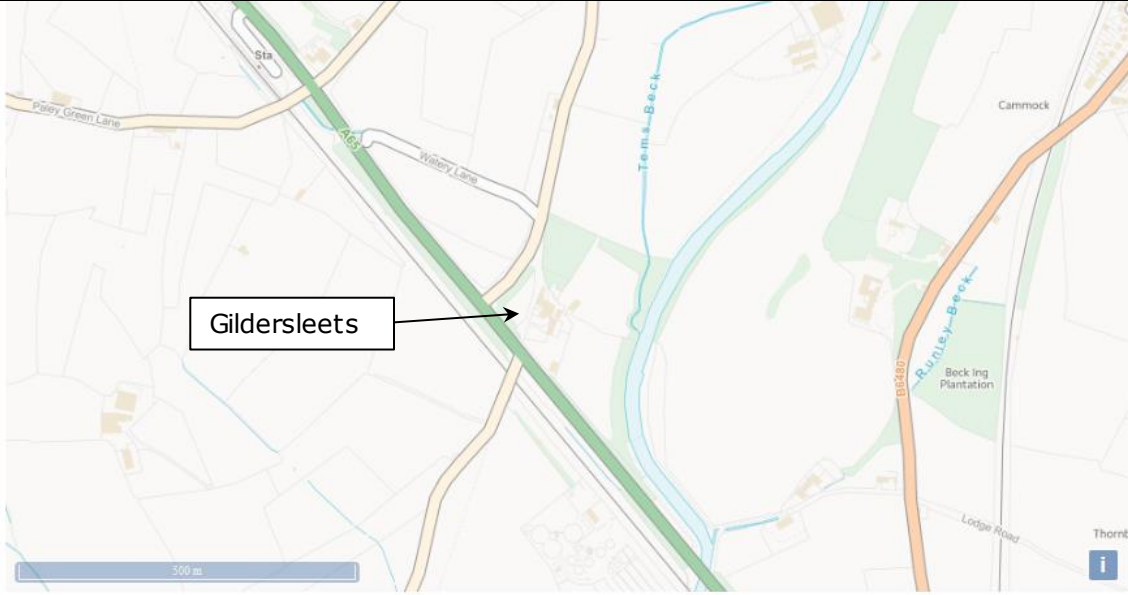
<p>Reservoir Flooding</p>

<p>Extent of flooding from reservoirs</p> <ul style="list-style-type: none"> ● Maximum extent of flooding <p>Gildersleets is not shown to be at risk of flooding from reservoirs.</p>
<p>Flood Alert and Warning Areas</p>	<p>Gildersleets is included in the Upper River Ribble Flood Alert Area</p>
<p>Current Flood Defences</p>	<p>There are no formal flood defences to protect the Gildersleets from the River Ribble. A flood defence barrier was installed in a partnership project between NYCC Highways and NYCC Flood Risk Management Team to prevent surface water flows from the A65 flooding the properties. This work was funded by central government flood recovery framework grant in 2015.</p>

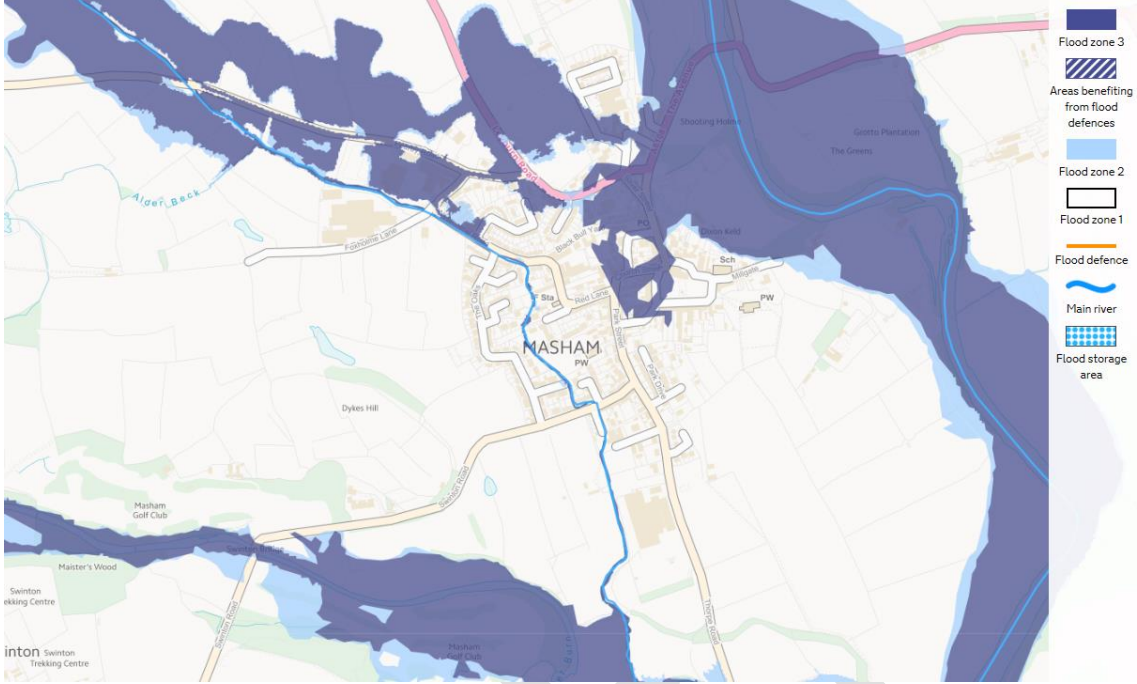
<p>The flood map for planning is primarily based on the modelling used to inform the rivers and sea (in addition to anecdotal evidence of flooding). The flood zone extents therefore mirror the map above. Both main rivers are easily identifiable in light blue and the map confirms that there are no formal defences in Masham.</p>
<p>Pluvial Flood Risk (Surface Water)</p>

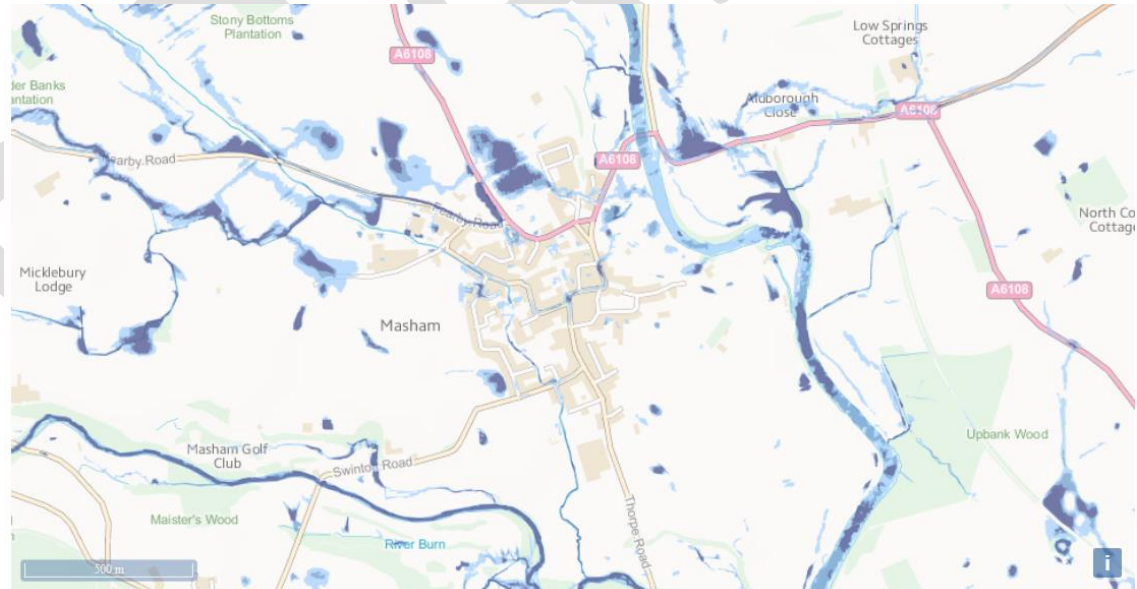
<p>Extent of flooding from surface water ● High ● Medium ● Low Very low</p> <p>It is noted the areas shown at most risk within Masham are predominantly contained within the highways and are representative of the flow paths observed in recent event. The map does not however show any links between Swinney Beck and the flow paths (this is likely due to the modelling methodology and we must acknowledge the limitations of modelling). Of particular interest to this study is the high (frequency of more than every 1 in 30 years), medium (frequency between 1 in 30 years and 1 in 100 years) and low (between 1 in 100 and 1 in 1,000</p>

years) risk shown on Westholme Road adjacent to Swinney Beck, Red Lane, Park Square, Church Street and Silver Street.
<p>Reservoir Flooding</p>

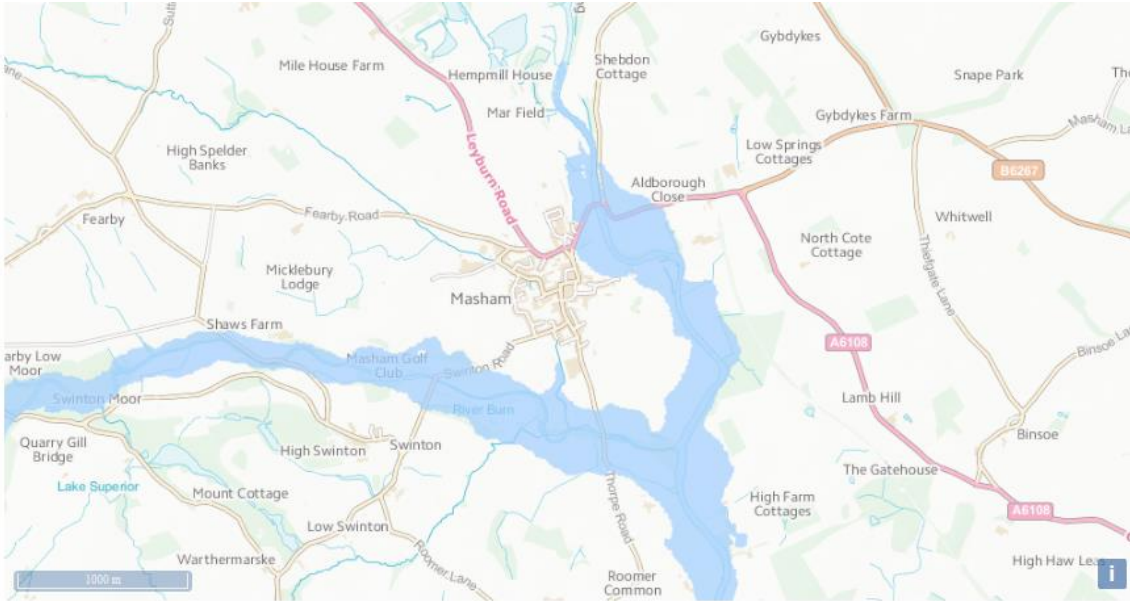
<p>Extent of flooding from reservoirs</p> <ul style="list-style-type: none"> Maximum extent of flooding <p>The risk of flooding from reservoirs is shown to follow a similar extent to the risk of fluvial flooding. Overall, the centre of Masham is not shown to be at risk of flooding from reservoirs.</p>
<p>Flood Alert and Warning Areas</p>	<p>Masham is included in the Lower River Ure Flood Alert Area</p>
<p>Current Flood Defences</p>	<p>Masham is not shown to benefit from any flood defences.</p>

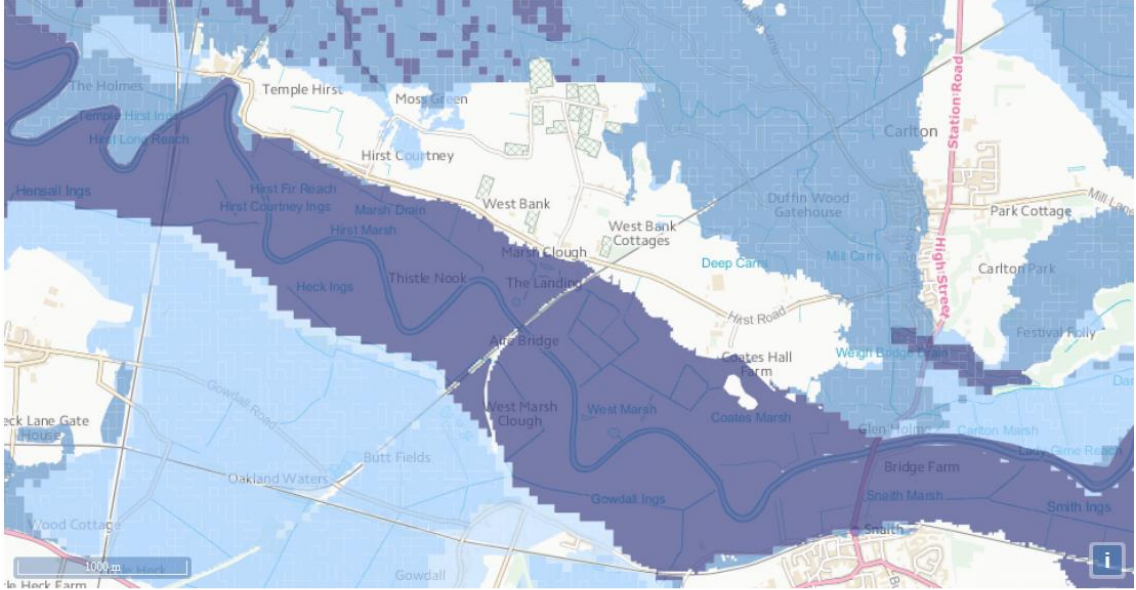
Source of Flooding	Understanding of Risk
<p>Flood Risk from Rivers and Sea</p>

<p>Extent of flooding from rivers or the sea</p> <ul style="list-style-type: none"> ● High ● Medium ● Low ● Very low <p>The predominant area of risk associated with the River Aire is to the southern side of Hirst Road. The properties on the south side of Hirst Road are at high (a flooding frequency of more often than 1 in 30 years) and medium (a flooding frequency of between 1 in 30 and 1 in 100 years) risk of flooding. It is clear to see when on site that Hirst road is considerably higher than the surrounding area and as such acts as a barrier to the water for the properties to the north side of the road. The land immediately north of the road is shown to be at less than very low risk (frequency of less than 1 in 1,100 years).</p>
<p>Flood Map for Planning</p>

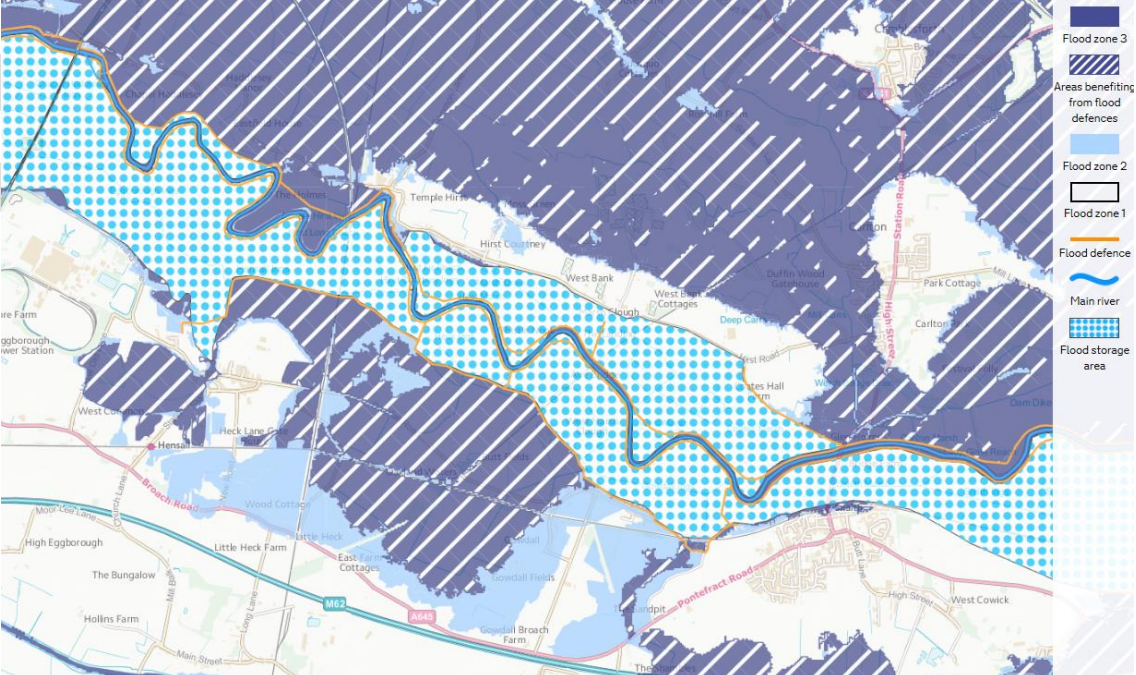
<p>The flood map for planning illustrates the location of the formal flood defences (orange lines) in relation to the areas at risk and flood storage areas. The washlands between the River Aire and Hirst Road are clear to see as flood storage areas. The northern extent of the storage area is is</p>

<p>defined by Hurst Road with no formal defences present. Flood storage areas are defined by the EA as those areas that act as a balancing reservoir, storage basin or balancing pond. Their purpose is to attenuate an incoming flood peak to a flow level that can be accepted by the downstream channel. It may also delay the timing of a flood peak so that its volume is discharged over a longer time interval. Flood storage areas do not completely remove the chance of flooding and can be overtopped or fail in extreme weather conditions.</p> <p>The A19 is shown in the far west of the map and can be seen crossing the flood storage area.</p>
<p>Pluvial Flood Risk (Surface Water)</p>

<p>Current Flood Defences</p>	<p>As discussed above, the flood map for planning shows an extensive network of flood defences, both adjacent to the River Aire channel and within the fluvial floodplain to define and manage the water levels within the washlands. There are no formal defence between the current defences and the properties on the south side of Hirst Road.</p>

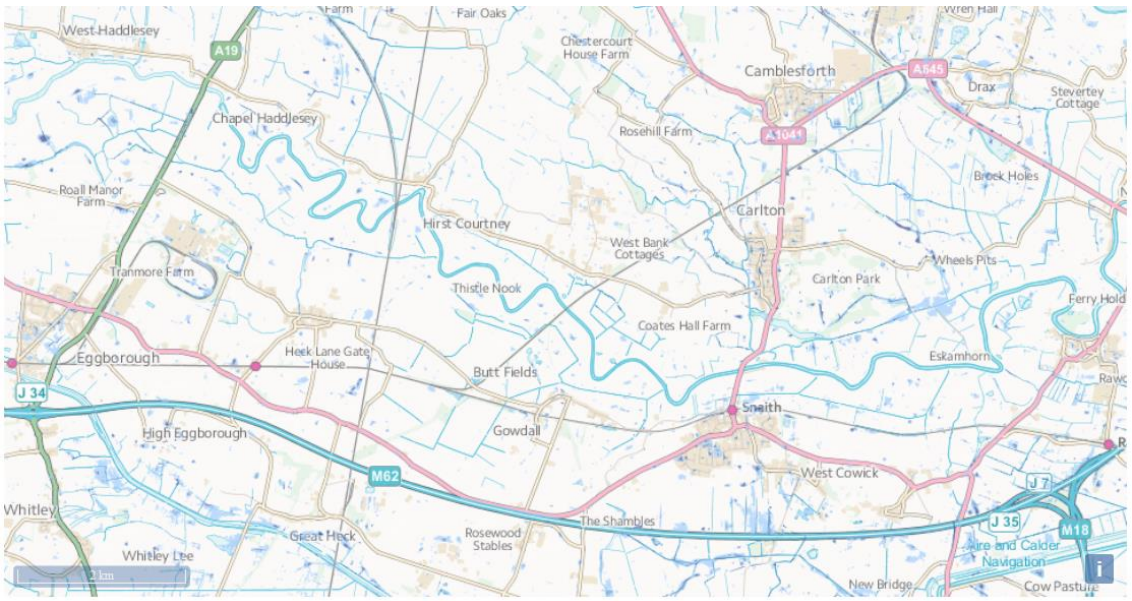
<p>Extent of flooding from surface water</p> <ul style="list-style-type: none"> ● High ● Medium ● Low ○ Very low <p>Given the topography and the generally well-draining soils, the surface water flood extents are limited. The predominant risk of flooding in the area is fluvial/tidal.</p>

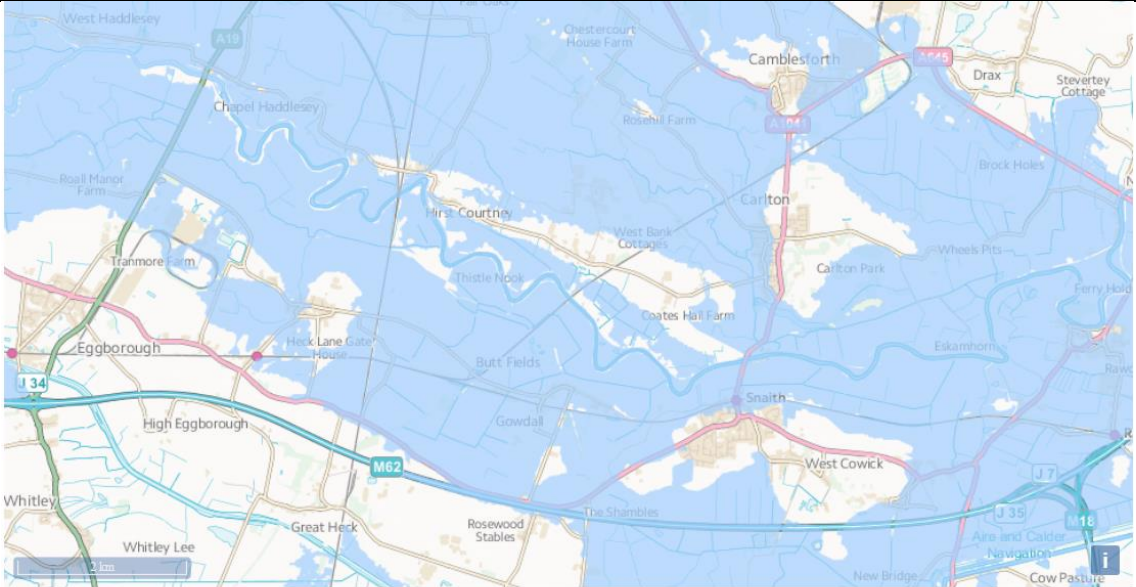
<p>Reservoir Flooding</p>

<p>Extent of flooding from reservoirs</p> <ul style="list-style-type: none"> Maximum extent of flooding <p>Given the number of reservoirs located within the extensive upstream catchments, there is a residual risk of reservoir flooding in the area should one of the reservoirs fail. The flood extents are akin to the fluvial but not as severe around Hirst Courtney and West Bank.</p>
<p>Flood Alert and Warning Areas</p>	<p>There are a number of flood alert and flood warning areas that cover the lower air reaches.</p> <p>Areas upstream of the East Coast Mainline are located within the River Aire from Brotherton to Chapel Haddlesey flood alert area. Whilst on the downstream side of the railway line Hirst Courtney, West Bank and Carlton are downstream to Airmyn is cover by the Tidal River Aire Catchment flood Alert Area.</p> <p>Chapel Haddlesey has a flood warning area that covers West Haddlesey and Chapel Haddlesey including Millfield Road and downstream to Lock Farm.</p> <p>The Flood Warning Area for Hirst Courtney extends from Temple Hirst through to the eastern side of Hirst Courtney. It includes Main Street and Hirst Road.</p> <p>A third flood warning areas is located at Hirst Marsh and West Marsh. The flood warning area covers the southern part of Higher Road including West Bank to Coats Hall Farm</p> <p>The western extent of Carlton is covered by the River Aire at Carlton flood warning area and includes Carlton from Low Street to Horley Park including Lynwith Lane, Almond Tree Avenue, The pastures, Camm Land and Church Fields.</p>

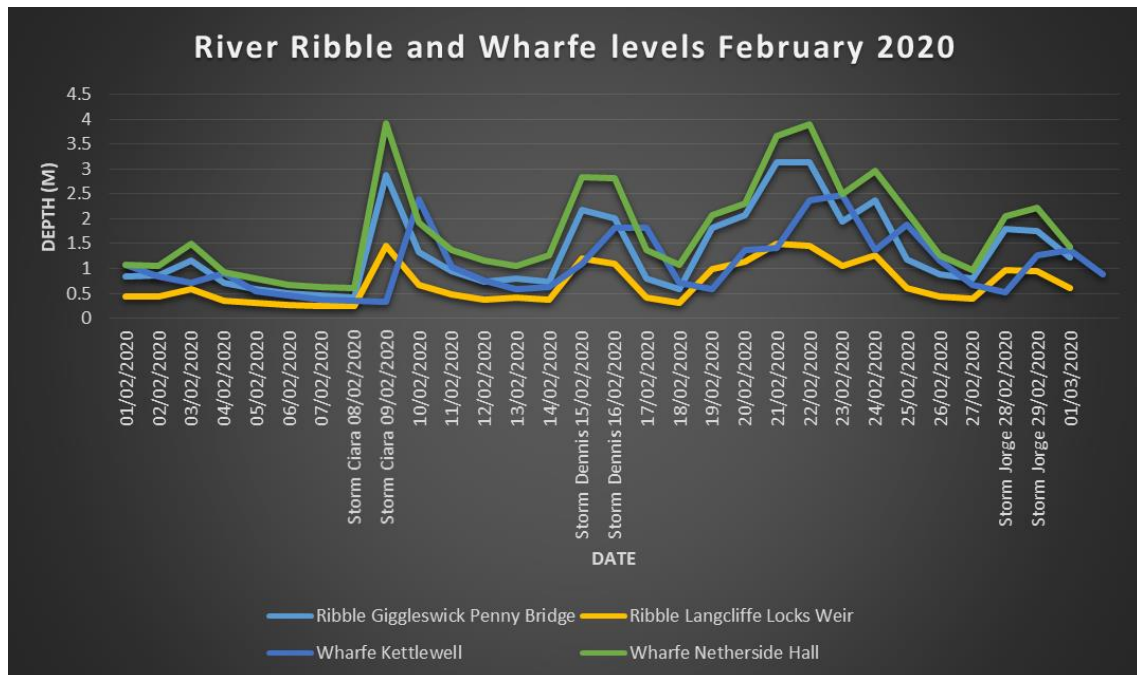
Figure 6: River Levels for February in Craven District

The river Ribble at Pennybridge recorded a highest ever level of 2.87m on the 9th February. On the same day the Wharfe at Netherside hall also recorded a highest ever peak of 3.91m. The typical range for these sites are 0.009-2.48 and 0.30-2.20 respectively. The river Wharfe at Kettlewell peaked at 2.39 on the 10th February, and the Ribble at locks weir recorded a monthly peak of 1.5m on the 21st February.

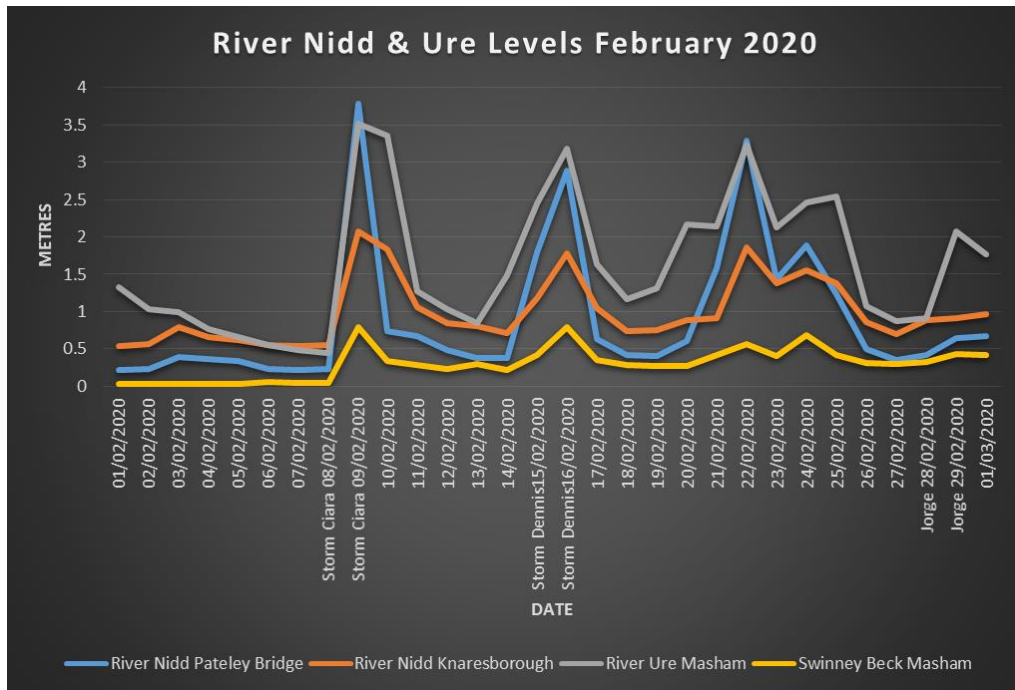
Figure 7: River Levels for February in Harrogate District

Across the county in Harrogate district, the river Nidd and Ure also show 4 significant peaks, the 3 storms, and the event on the 21st. The river Nidd at Pateley Bridge recorded a highest ever peak of 3.93 m on the 9th during Storm Ciara, typical range for this site is between 0.14 and 2.50m. The Nidd at Knaresborough peaked at 2.1m on the same day. The Ure at Masham also recorded a monthly peak on the 9th February with 3.5m. The Ure at Boroughbridge recorded a monthly peak of 15.6m on the 10th February.

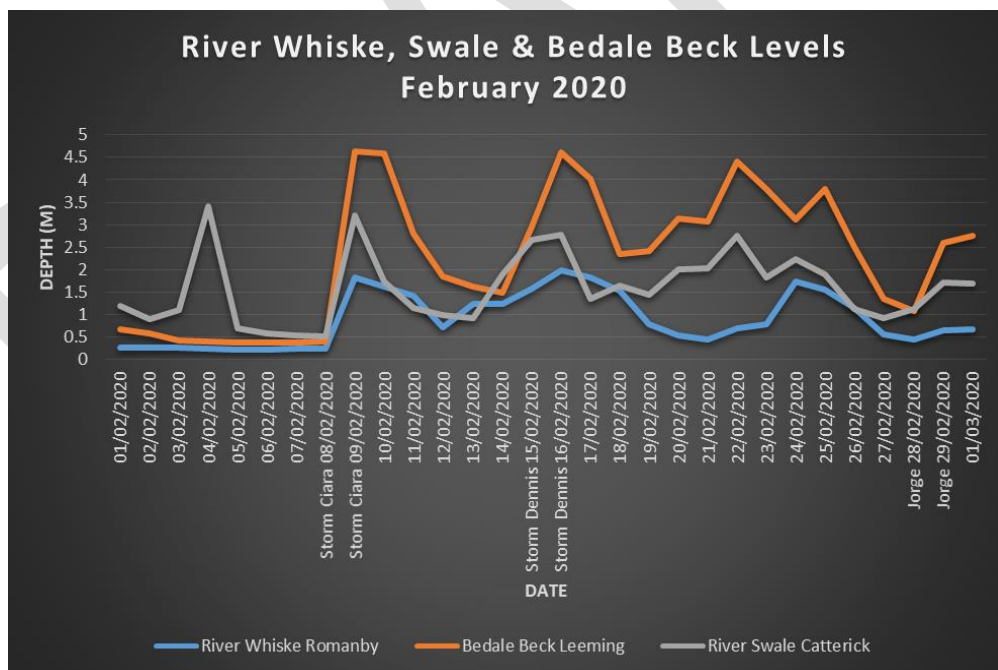
Figure 8: River Levels for February in Hambleton District

Bedale Beck at Leeming peaked on the 9th February at 4.63m and the River Wiske at Romanby recorded 1.99m on the 16th February, after Storm Dennis. All 3 Rivers show the 4 peaks in flow corresponding with storm and rainfall events.

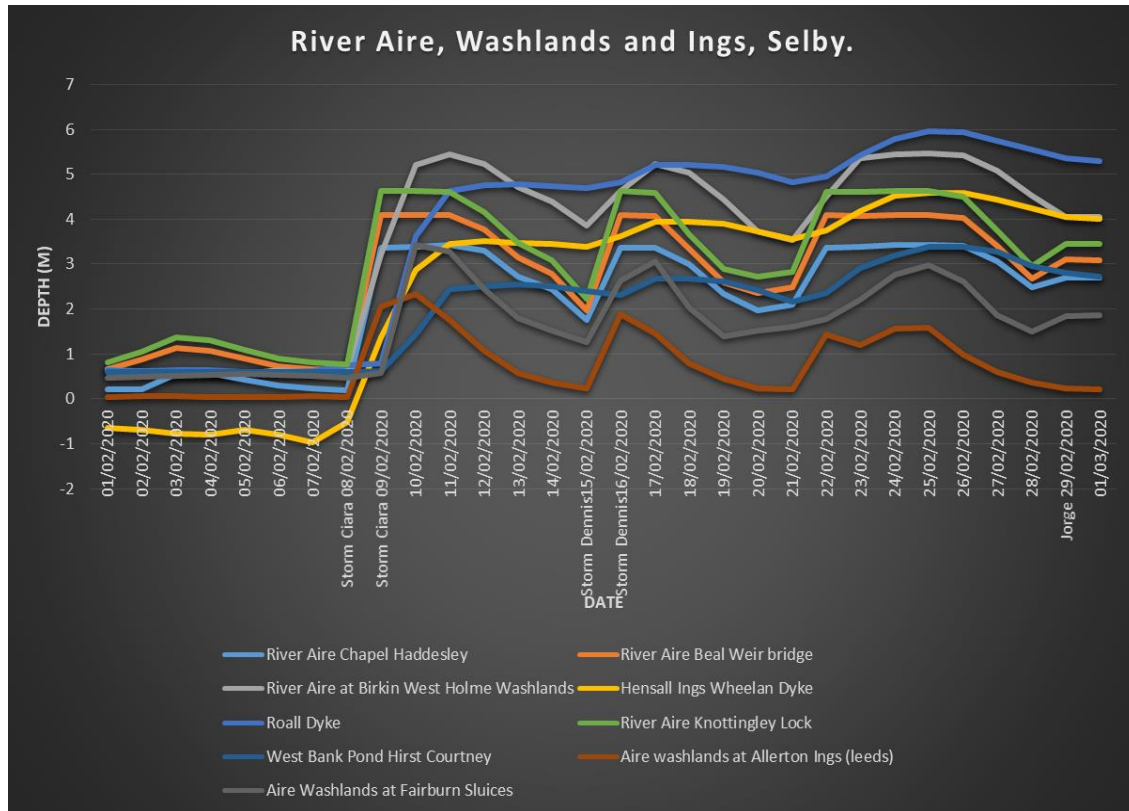
Figure 9: Figure 8: River Levels in the Aire Catchment

The river Aire runs through Selby district, in the southern part of North Yorkshire. The highest peak recorded at Chapel Haddesely was 3.43m on the 25th February. It also peaked on this date at Beal Weir (4.1m) and Birkin Westholme Washalnds (5.4m). Throughout the month, the river has significant peaks at all monitoring sites during storm or significant rainfall events, before dropping down again. Levels at West Bank pond, Wheelan Dyke and Roal Dykeshow an initial rise during storm Ciara, and then continue to rise and record higher peaks at Storm Dennis,

then continue to rise again and record monthly peaks on the 25th February. Roall Dyke recorded 5.95m, West Bank pond recorded 3.38m, the highest level on record, typical levels here are between 0.27 & 1.00m. Wheelan Dyke also recorded the highest level on record at 4.59m, they typical range for this site is -0.61-2.00m. It should be noted that the event of the Lower Aire was volume driven rather than by river levels, this is discussed further in Section 5.

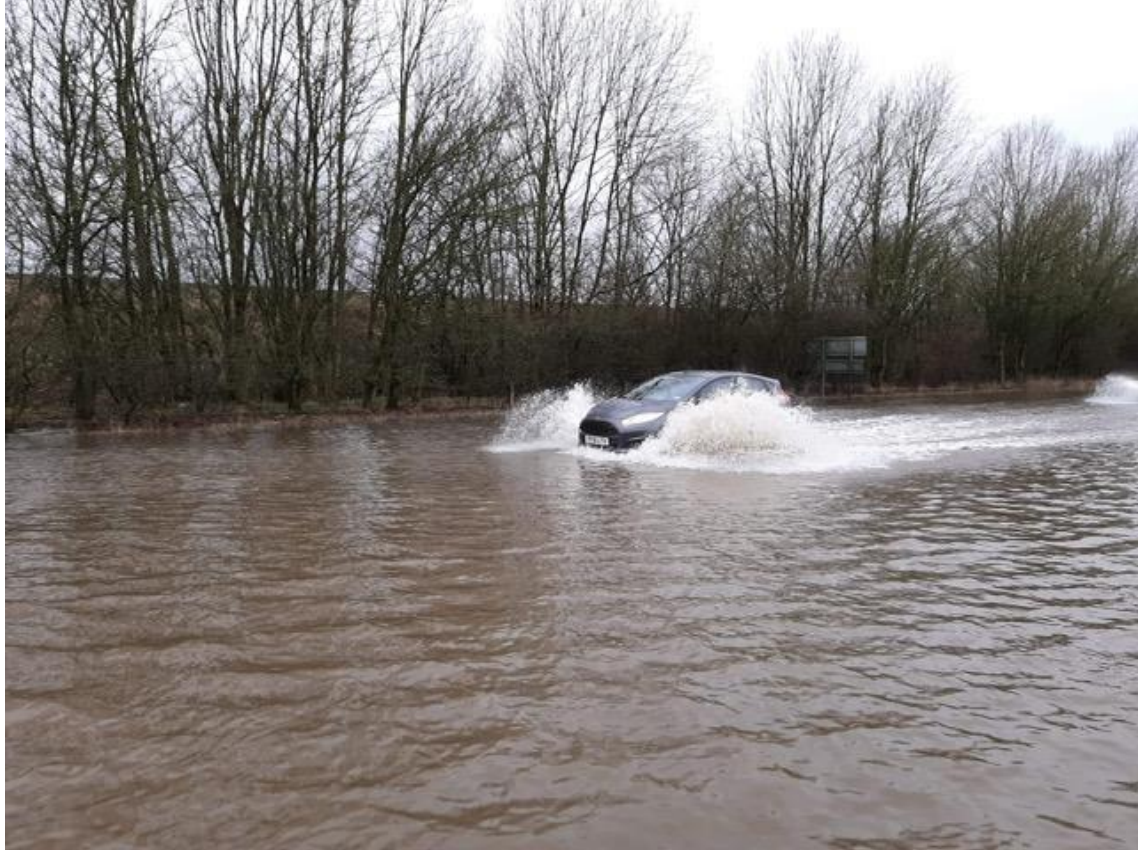
Five properties were recorded to have flooded in Gildersleets, with significant depths of flooding occurring on the A65 as shown in Figure 5. The A65 was not closed during the event. It was noted that the passage of vehicles exacerbated flows towards the properties.

Figure 10: A65 at Gildersleets

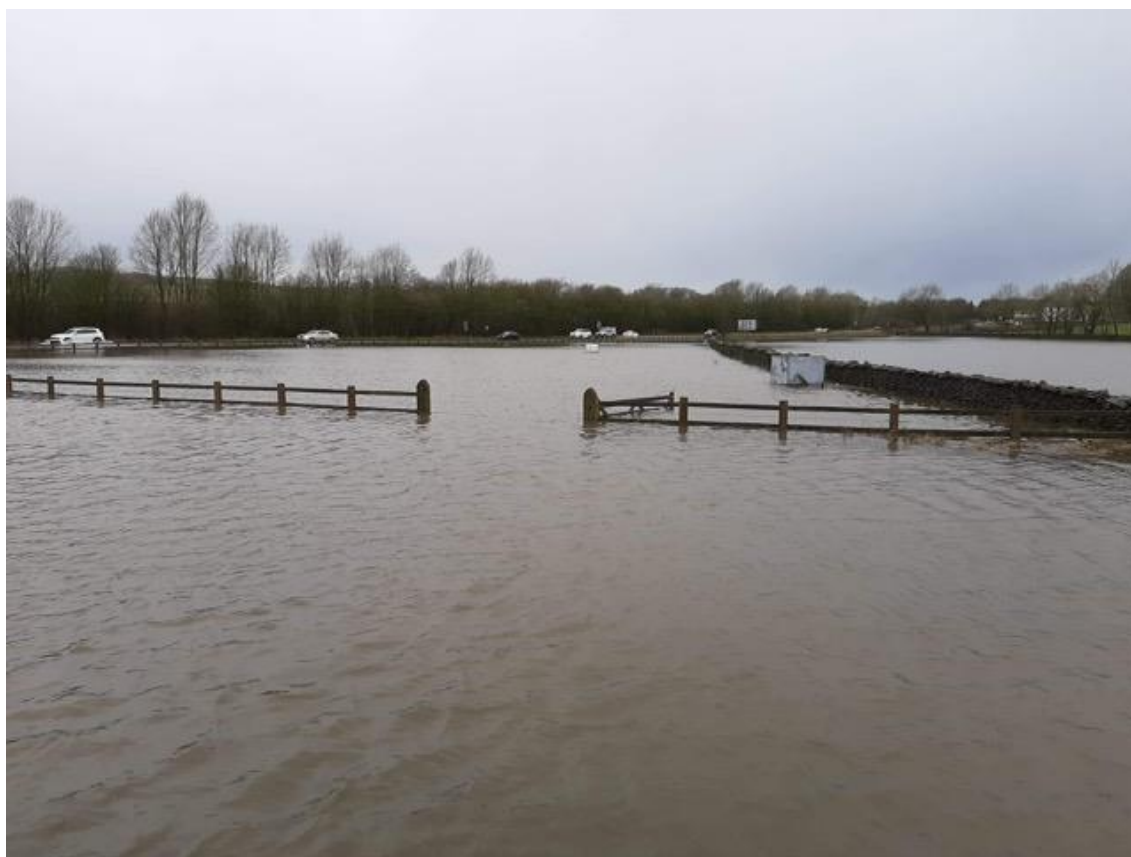
Figure 11: Looking north west from Gildersleets towards the A65.

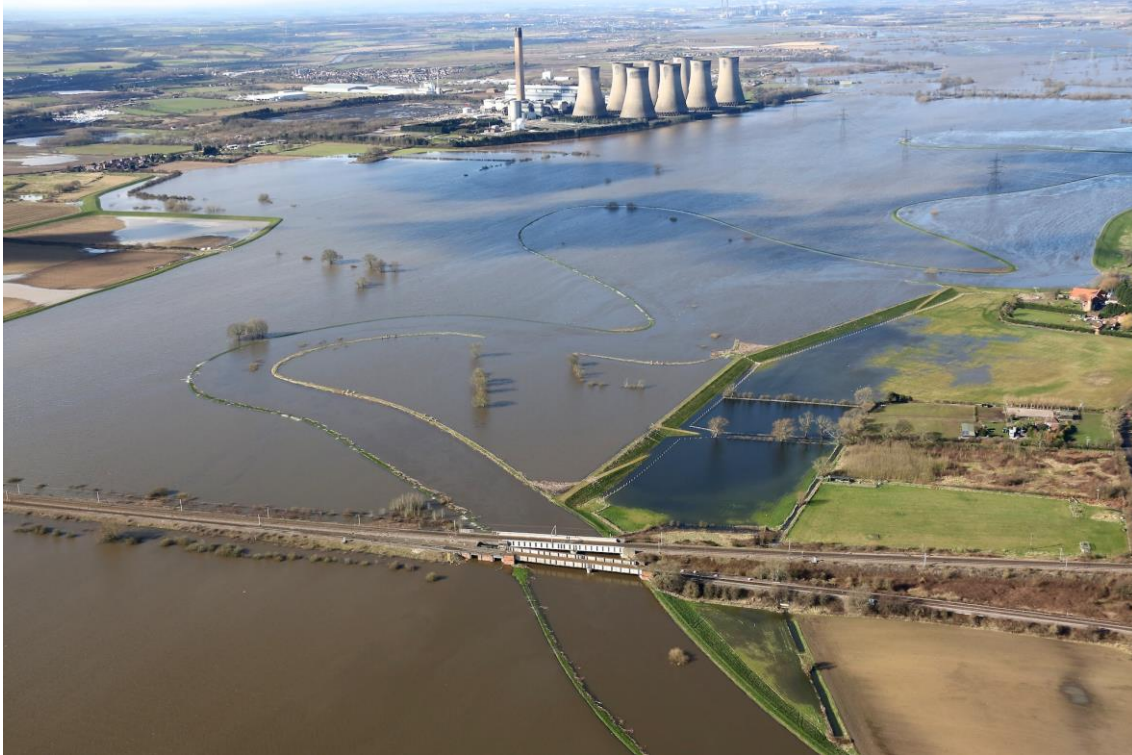
Aerial Imagery shows the vast extent of the flooding in the area.

Figure 12: River Aire Floodplain looking west

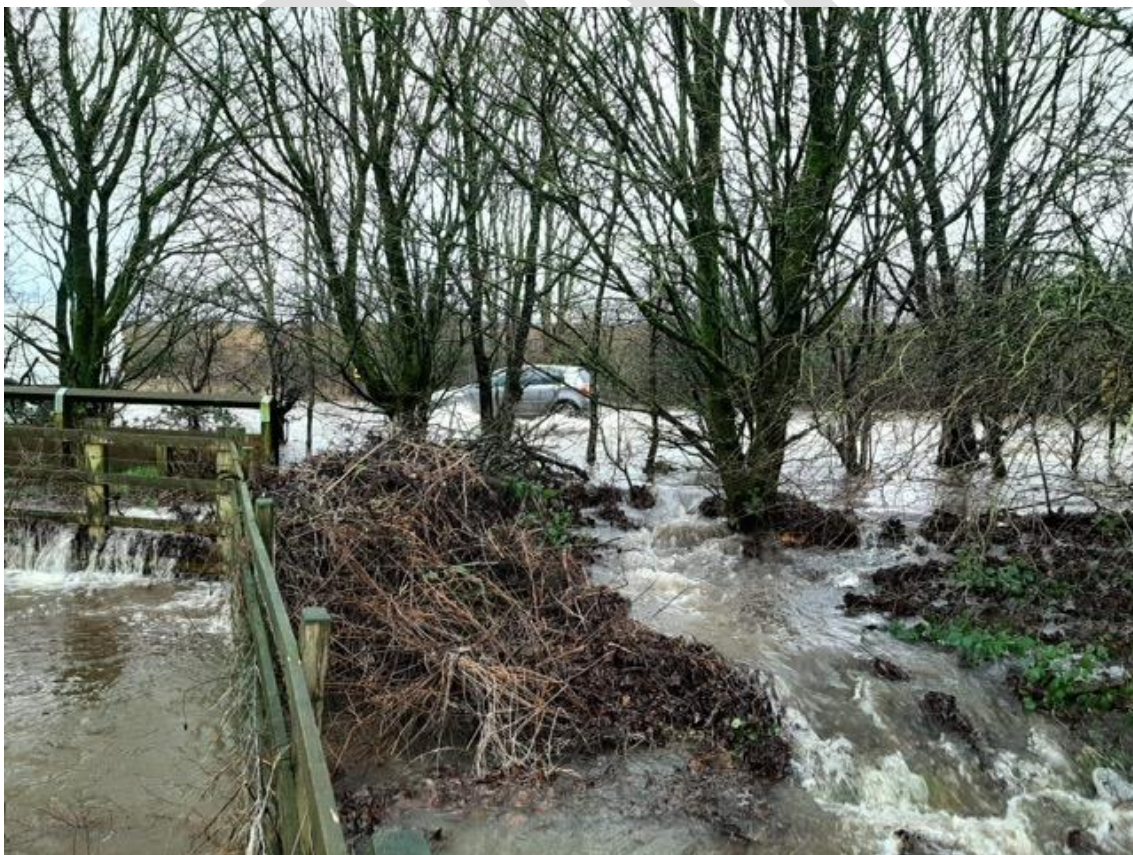
It is apparent from the submitted photographs that significant amounts of water is by-passing structure (Figure 15) erected next to the A65 which is resulting in continued flooding of the properties.

Figure 15: Gildersleets - floodwater by-passing bund

- 5.1 The following recommendations are made as a result of the conclusions of the Section 19 report:
- 5.2 LLFA and NYCC Highways to work with the community of Gildersleets to review the feasibility of any flood alleviation or improved resilience scheme for the community.
- 5.3 All risk management authorities to continue responsive service and the monitoring of Swinney Beck in Masham.

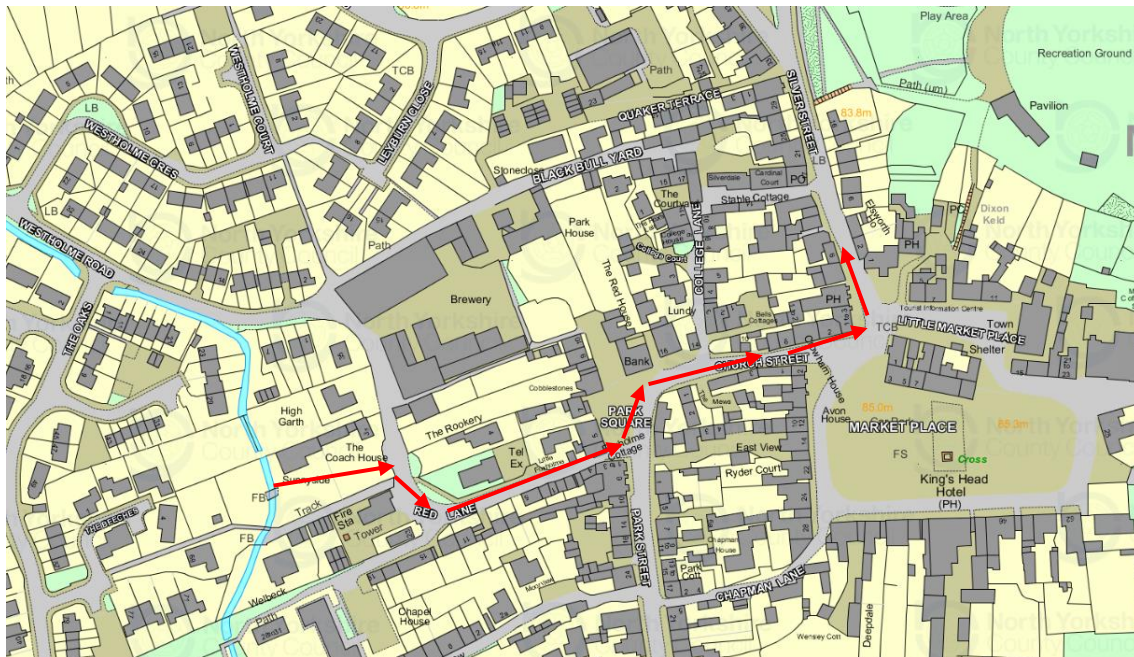
Figure 16: Masham Flood Flow Route 9th February 2020

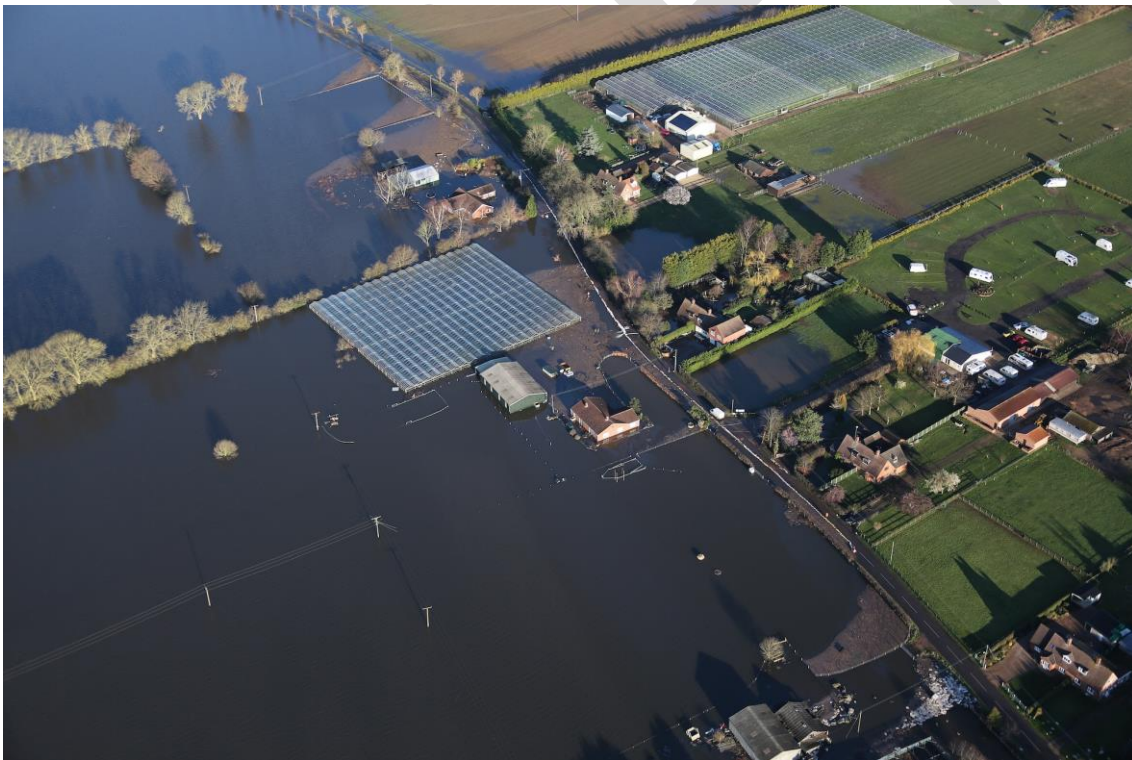
In terms of exacerbating the flooding, again it is impossible to say without further modelling how much impact, if any the makeshift defence had on water levels. Given the enormous expanse of floodplain, a bund of this sort is unlikely to raise water levels at all, if only by a few millimetres, certainly not enough to cause further damage than had already been caused. Whilst the Section 19 cannot make comment on the immediate emergency response, the uncertainty about where or not it increased flood risk to the south of the river and the introduction of residual risk associated with breach is considered unacceptable and a bund of this sort should not be attempted in future unless endorsed by the EA as part of its emergency response.

Figure 17: West Bank - Makeshift Defence Extent

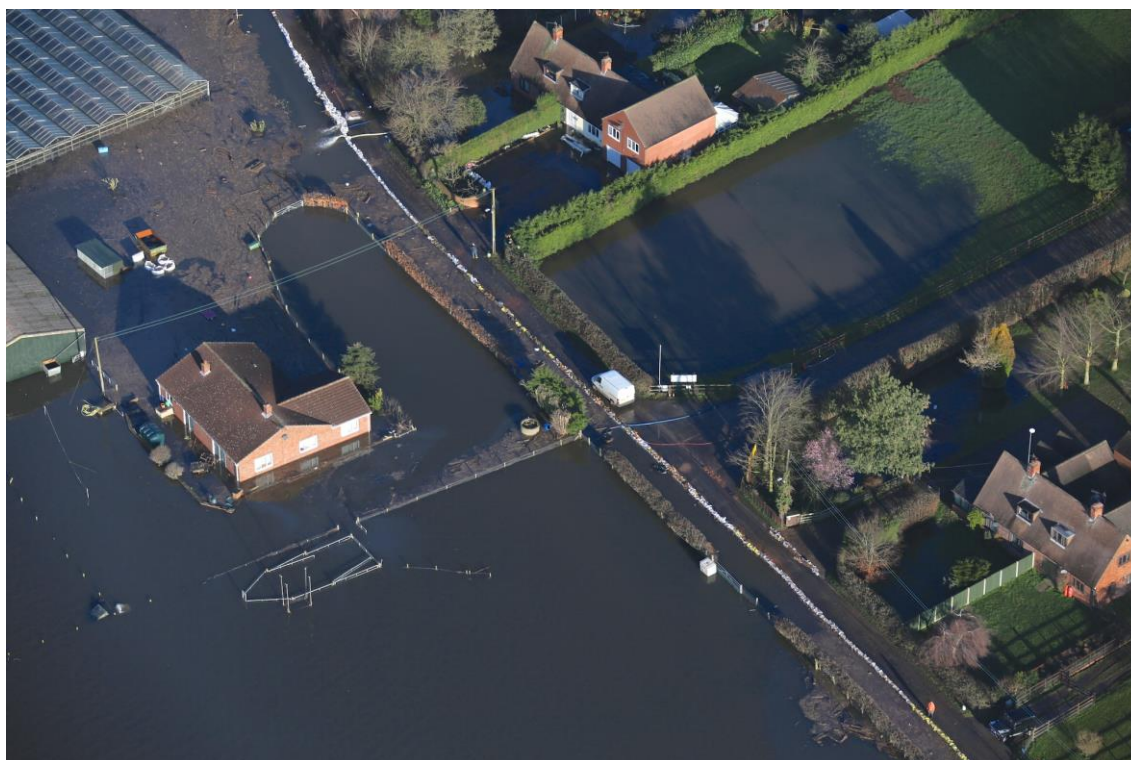
Figure 18: West Bank - Makeshift Defence

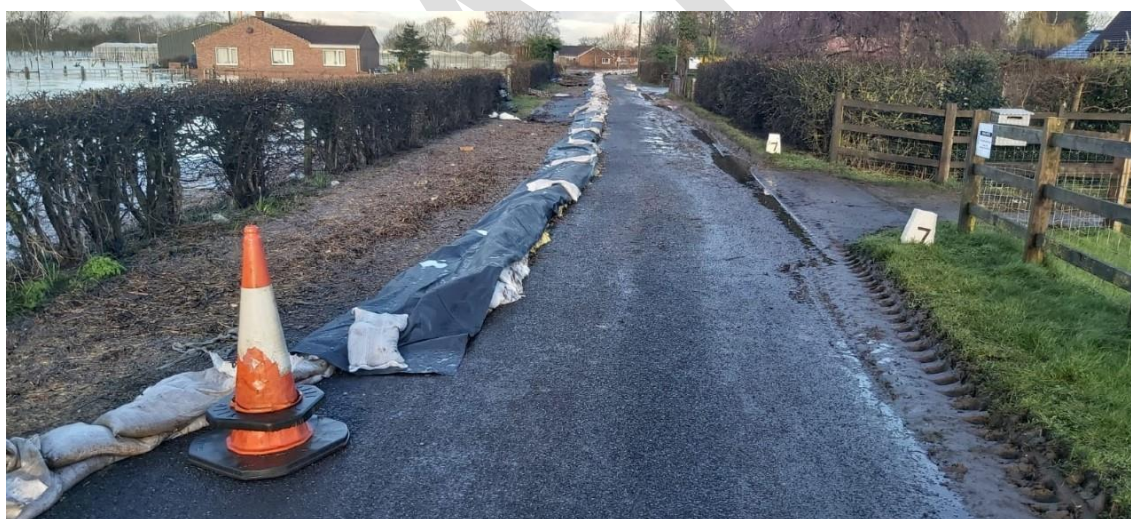
Figure 19: West Bank Visqueen and Rubble Defence

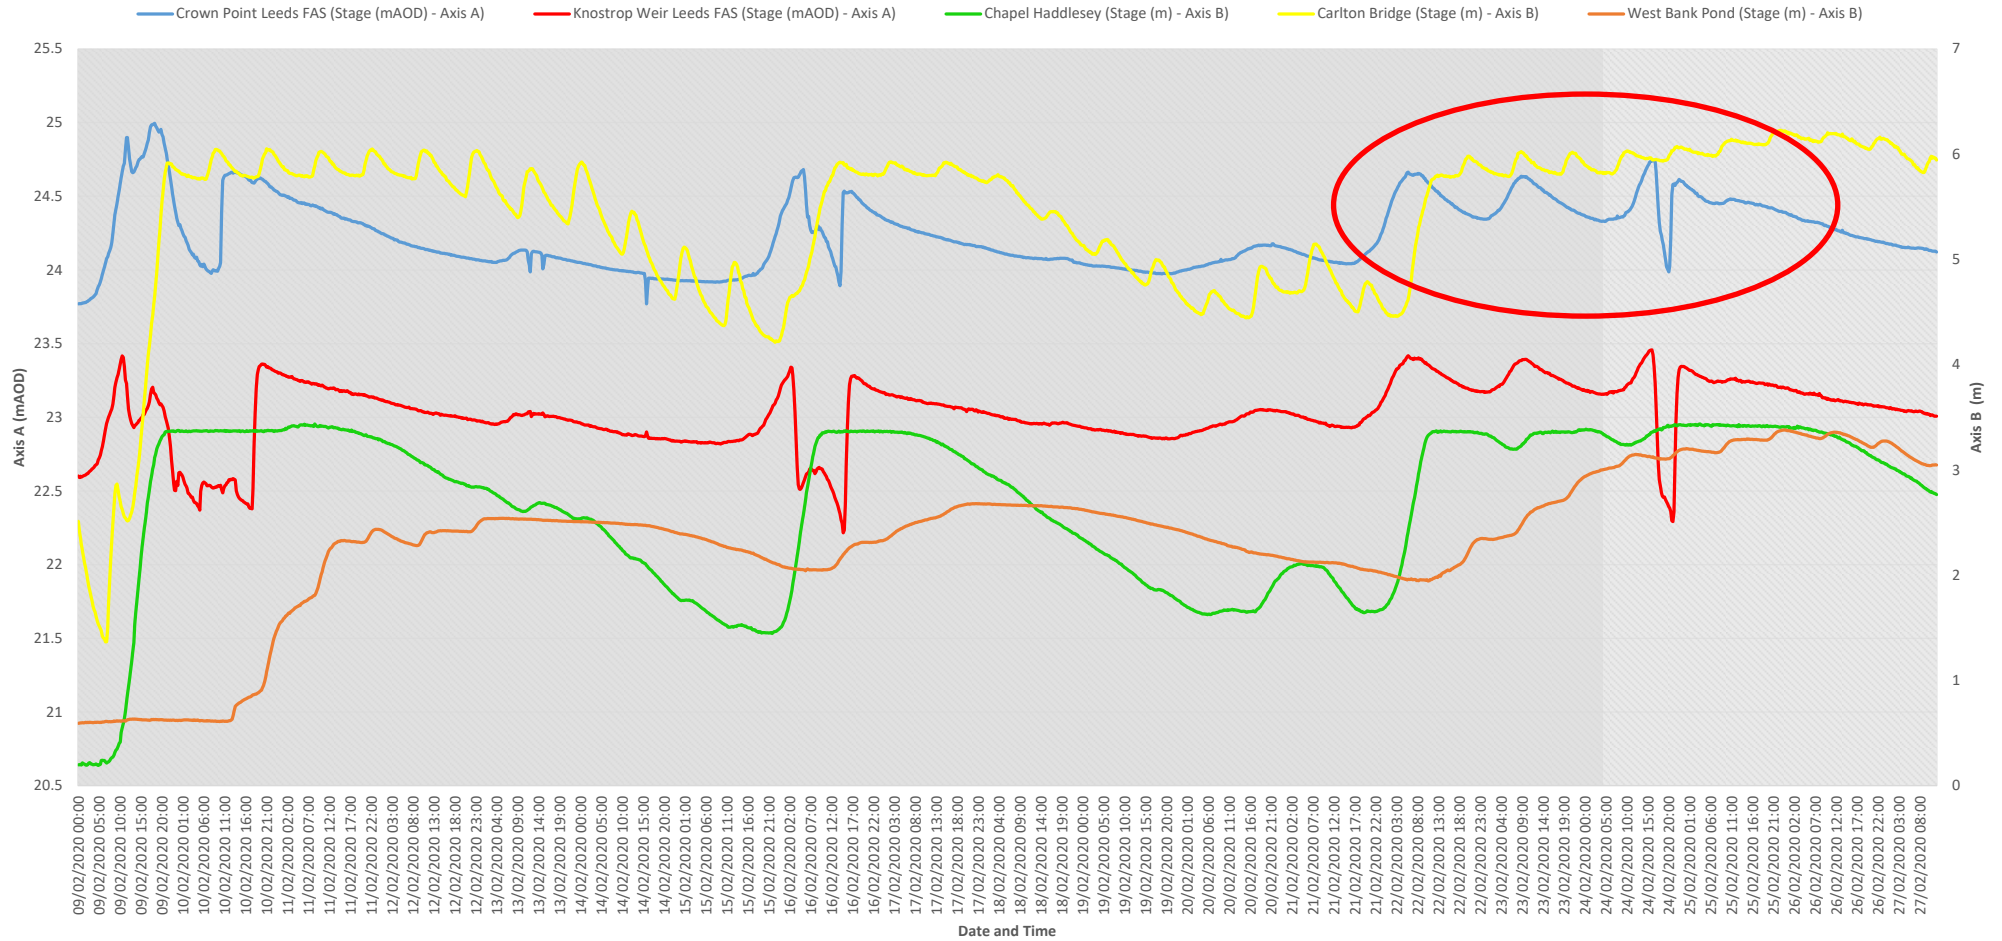
Figure 20: River Aire and West Bank Pond Levels

The operation of the weirs in Leeds can be identified from the stage data presented in Figure 20. It is clear that the weirs were operated during Storm Ciara and Dennis with no ill effects noted in the Lower Catchment i.e. no flooding reported.

River Aire Hydrographs 9th - 27th February 2020

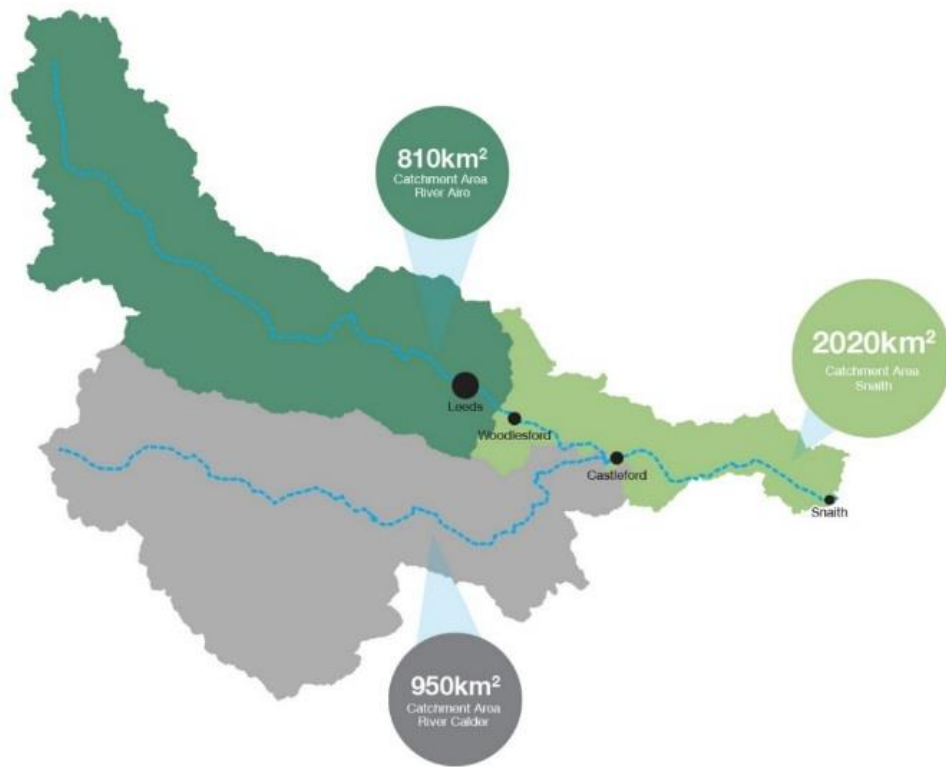
- The Leeds FAS Flood Risk Assessment showed, from modelling, that the impact on river levels only reached as far as Woodlesford which is 6km (just under 4 miles) downstream of Leeds. Snaith is 44km (27 miles) downstream of Leeds.
- The ability of river levels in Leeds to influence flood levels downstream on the River Aire is strongly influenced by relative catchment size. The catchment size of Leeds is a very small proportion of the catchment size at Snaith which also includes the River Calder (see diagram below).

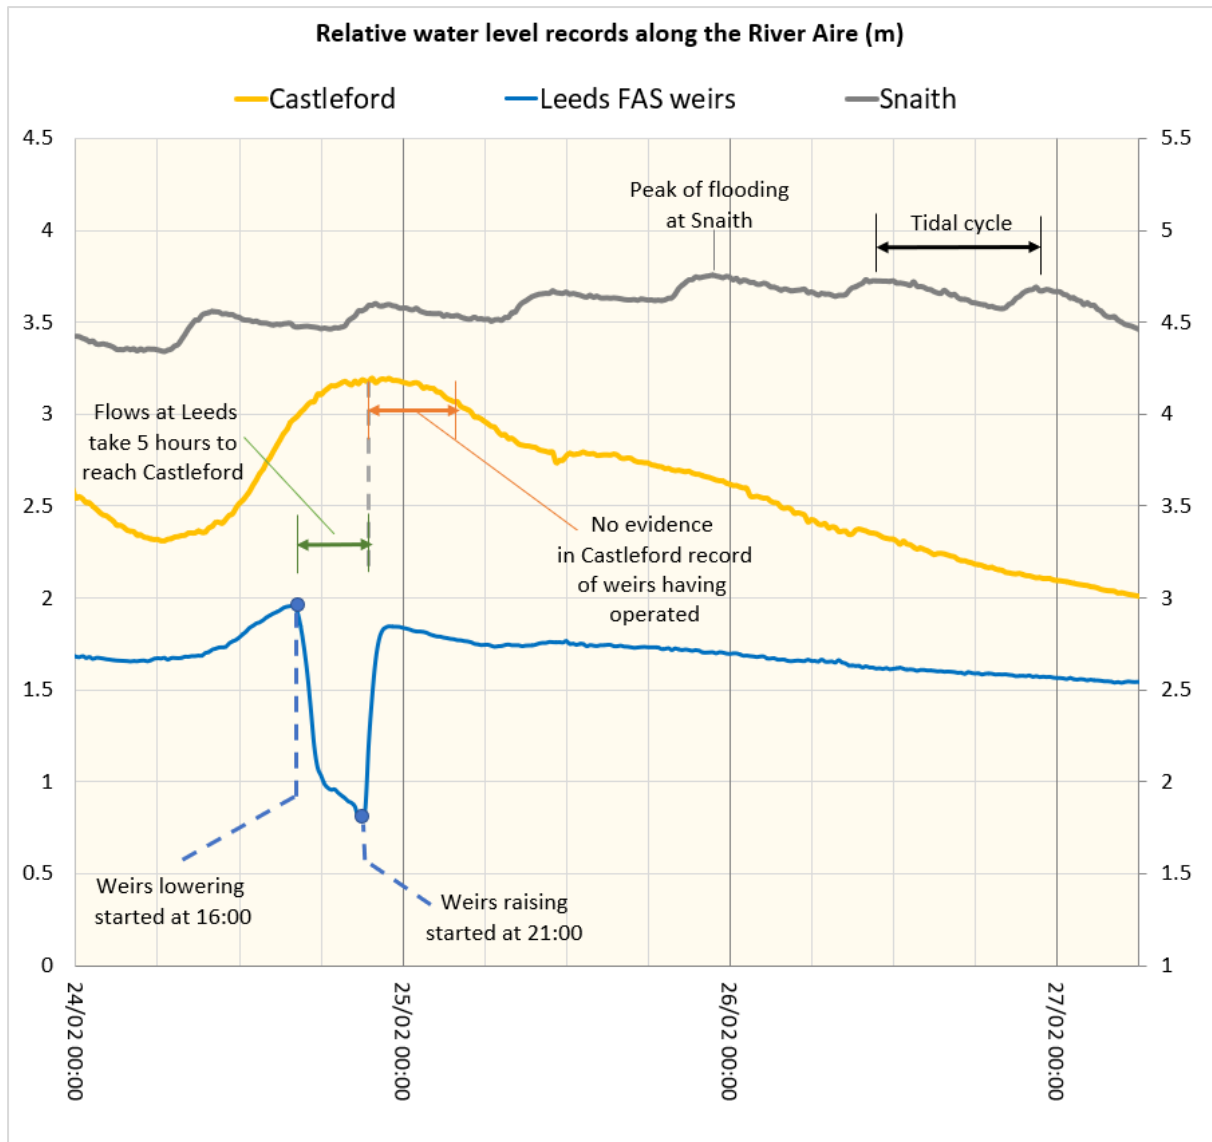
The Leeds FAS weirs were lowered on a single occasion on the 24 February at 16:00hrs. Gauge information downstream of Leeds, at Castleford, gives no indication of any influence of the weirs on downstream flows. See graph below that also shows levels at Snaith for comparison.
