**7. Section 19 Investigation Report on the 6 May 2024 Flood Event in Knaresborough (Pages 11 - 60)**

To inform Members on the conclusions and recommendations of the Flood Investigation report on the significant flood event that affected Knaresborough on 6 May 2024.

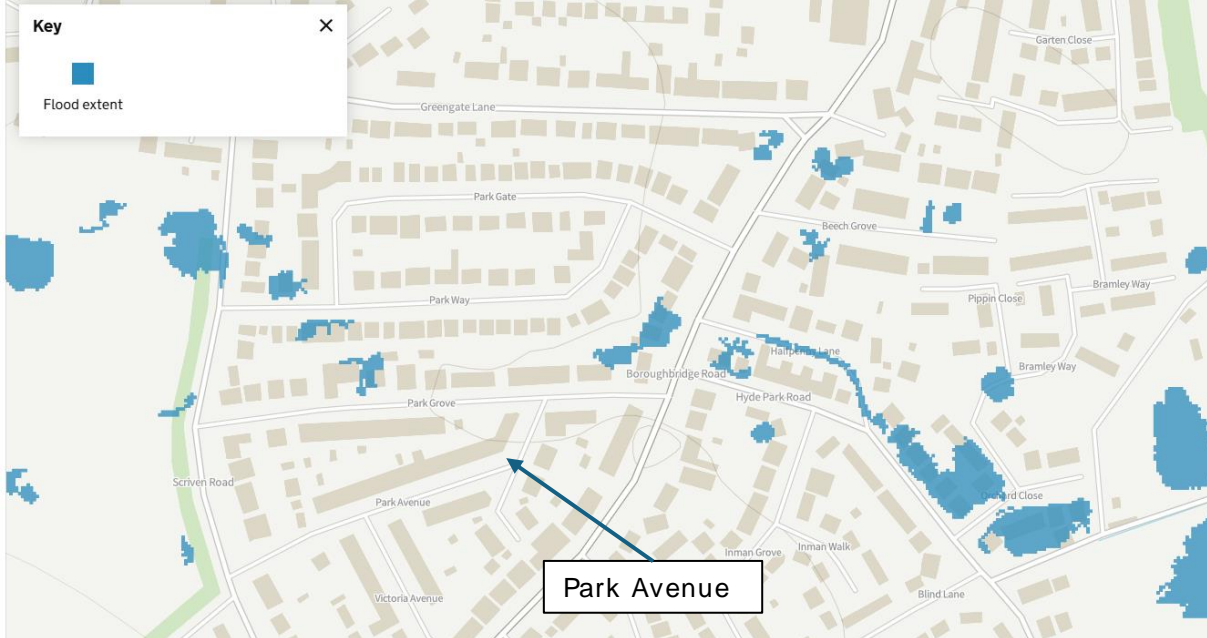
Table 1: Park Avenue Understanding of Flood Risk

The Risk of Flooding from Surface Water map indicates that there are some pockets of High risk of flooding (1 in 30 year event) associated with localised low spots along Park Grove but properties along Park Avenue are not show to be at risk. In the Medium and Lower likelihood scenarios, the flood extents expand, and flow paths emerge from Jacob Smith Park and flow along Park Grove, whilst some flood extent would be expected in the 1 in 1,000 year event on Park Avenue and significant flooding on Park Grove, the properties on Park Avenue that reported flooding continue to be indicted as being very Low risk.

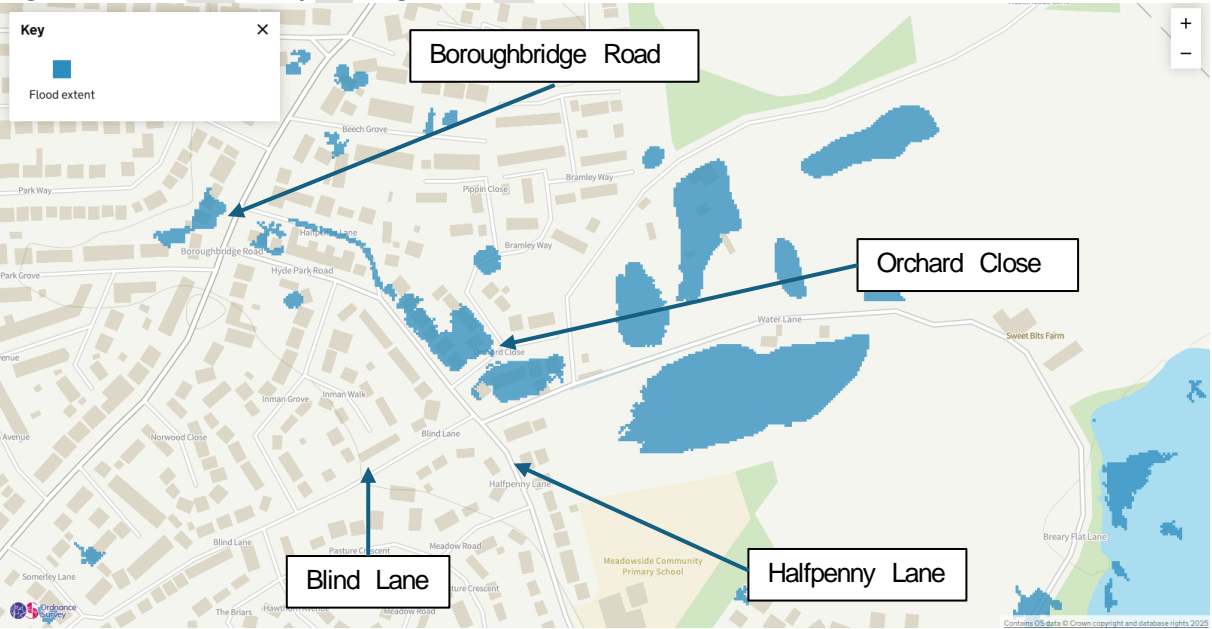
Table 2: Orchard Close and Halfpenny Lane Understanding of Flood Risk

The maps identify a large number of properties within the High and Medium risk area from surface water flooding. Initially in the High risk scenarios the flooding is isolated to ponding within low spots. As the intensity increases it appears that the highways become conduits for surface water. There is a strong correlation of runoff along Park Grove, Boroughbridge Road and Blind Lane converging on Halfpenny Lane and the Orchard.

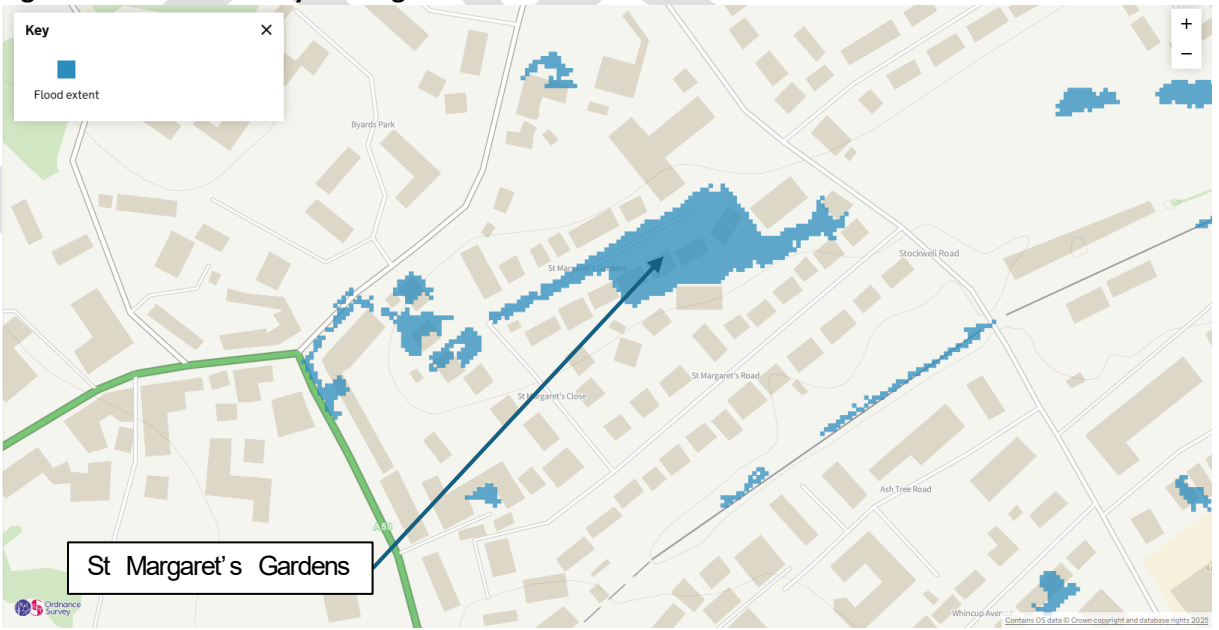
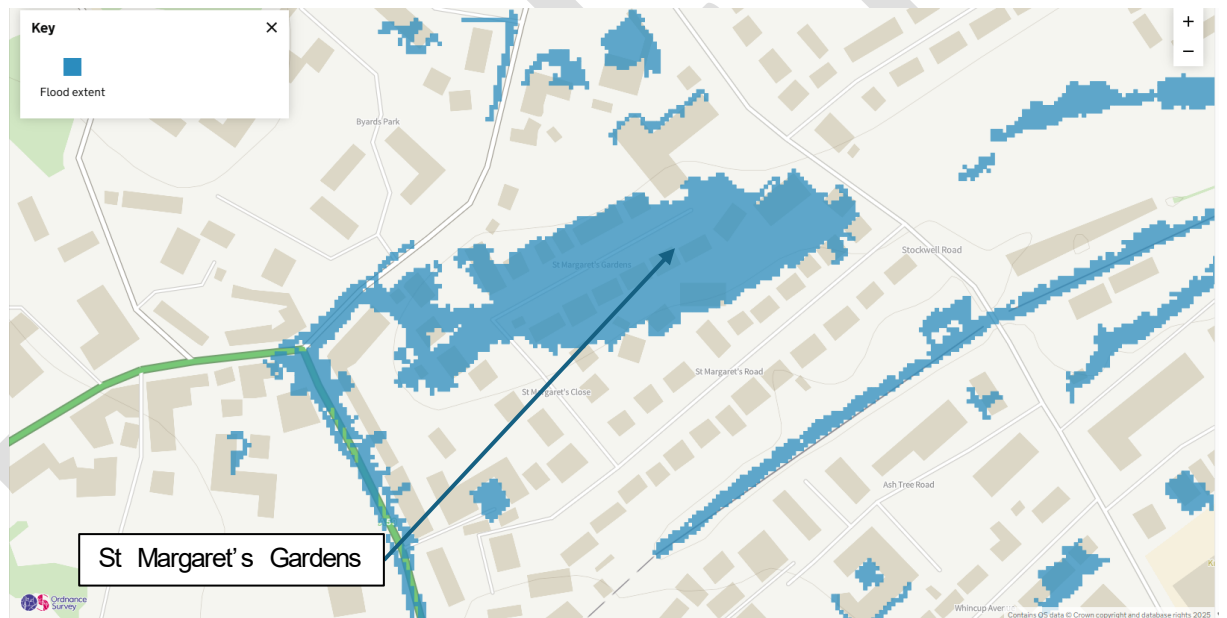
Table 3: St Margaret's Gardens: Understanding of Risk

It is noted the map above shows the surface water flood risk for St Margaret's Gardens. The data presents a large area of properties that are within the High and Medium risk area from surface water flooding. The mapping in this location shows a higher number of properties at risk of flooding than reported flooding during event. It could be considered that the above flood extent and risk is conservative.

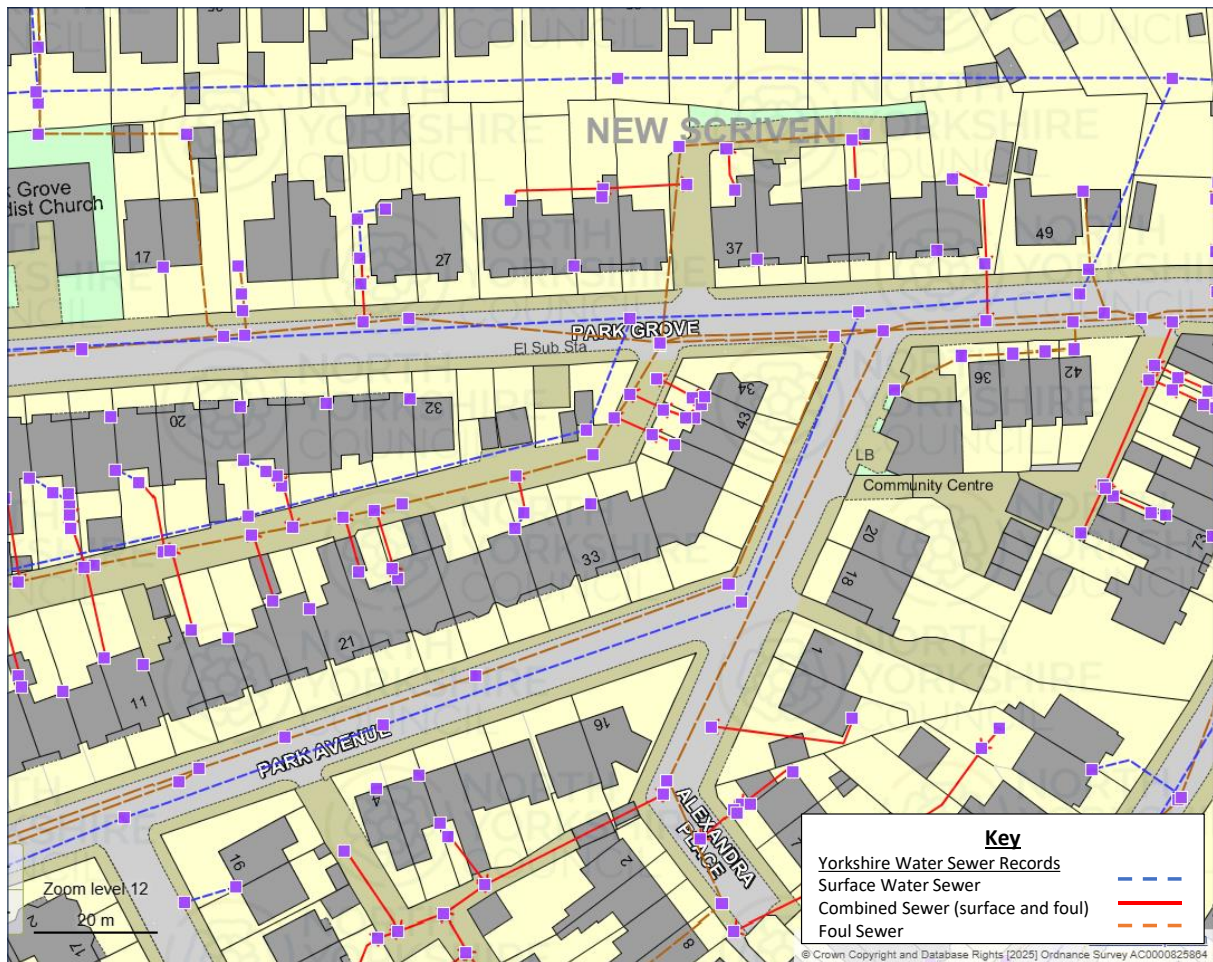
Figure 3: Park Avenue Public Sewer Records

The area is served by a network of public foul and surface water sewers in Figure 3. It is noted however that a number of the properties area indicated to have a single combined foul and surface water drain (denoted red) connecting to the foul only sewer (brown lines) . This suggests that surface water is being discharge d into a system that was historically designated for foul waste water only. The public sewers are maintained and regulated by Yorkshire Water. The location of NYC highway drainage is presented in Figure 4.

Whilst the foul sewer was running fine during the investigation the flow rapidly increased during a 5-minute rain shower observed. It is noted that Yorkshire Water have already removed an interceptor trap to try and improve the flow out of one of the properties.

It is noted from the resident's witness account that this is not the first instance of flooding from this source, with flooding reported in 2006, 2021 and 2024. Whilst the event of 6<sup>th</sup> of May was unprecedented the issue on Park Avenue does not appear to be isolated and points to a long-term issue with miss-connections of surface water into the foul drain. The foul drain is designed to accommodate the foul water only from the properties and surface water should not be connected to the foul drains, as such, the drain does not have any capacity for surface water runoff resulting in flooding.

A recommendation is made that YW continues to monitor and explore means of resolution to the internal flooding on Park Avenue. Residents should also check where possible whether their drainage is combined or separate and make enquiries with Yorkshire Water as to how the miss-connections could be resolved or their impacts reduced by slowing the flow through sustainable drainage methods such as water butts or raingardens.

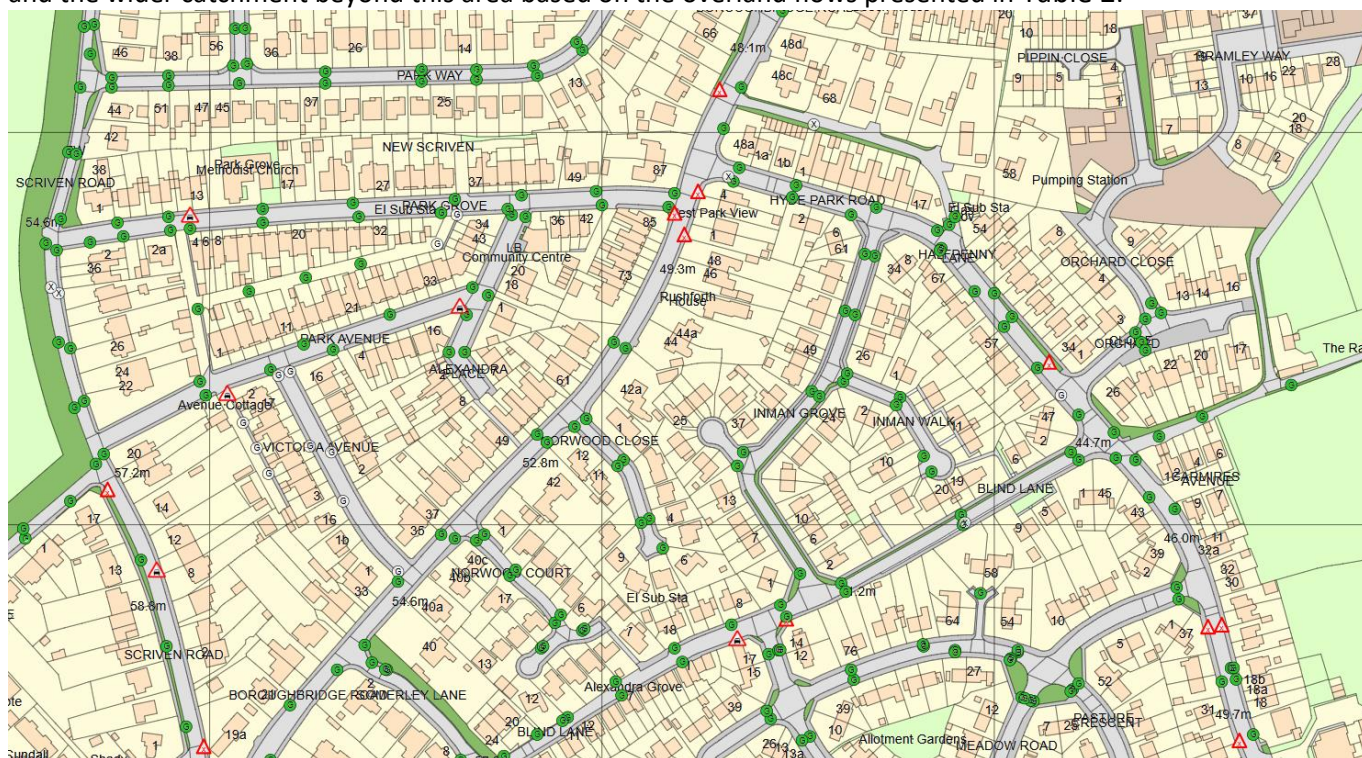
Figure 6: Kaarbontech Data for Park Avenue, Halfpenny Lane and Orchard Close

Figure 6 below shows the current layout of highway gullies within the vicinity of Halfpenny Lane and Orchard Close and the wider catchment beyond this area based on the overland flows presented in Table 2.

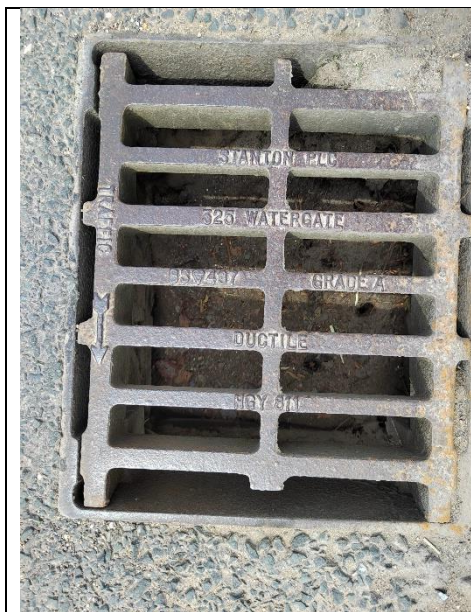
Figure 8: Gully Halfpenny Lane

Further gullies on Blind Lane were also identified by residents as being ineffective during the event. Photographs of the two gullies are presented in Figure 9 and Figure 10 below. The gully in Figure 9 is blinded with debris. It cannot be proven when this occurred, but a significant amount of debris would have been washed onto the gully grate during the event. The gully chamber and outlet were not full and blocked. Likewise, the gully in Figure 10 does have vegetation growing out of the grate, but the gully chambers itself was clear with the outlet functional. This indicates that the two particular gullies whilst blinded are emptied at an appropriate frequency. It does highlight however a requirement for further sweeping and inspections.
